Elder Creek Stormwater Facility Performance Efficiency Evaluation

Final Report

September 2010

Seminole County, Florida

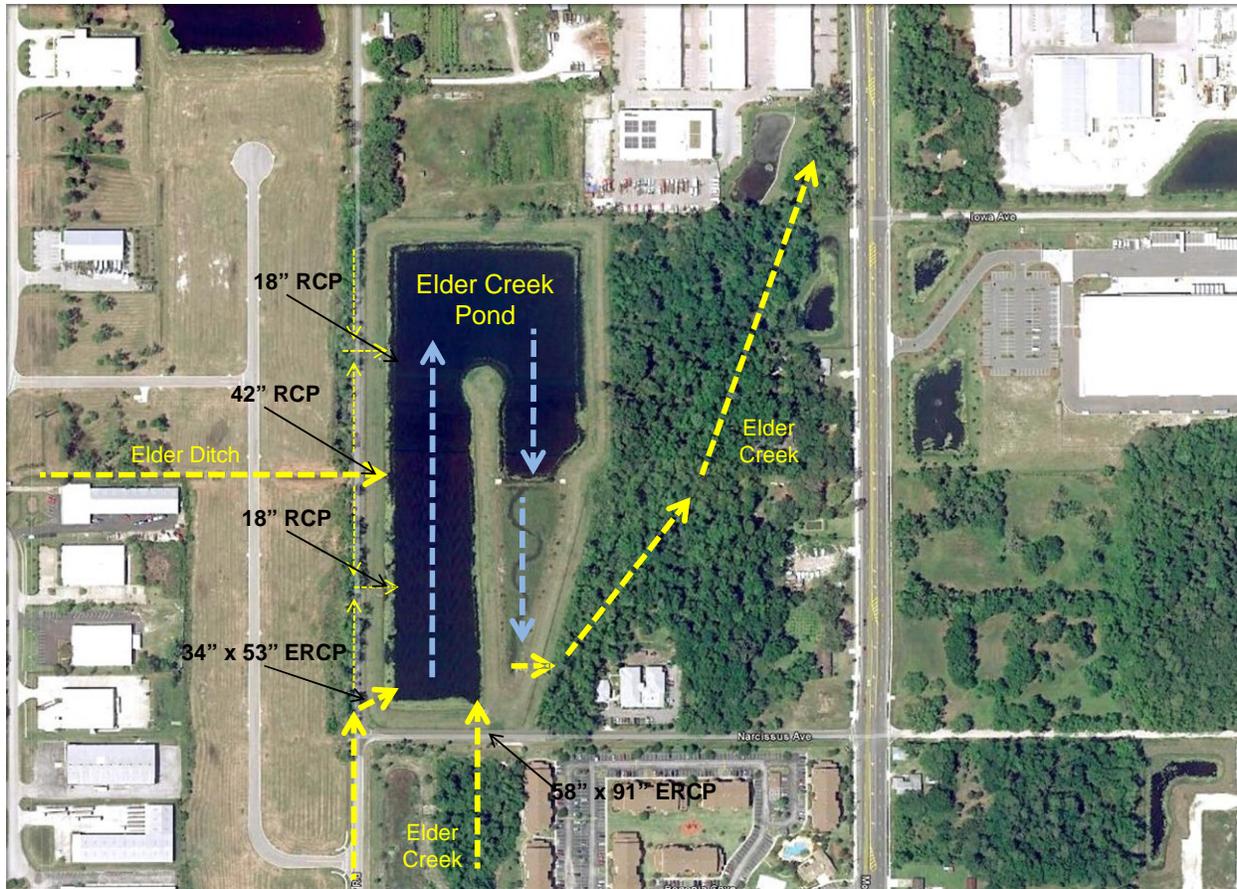
Figure 1-3. Significant Inflows and Water Movement in the Elder Creek Wet Detention Pond.

An aerial overview of the Elder Creek regional stormwater facility is given on Figure 1-2, and a schematic of significant inflows and flow patterns is given on Figure 1-3. The treatment system consists of an 11.35-acre wet detention pond which was constructed on-line along the historical flow path for Elder Creek. A north-south peninsula was added to prevent short-circuiting and to maximize the flow path within the pond. Inflows into the pond first enter the open water segment which consists of a wet detention pond with a maximum depth of approximately 8 ft.

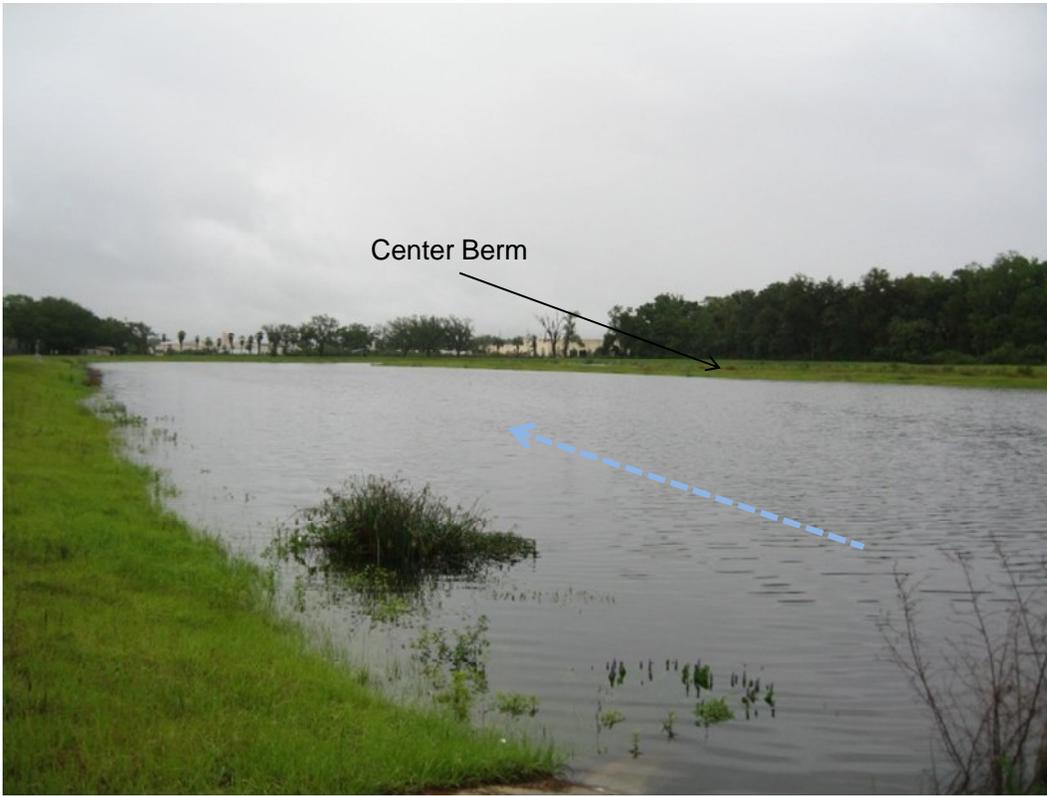
Figure 1-4. Open Water Areas of the Elder Creek Pond.

A photograph of open water areas on the west side of the Elder Creek pond is given on Figure 1-4. The open water portion of the pond is approximately 9.90 acres in size. Discharges from the open water area occur over the 181-ft long broad-crested weir structure indicated on Figure 1-5 which is located on the east side of the peninsula. A fiberglass skimmer is located upstream from the weir structure to prevent floating material from discharging over the weir. Discharges over the weir enter a 1.45-acre shallow wetland littoral zone is intended to provide final polishing for the creek inflows prior to reaching the outfall structure for the pond. A photograph of the shallow wetland littoral zone area is given on Figure 1-6.

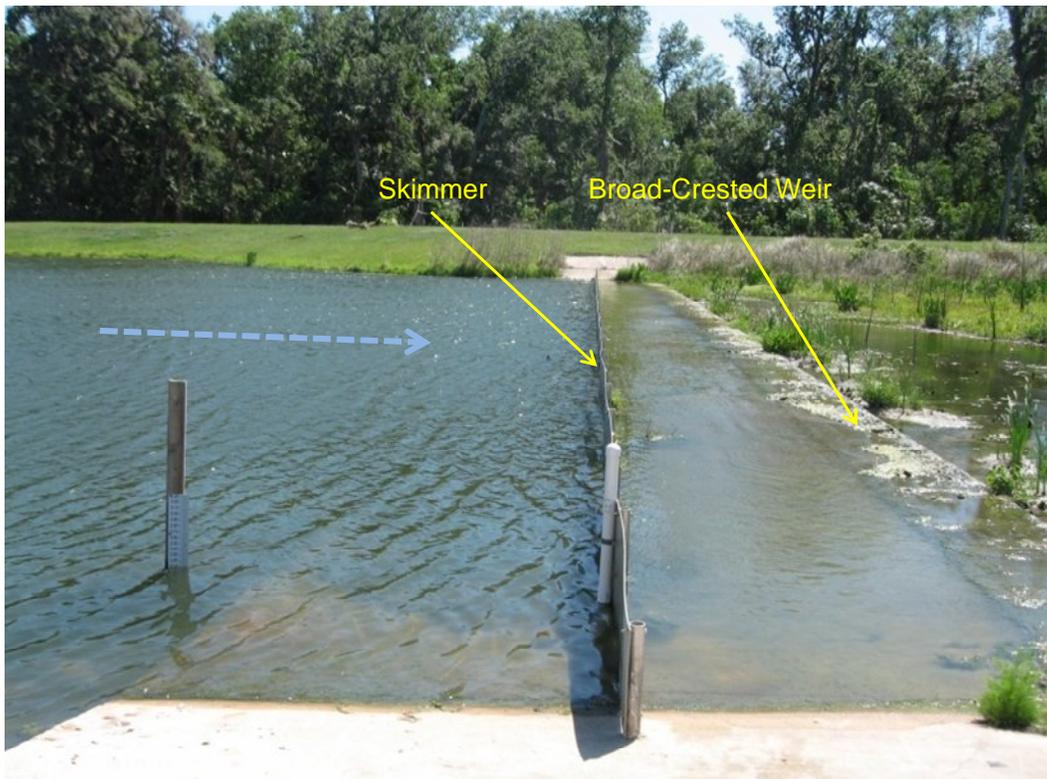
Figure 1-5. Broad-crested Weir Structure.

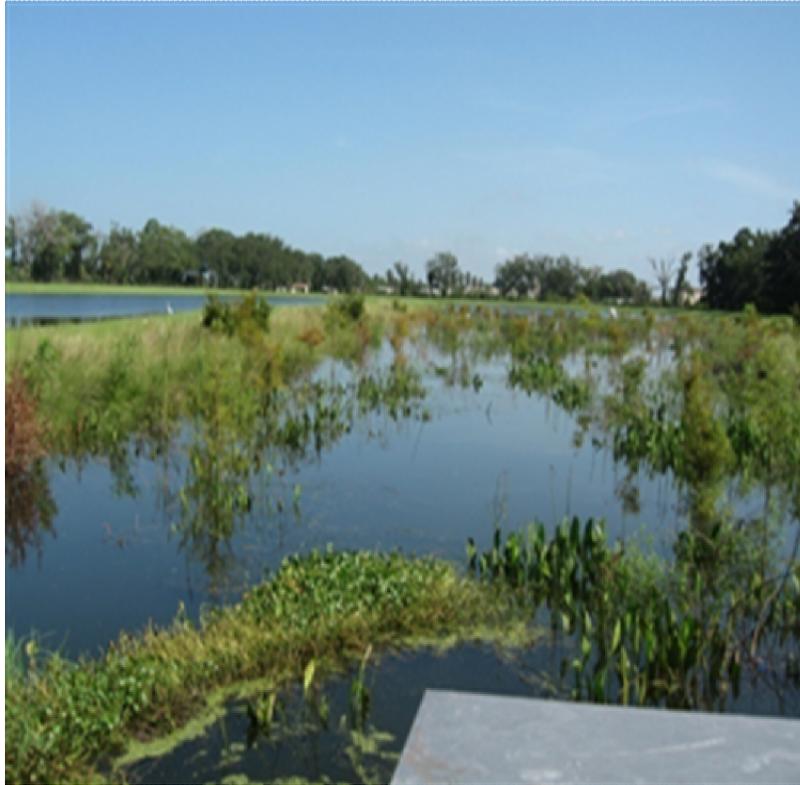
Figure 1-6. Shallow Wetland Littoral Zone.

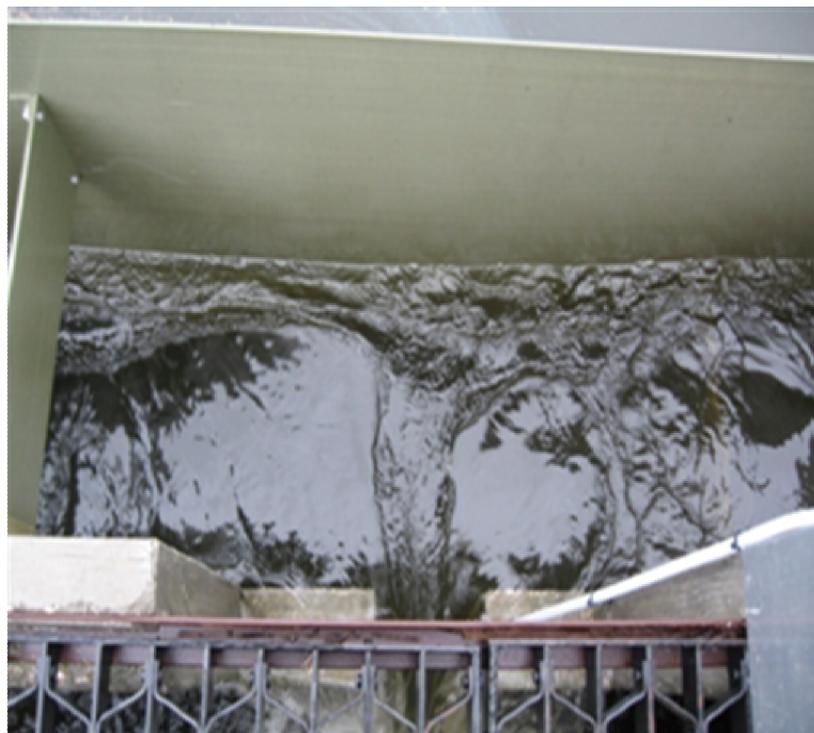
Figure 1-7. Pond Outfall Structure.

A photograph of the pond outfall structure is given on Figure 1-7. The outfall structure contains a compound rectangular weir which provides for slow release of water from the system during small rain events and larger release rates during conditions of high inflow rates into the pond. Discharges through the outfall structure travel through a 42-inch RCP and ultimately rejoin the historic flow path of Elder Creek. Photographs of the pond discharge and the point of inflow to Elder Creek are given on Figure 1-8. The design of the pond requires that all discharge through Elder Creek must pass through the treatment pond even under high flow conditions.

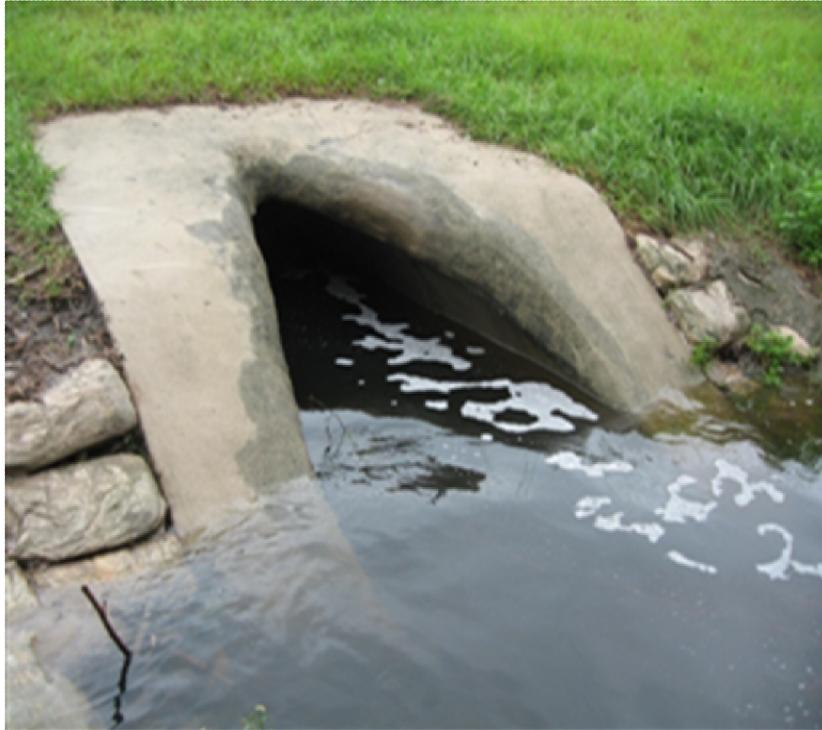
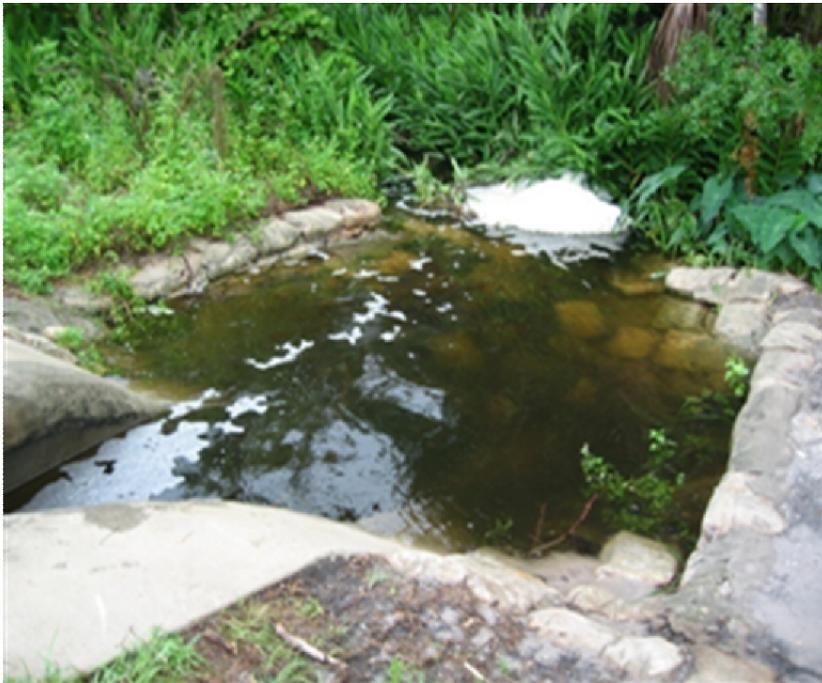
a. Outfall Discharge Pipe

b. Inflow to Elder Creek

Figure 1-8. Pond Discharge and Inflow to Elder Creek.

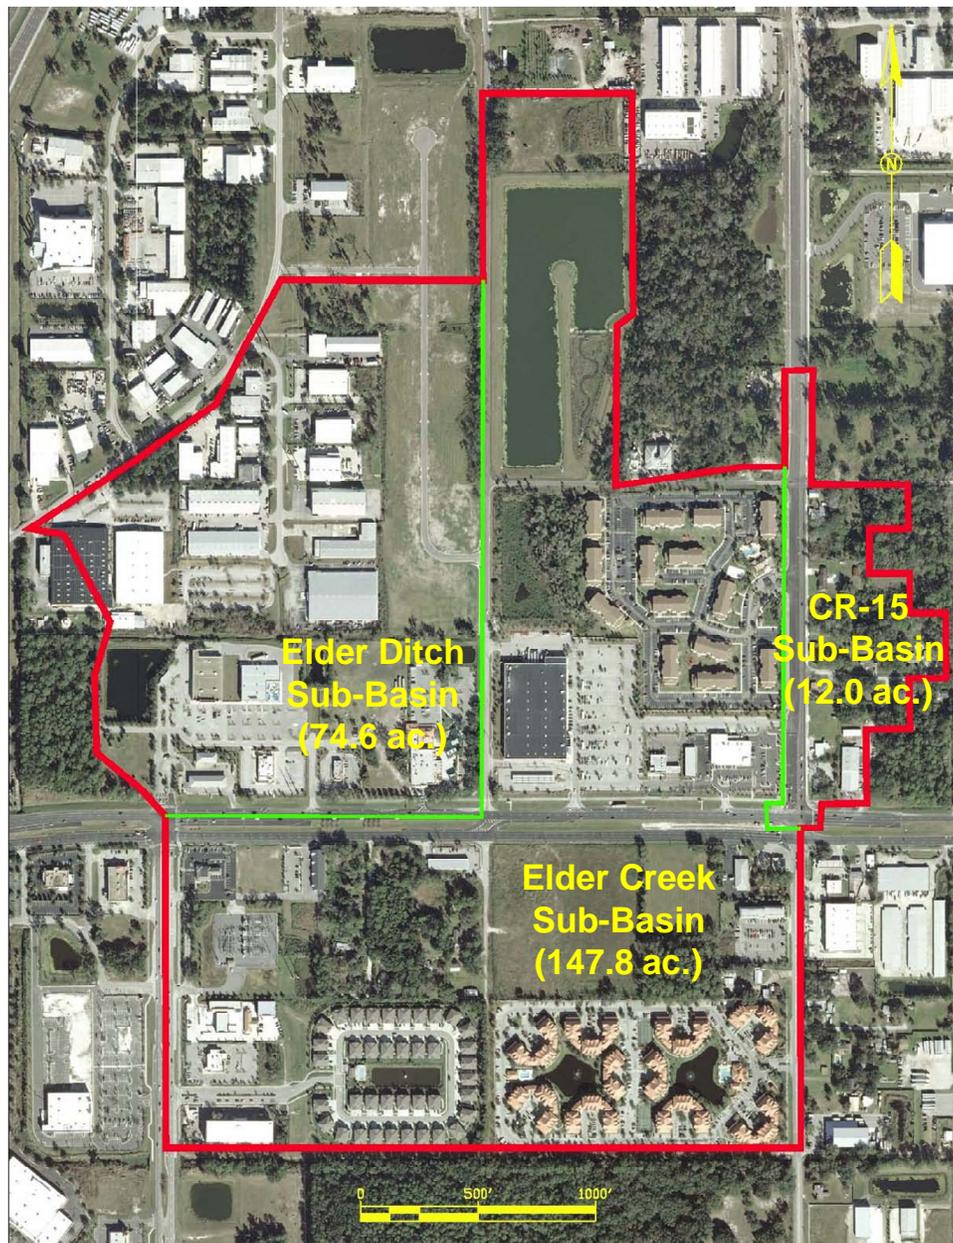
Figure 1-9. Overview of the Elder Creek Pond Basin Area.

An overview of the contributing drainage basin area for the Elder Creek wet detention pond is given on Figure 1-9. The basin area includes approximately 74.6 acres of the 220-acre Elder Ditch sub-basin which is located west and southwest of the Elder Creek pond and approximately 147.8 acres of the 396-acre Elder Creek sub-basin which is located primarily south and east of the pond. In addition, the pond also provides treatment for approximately 12 acres of sub-basin areas associated with CR-15 (Monroe Road), located immediately east of the Elder Creek pond. Overall, the contributing drainage basin area to the pond is approximately 234.4 acres. According to CDM (2002), approximately 80% of the sub-basin areas consist of impervious surfaces.

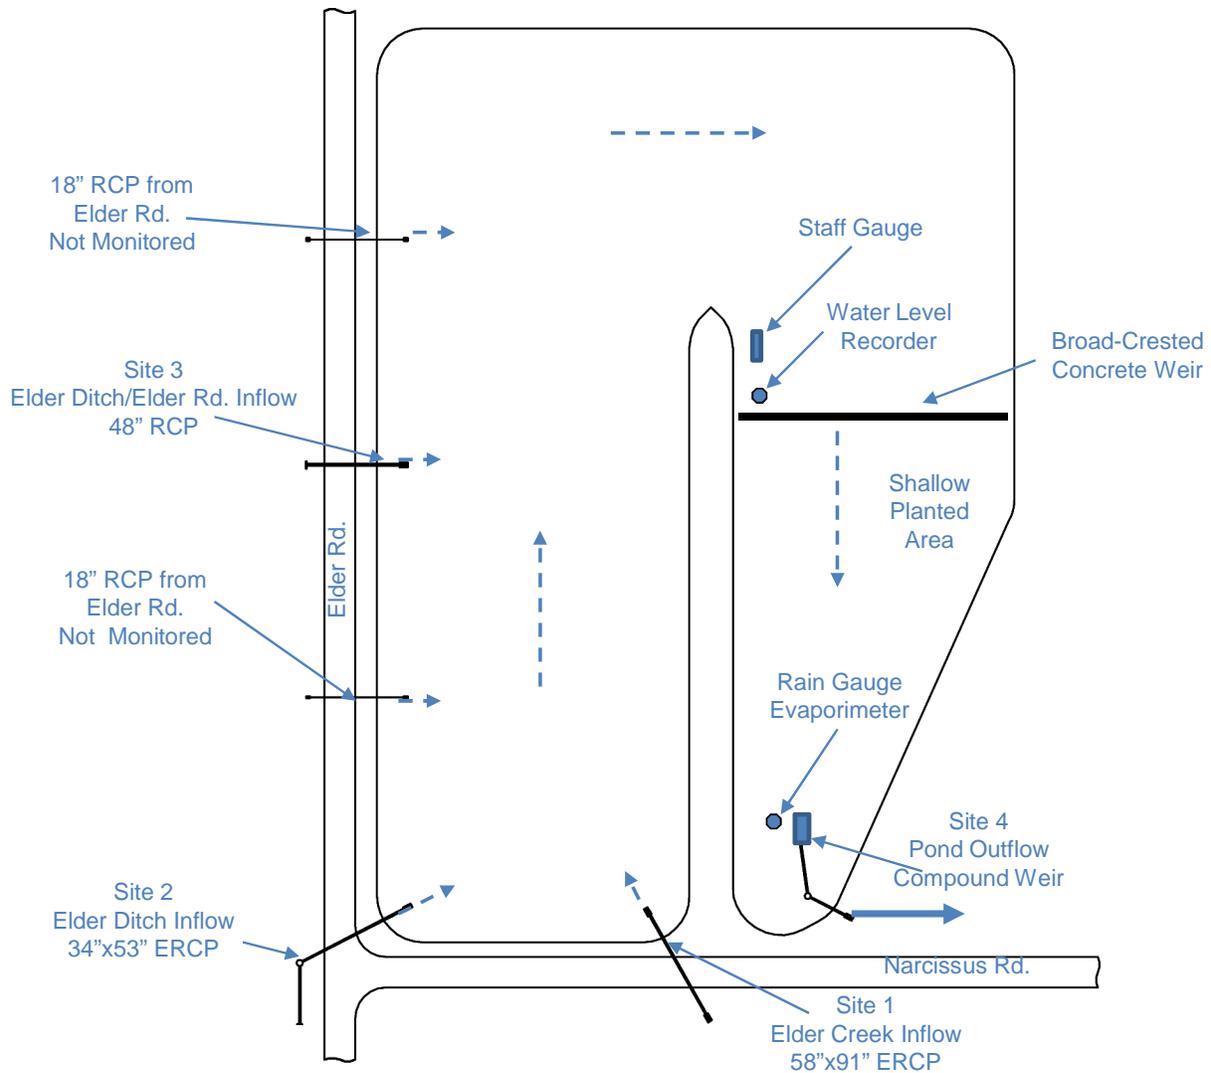
Figure 2-1. Monitoring Locations for the Elder Creek Site.

As discussed in Section 2.1 and illustrated on Figure 2-1, two smaller 18-inch RCP inflows, which provide drainage for portions of Elder Road, were not directly monitored as part of this project. These inflows were thought to be relatively minimal in comparison with the larger inflows which were included in the monitoring program. As a result, inflows from the smaller inputs were estimated using hydrologic modeling of the estimated runoff volume generated during each of the individual monitored rainfall events summarized in Table 3-1. This modeling exercise is used to represent the total runoff volume which discharged into the Elder Creek pond from the two 18-inch RCP inflows along the west side of Elder Road.

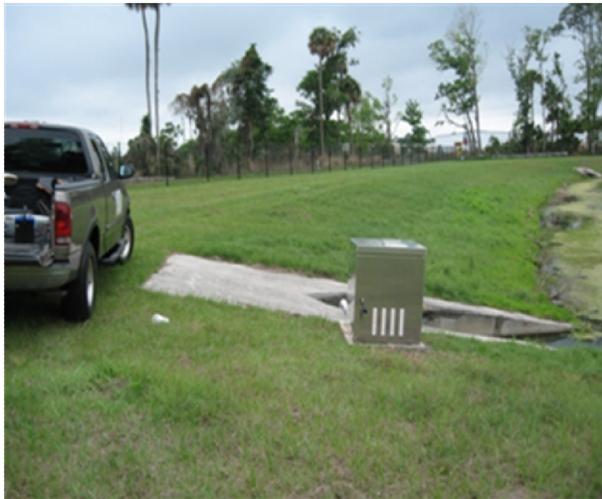
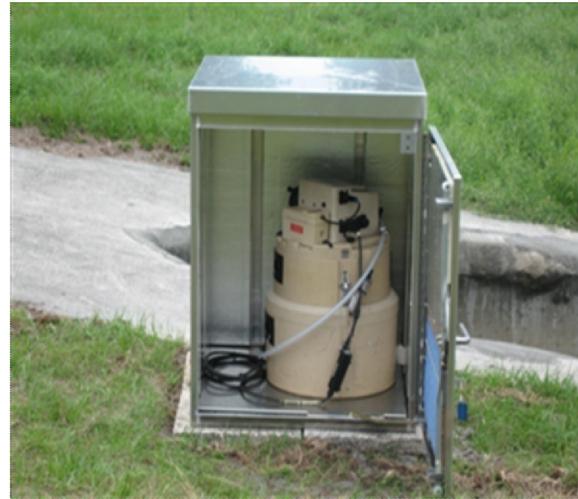
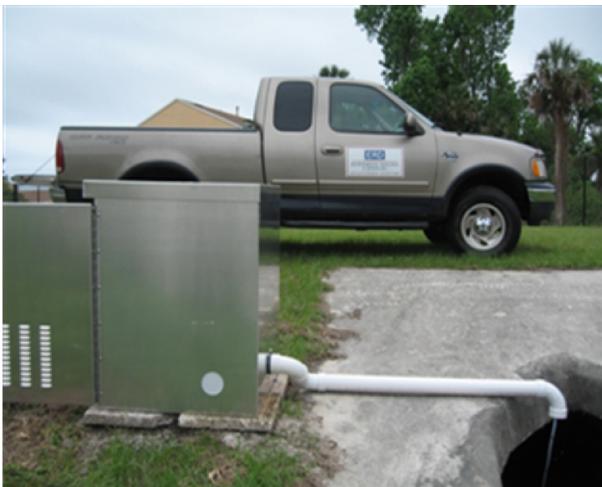
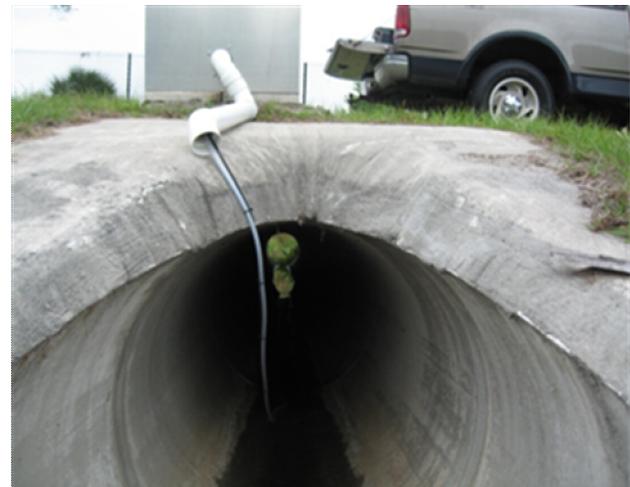
Figure 2-2. Inflow Monitoring Equipment at Site 1.

a. Equipment Location

b. Sampling Equipment

c. Housing for Sample Tubing and Flow Probes

d. Sample Intake and Flow Probe Extended into Pipe

Stormwater samplers with integral flow meters were installed at each of the three inflow (Sites 1, 2, and 3) and outflow (Site 4) monitoring sites indicated on Figure 2-1. The inflow monitoring site for Elder Creek (Site 1) was located in the 58-inch x 91-inch ERCP approximately 15 ft upstream from the point of inflow to the pond. An automatic sequential stormwater sampler with integral flow meter, manufactured by Sigma (Model 900MAX), was installed adjacent to the pipe inflow. The autosampler was housed inside an insulated aluminum shelter, and sensor cables and sample tubing were extended approximately 15 ft inside the 58-inch x 91-inch ERCP. This autosampler was used to provide a continuous measurement of inflow into the treatment pond from Elder Creek under both storm event and baseflow conditions, as well as to collect flow-weighted samples at the inflow over a wide range of flow conditions. The internal flow meter was programmed to provide a continuous record of inflow into the pond, with measurements stored into internal memory at 10-minute intervals. The

automatic sampler contained a single 20-liter polyethylene bottle and was programmed to collect samples in a flow-weighted mode, with 500 ml aliquots piped into the collection bottle with every programmed increment of flow. Since 120 VAC power was not available at the site, the automatic sampler was operated on 12 VDC batteries which were replaced on a periodic basis. Photographs of inflow monitoring equipment used to monitor the 58-inch x 91-inch ERCP Elder Creek inflow at Site 1 are given on Figure 2-2.

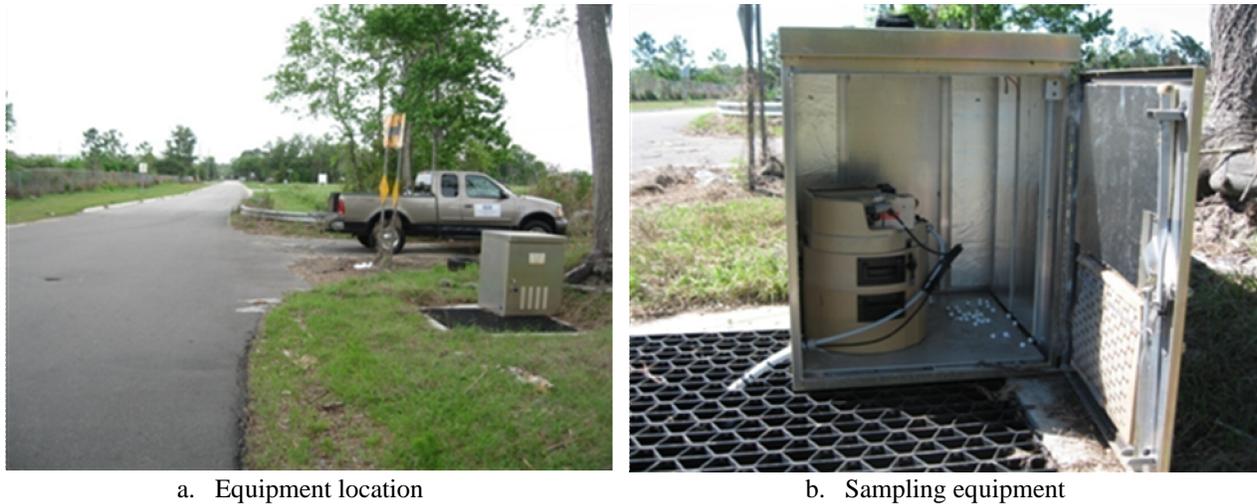
Figure 2-3. Inflow Monitoring Equipment at Site 2.

Inflow monitoring Site 2 was located inside the 34-inch x 53-inch ERCP which discharges into the southwest side of the Elder Creek pond. Photographs of this monitoring site are given on Figure 2-3. The monitoring site was located outside of the fenced perimeter of the pond at an upstream stormsewer junction located on the west side of Elder Road. This location was selected so that the flow monitoring site would be upstream from any significant tail water effects caused by the pond under typical rainfall conditions. An automatic sequential stormwater sampler with internal flow meter, manufactured by Sigma (Model 900MAX), was installed on top of the grate structure for the junction box. The autosampler was housed inside an insulated aluminum shelter, and sensor cables and sample tubing were extended from the sampler through the top grate to the flow monitoring site located approximately 15 ft upstream in the 34-inch x 53-inch ERCP. The integral flow meter was programmed to provide a continuous record of inflow, with measurements stored into internal memory at 10-minute intervals. The automatic sampler contained a single 20-liter polyethylene bottle, and was programmed to collect samples in a flow-weighted mode, with 500-ml aliquots pumped into a collection bottle with every programmed increment of flow. Since 120 VAC power was not available at the site, the automatic sampler was operated on 12 VDC batteries which were replaced on a periodic basis.

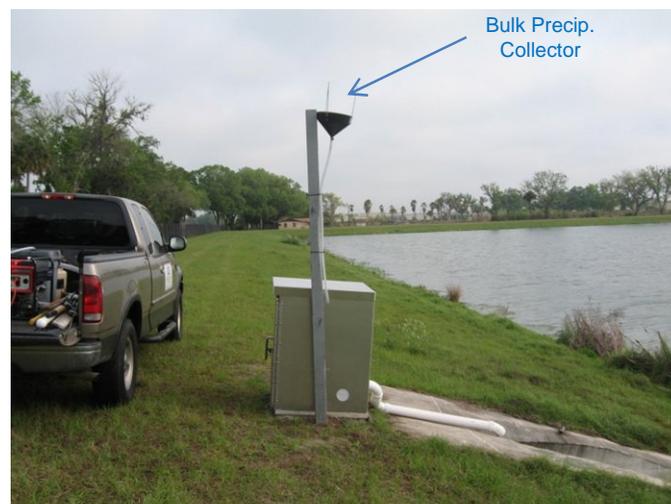
Figure 2-4. Inflow Monitoring Equipment at Site 3.

Inflow monitoring Site 3 was located on the west central portion of the pond. This site provides inflow from Elder Ditch, which enters the pond through a 48-inch RCP, as well as a relatively small amount of direct runoff from Elder Road. A photograph of monitoring equipment used at Site 3 is given on Figure 2-4. An automatic sequential stormwater sampler with internal flow meter, manufactured by Sigma (Model 900MAX), was installed adjacent to the inflow for the 48-inch RCP. The autosampler was housed inside an insulated aluminum shelter, and sensor cables and sample tubing were extended from the sampler approximately 15 ft upstream in the 48-inch RCP to avoid tail water impacts from the pond during routine storm events. The integral flow meter was programmed to provide a continuous record of inflow at this site, with measurements stored into internal memory at 10-minute intervals. The automatic sampler contained a single 20-liter polyethylene bottle, and was programmed to collect samples in a flow-weighted mode, with 500-ml aliquots pumped into a collection bottle with every programmed increment of flow. Since 120 VAC power was not available at the site, the automatic sampler was operated on 12 VDC batteries which were replaced on a periodic basis. The bulk precipitation collector was also located at this site and is indicated on Figure 2-4.

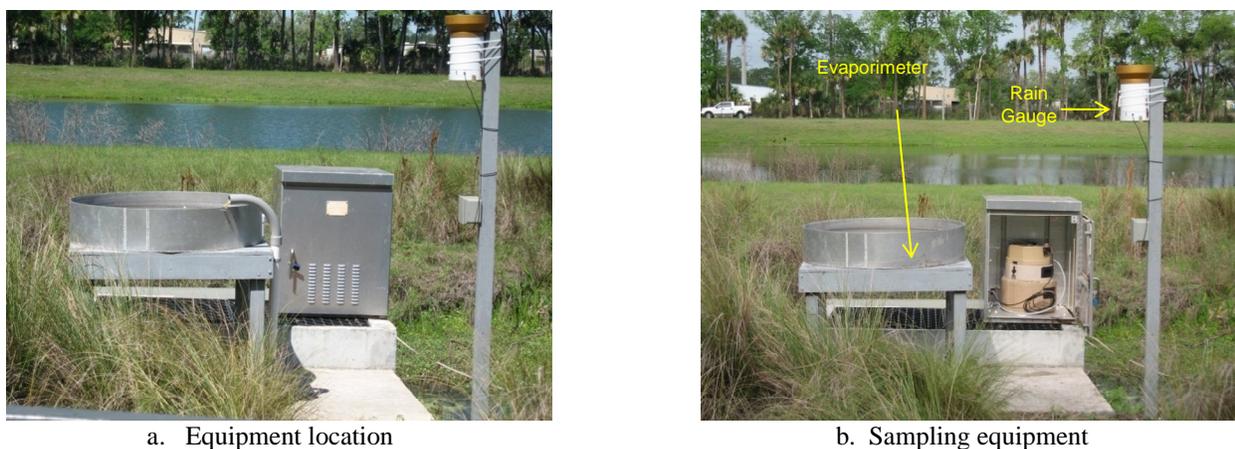
Figure 2-5. Inflow Monitoring Equipment at Site 4.

The outflow monitoring site (Site 4) was located at the pond outfall structure on the southwest side of the Elder Creek pond. Photographs of the monitoring equipment installed at Site 4 are given on Figure 2-5. An automatic sequential stormwater sampler with internal flow meter, manufactured by Sigma (Model 900MAX), was installed on top of the outfall structure. The autosampler was housed inside an insulated aluminum shelter, and sensor cables and sample tubing were extended from the sampler to the front side of the outfall structure adjacent to the horizontal bleed-down weir device. The integral flow meter was programmed to provide a continuous record of discharges from the pond, with measurements stored into internal memory at 10-minute intervals. The automatic sampler installed at this time contained a single 20-liter polyethylene bottle, and was programmed to collect samples in a flow-weighted mode, with 500-ml aliquots pumped into a collection bottle with every programmed increment of flow. Since 120 VAC power was not available at the site, the automatic sampler was operated on 12 VDC batteries which were replaced on a periodic basis.

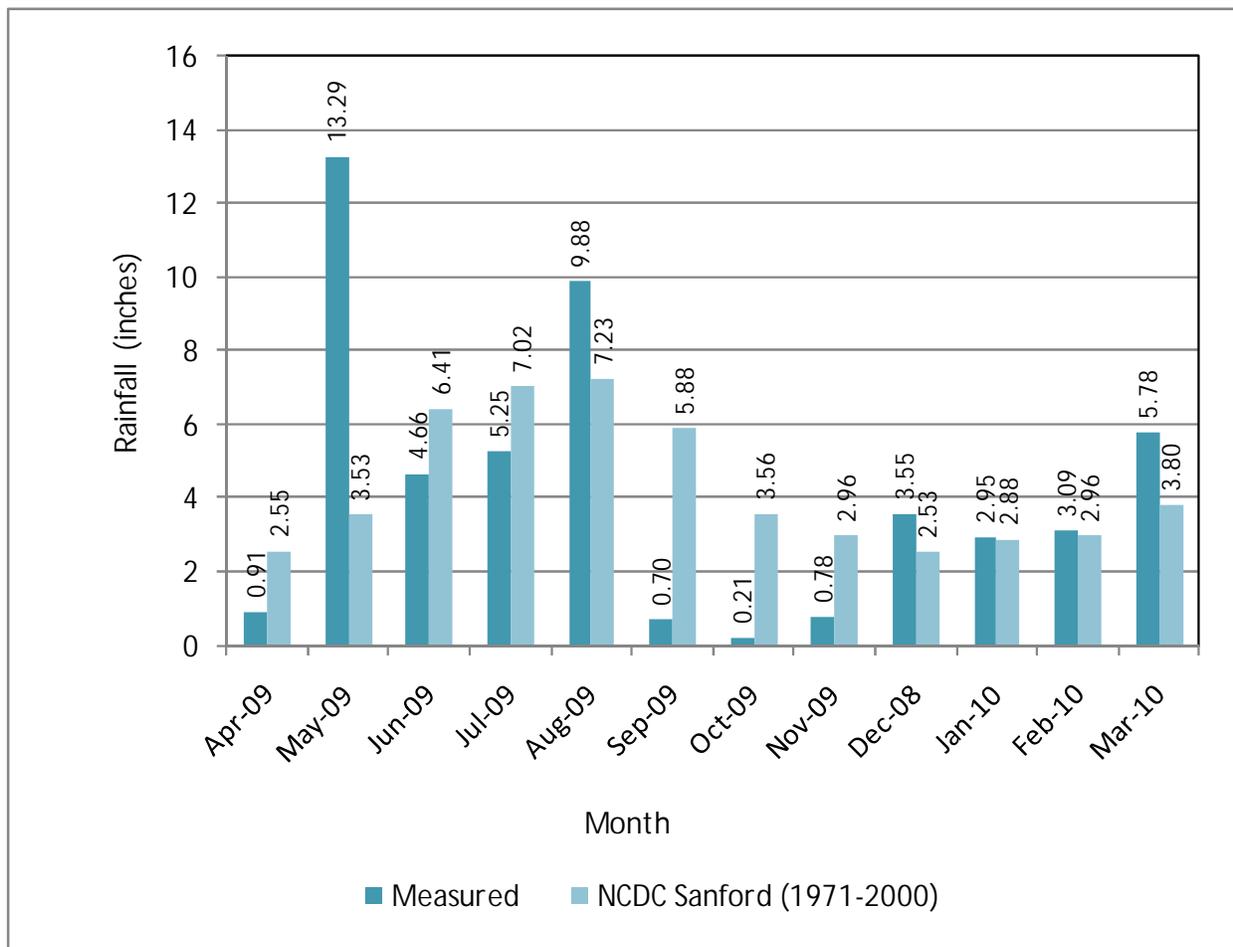
Figure 3-1. Comparison of Average and Measured Rainfall in the Vicinity of the Elder Creek Pond Site.

A comparison of measured and typical “average” rainfall in the vicinity of the Elder Creek pond is given in Figure 3-1. Measured rainfall presented in this figure is based upon the field-measured rain events at the pond site presented in Table 3-1, summarized on a monthly basis. “Average” rainfall conditions are based upon historical average monthly rainfall recorded at the Sanford Airport over the 30-year period from 1971-2000. Historical average annual rainfall in the Sanford area is approximately 51.31 inches/year.

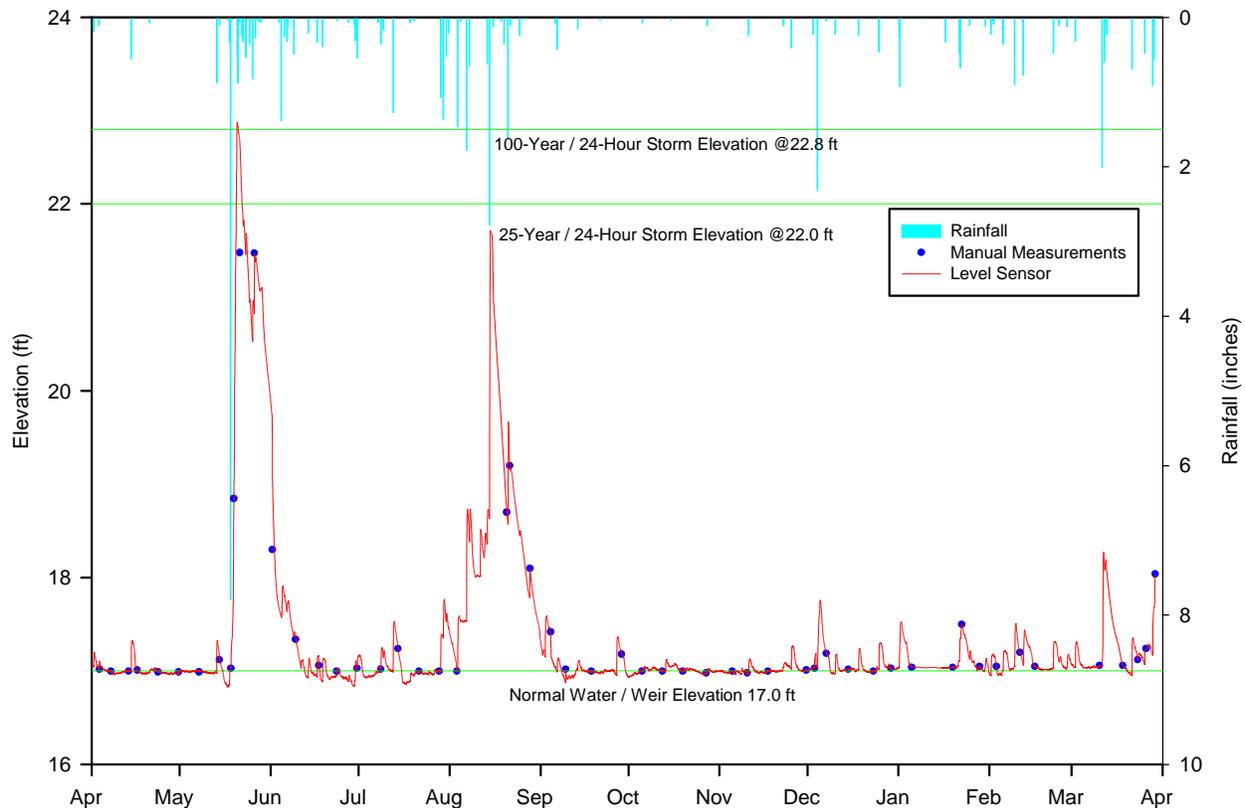
Figure 3-2. Fluctuations in Water Levels in the Elder Creek Pond from April 2009-March 2010.

A graphical summary of fluctuations in water levels in the Elder Creek pond from April 2009-March 2010 is given on Figure 3-2. Total daily rainfall is also summarized on this figure to illustrate changes in water surface elevations resulting from monitored rainfall events.

As seen in Figure 3-2, pond water levels were either slightly above or slightly below the normal water/weir elevation of 17.0 ft throughout much of the 12-month monitoring program. Pond surface elevations responded rapidly to rain events in excess of approximately 0.5 inches within the watershed, with a gradual drawdown occurring over a period of several days. Substantial increases in water elevations were observed within the Elder Creek pond as a result of the 7.79-inch rain event which occurred over the period from May 18-20, 2009, with water elevations briefly exceeding the 100-year/24-hour storm elevation of 22.8 ft during this event. A second significant peak in water surface elevations occurred during August as a result of multiple storm events during the first few weeks of the month. Pond water level elevations approached, but did not exceed, the 25-year/24-hour storm elevation of 22.0 ft. However, water drawdown from each of these events occurred relatively rapidly, with normal water surface elevations achieved within a period of approximately 2-3 weeks following the peak measured elevations. Water surface elevations within the pond exhibited a fluctuation of approximately 6 ft during the study period.

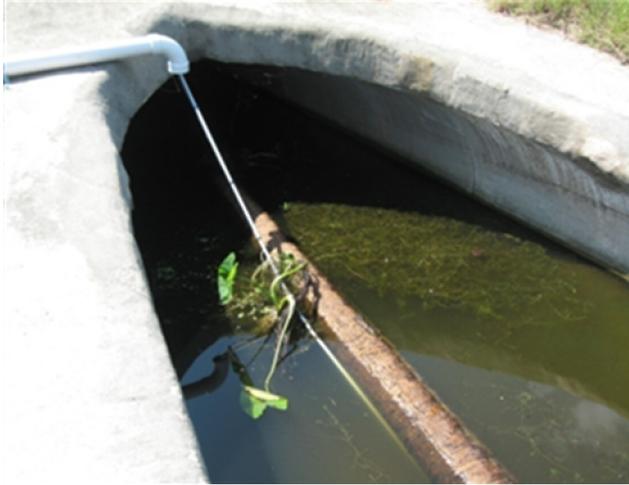
Figure 3-3. Photographs of the Elder Creek Pond During High Water Level Conditions in May 2009.

a. Floating palm tree relocated sample intake and flow sensor

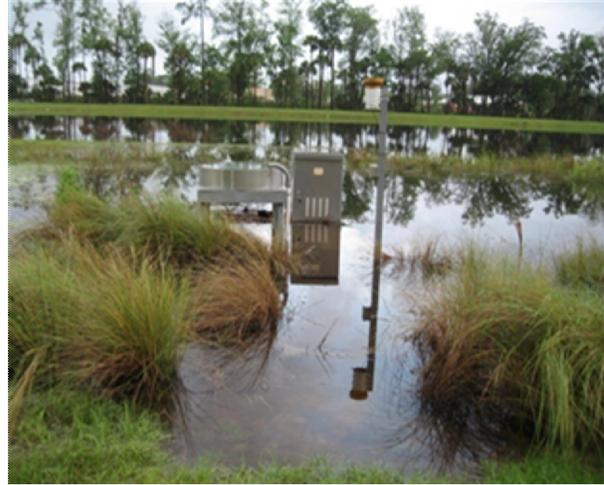
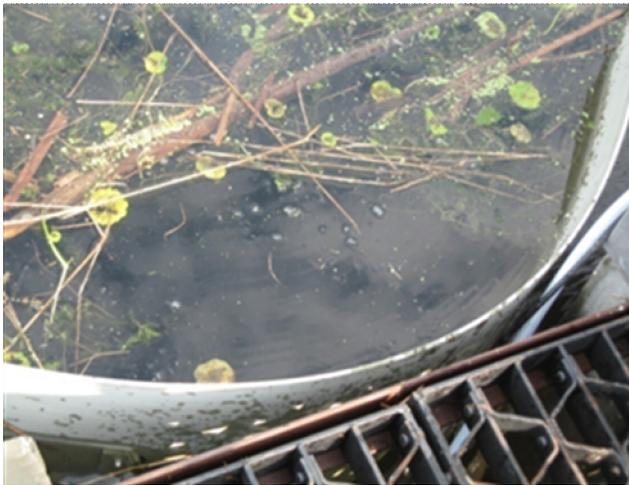
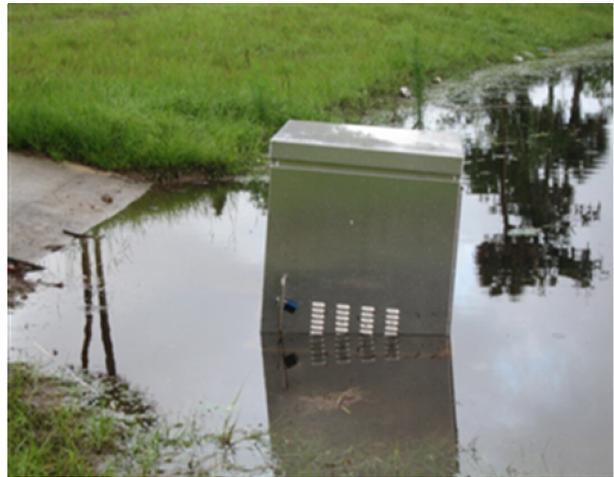
b. Flooding conditions at the outfall structure

c. High flows damaged outfall skimmer

d. Flooding conditions at Site 1

Photographs of the Elder Creek pond during high water conditions in May 2009 are given on Figure 3-3. Flooding conditions within the pond resulted in complete submergence of the outfall structure, and the high rate of water discharged through the outfall structure during this event damaged the fiberglass skimmer. A floating palm tree entered the pond through the 58-inch x 91-inch ERCP at Site 1 and dislodged and damaged the sample intake and flow sensor, requiring repair and replacement, respectively. The flooding conditions also partially submerged the equipment shelter installed at Site 1.

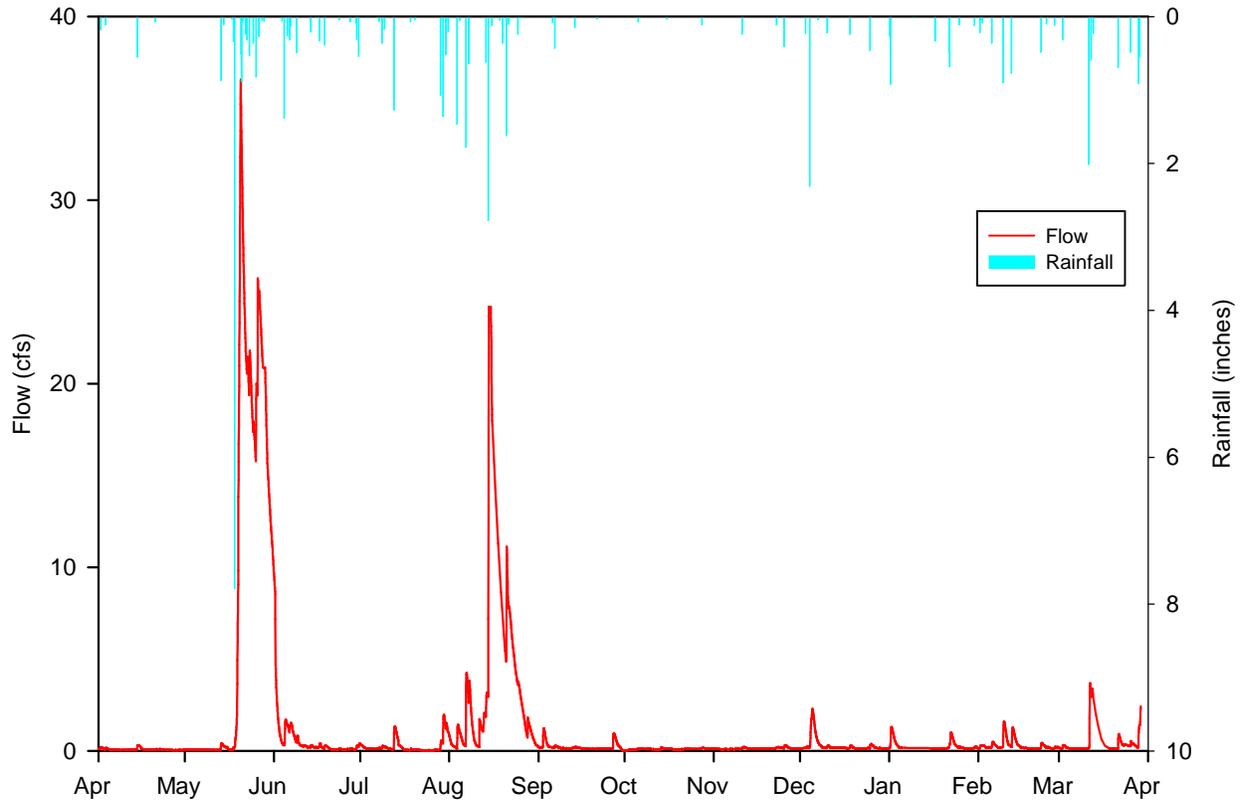
Figure 3-4. Inflow Hydrographs to the Elder Creek Pond from Site 1 (Elder Creek).

A graphical summary of inflow hydrographs to the Elder Creek pond through the 58-inch x 91-inch ERCP (Site 1) which discharges from Elder Creek into the pond is given on Figure 3-4. Inflows into the pond were typically 3-4 cfs or less during common storm events. However, inflows as high as 36 cfs occurred as a result of the 7.79-inch rain event which occurred during May 2009. An inflow rate of approximately 25 cfs was observed as a result of multiple rain events which occurred during the first few weeks of August.

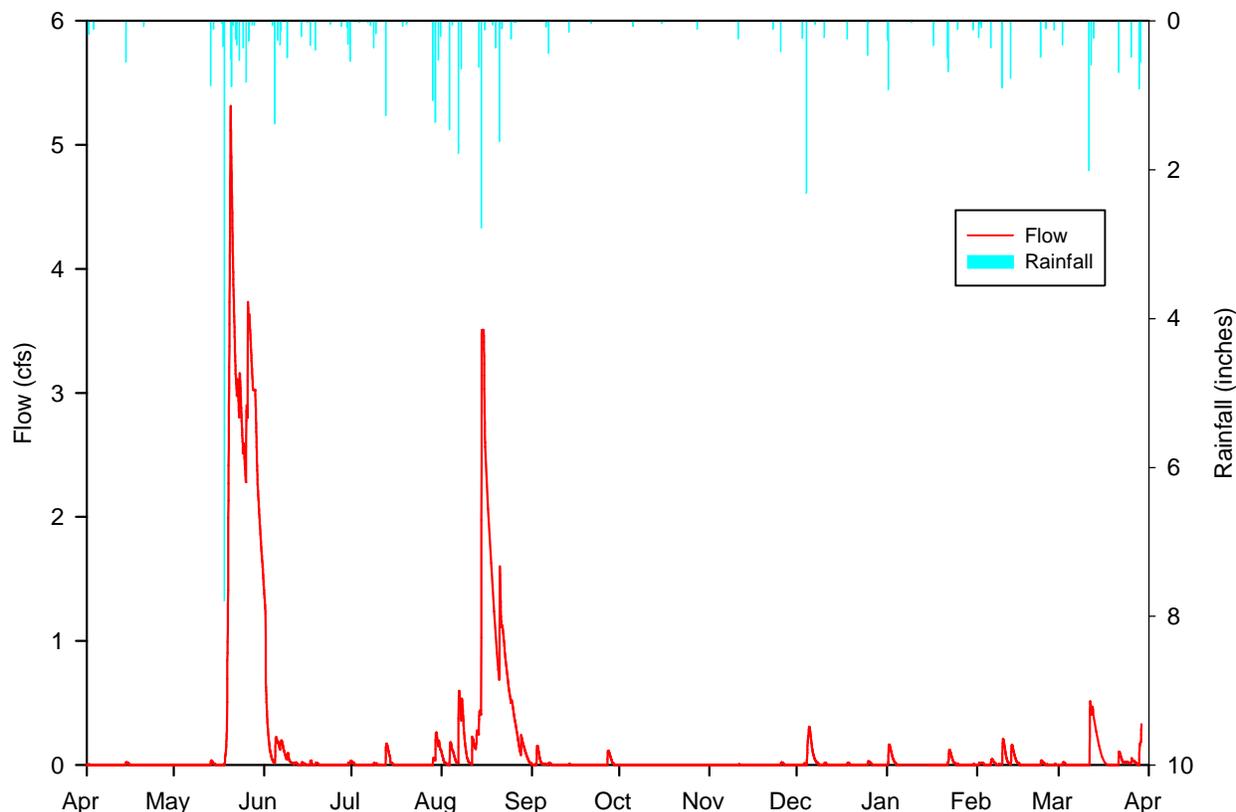
Figure 3-5. Inflow Hydrographs to the Elder Creek Pond from Site 2 (Elder Ditch).

A graphical summary of inflow hydrographs for the Elder Ditch inflow (Site 2) over the period from April 2009-March 2010 is given on Figure 3-5. Inflows into the pond from this site were typically approximately 0.5 cfs or less during a majority of the measured common rain events. However, inflow rates in excess of 5 cfs were observed at this site as a result of the 7.79-inch rain event which occurred during May 2009. Inflows of approximately 3.5 cfs were observed as a result of multiple storm events during the first few weeks of August 2009. Inflows from this site essentially ceased during extended periods of little or no rainfall.

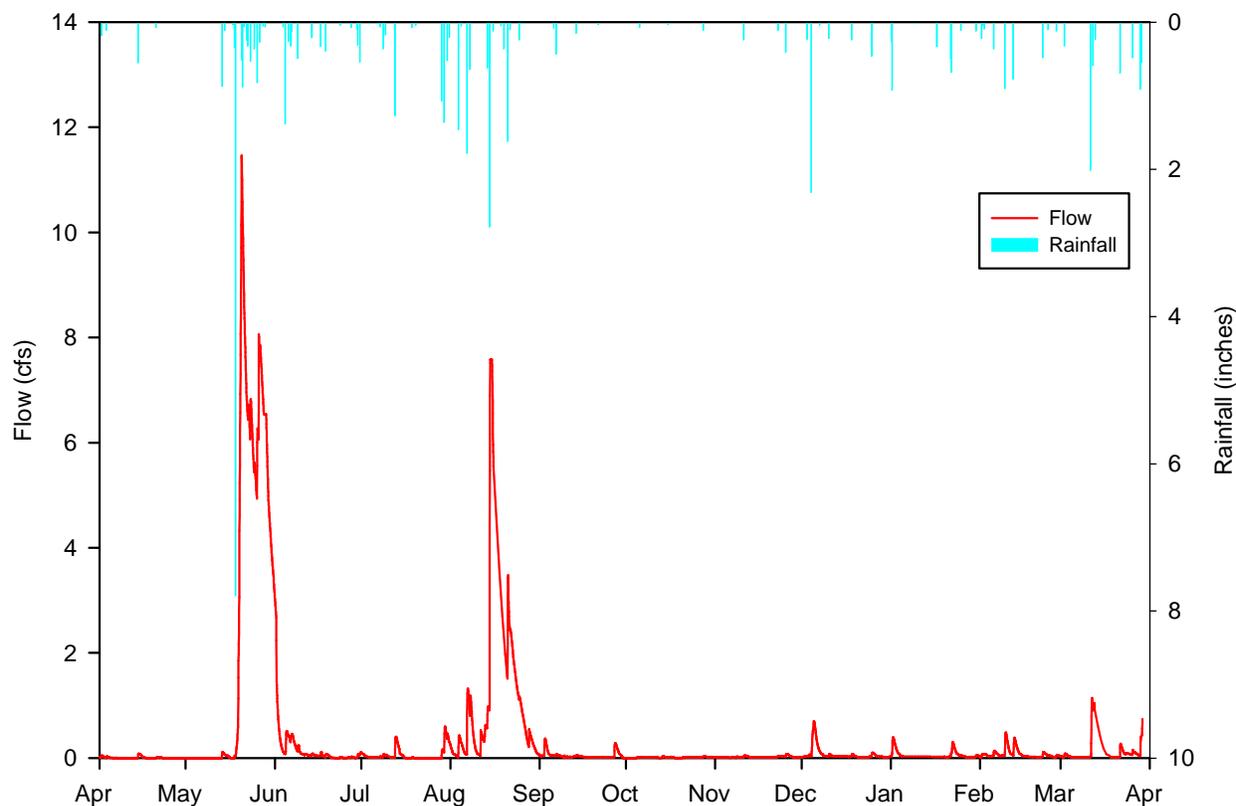
Figure 3-6. Inflow Hydrographs to the Elder Creek Pond from Site 3 (Elder Ditch).

A graphical summary of inflow hydrographs to the Elder Creek pond from Site 3 (Elder Ditch) over the period from April 2009-March 2010 is given on Figure 3-6. In general, inflow hydrographs measured at this site are similar to the inflow hydrographs measured as Sites 1 and 2. Discharges into the pond during typical storm events were approximately 1 cfs or less. However, inflow rates in excess of 11 cfs were observed as a result of the 7.79-inch rain event during May 2009, with inflow rates of approximately 8 cfs resulting from the extended period of rainfall during August 2009.

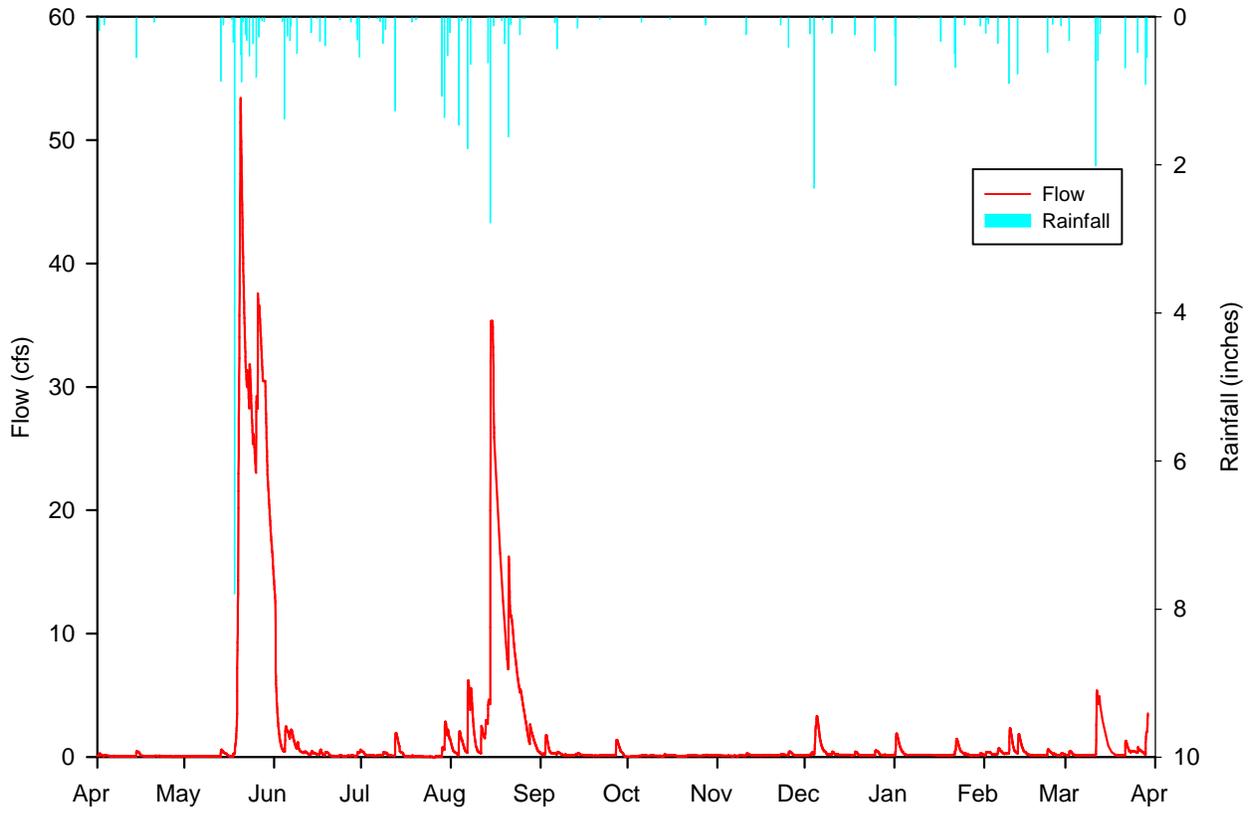
Figure 3-7. Discharge Hydrographs through the Pond Outfall.

A graphical summary of discharge hydrographs measured at the pond outfall structure is given on Figure 3-7. The vast majority of measured discharge rates at this site are less than approximately 1 cfs, with the exception of the significant rain events which occurred during May and August 2009. During the 7.79-inch rain event which occurred during May, discharge through the outfall structure exceeded approximately 50 cfs for a brief period. During the period of extended rainfall which occurred during early August, discharges through the discharge structure reached approximately 35 cfs. An expanded view of the outfall discharge hydrographs is given on Figure 3-8. In the absence of storm events, a constant baseflow was observed at the pond outfall which ranged from approximately 0.1-0.25 cfs.
