Elder Creek Stormwater Facility Performance Efficiency Evaluation

Final Report

September 2010

Seminole County, Florida

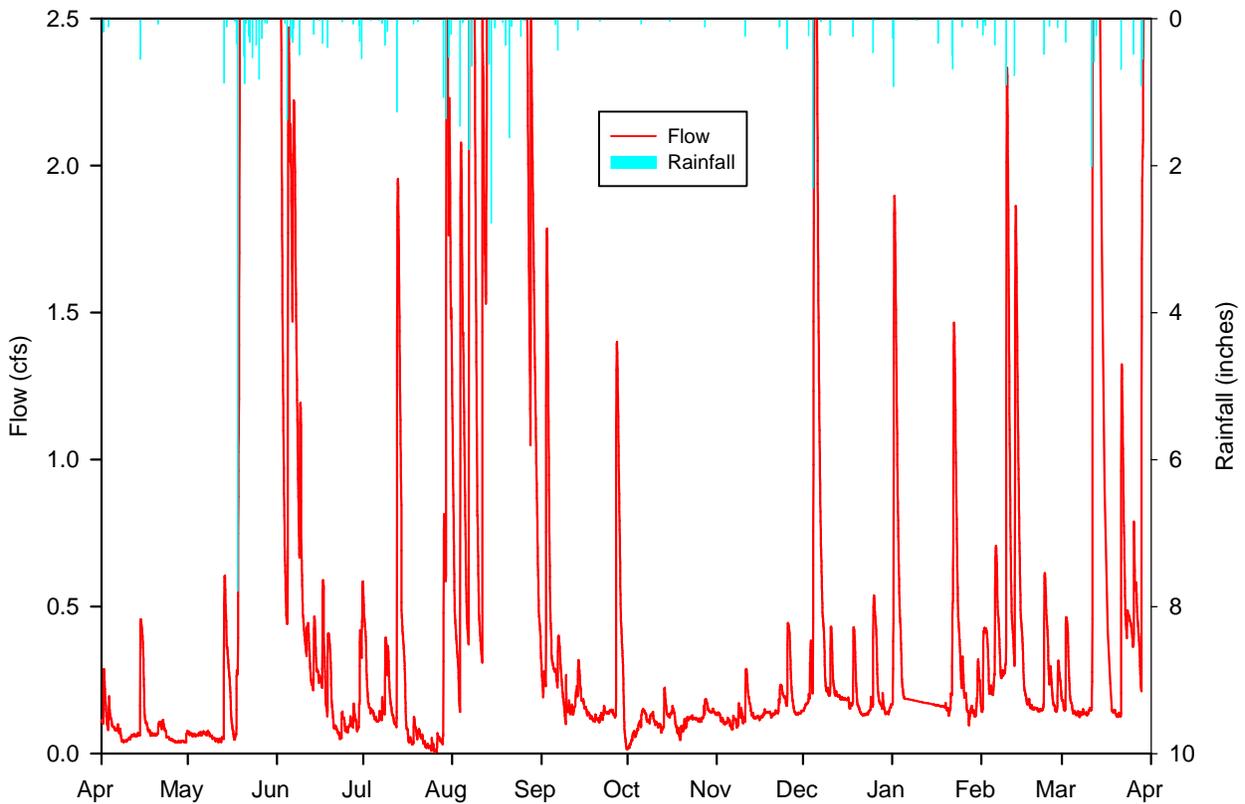
Figure 3-8. Expanded View of Outfall Discharge Hydrographs.

A graphical summary of discharge hydrographs measured at the pond outfall structure is given on Figure 3-7. The vast majority of measured discharge rates at this site are less than approximately 1 cfs, with the exception of the significant rain events which occurred during May and August 2009. During the 7.79-inch rain event which occurred during May, discharge through the outfall structure exceeded approximately 50 cfs for a brief period. During the period of extended rainfall which occurred during early August, discharges through the discharge structure reached approximately 35 cfs. An expanded view of the outfall discharge hydrographs is given on Figure 3-8. In the absence of storm events, a constant baseflow was observed at the pond outfall which ranged from approximately 0.1-0.25 cfs.

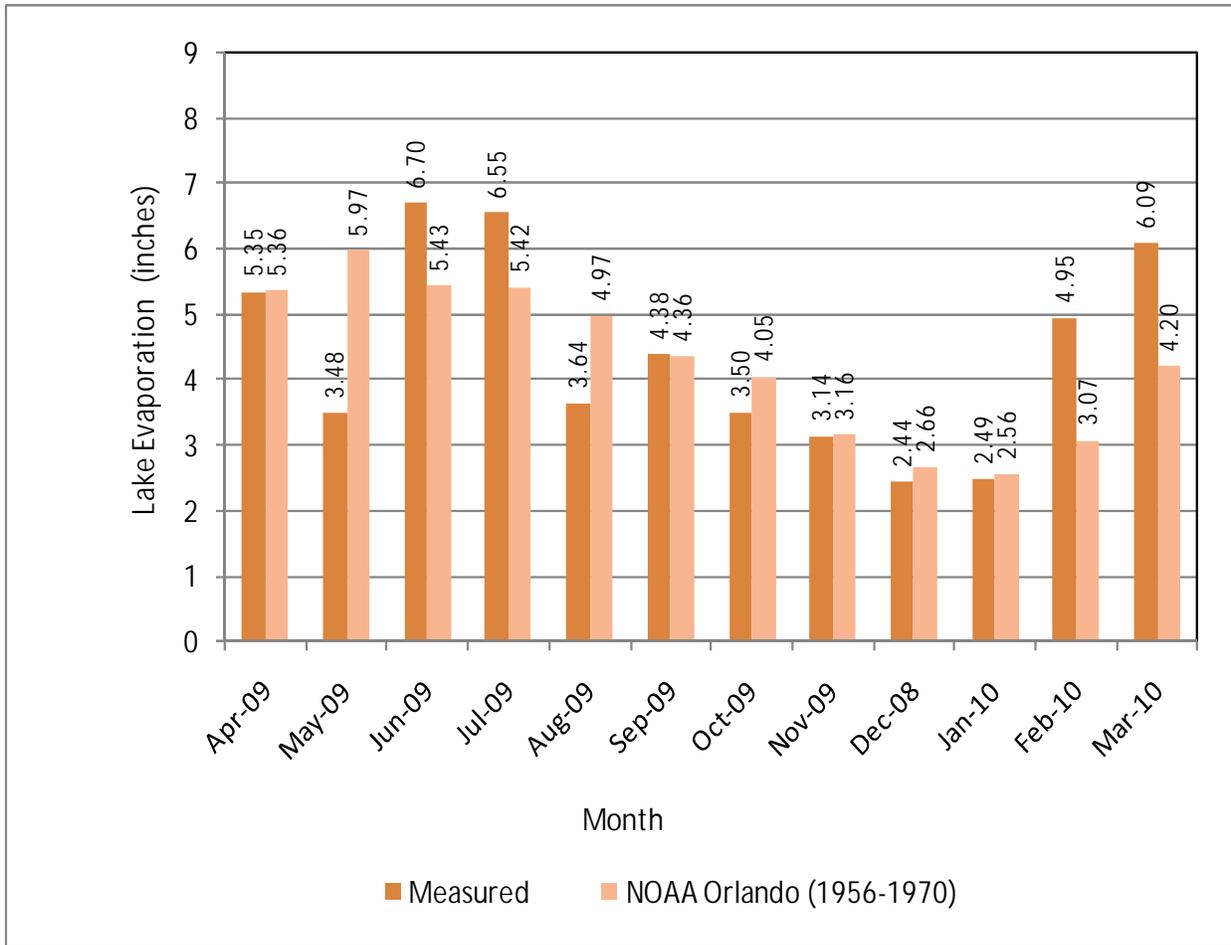
Figure 3-9. Monthly Lake Evaporation Measured at the Elder Creek Pond from April 2009-March 2010.

A graphical summary of monthly lake evaporation measured at the Elder Creek pond site from April 2009-March 2010 is given on Figure 3-9. The values summarized in this figure reflect the measured pan evaporation rates multiplied by 0.7. Monthly evaporation rates measured at the Orlando International Airport (OIA) meteorological station over the period from 1956-1970 are also provided on Figure 3-9 for comparison purposes. In general, a relatively close agreement was observed between the field-measured values at the Elder Creek site and the OIA monitoring station. The total evaporation measured at the Elder Creek site during the 12-month monitoring program was 52.71 inches compared with an annual average of 51.21 inches measured at the OIA monitoring site.

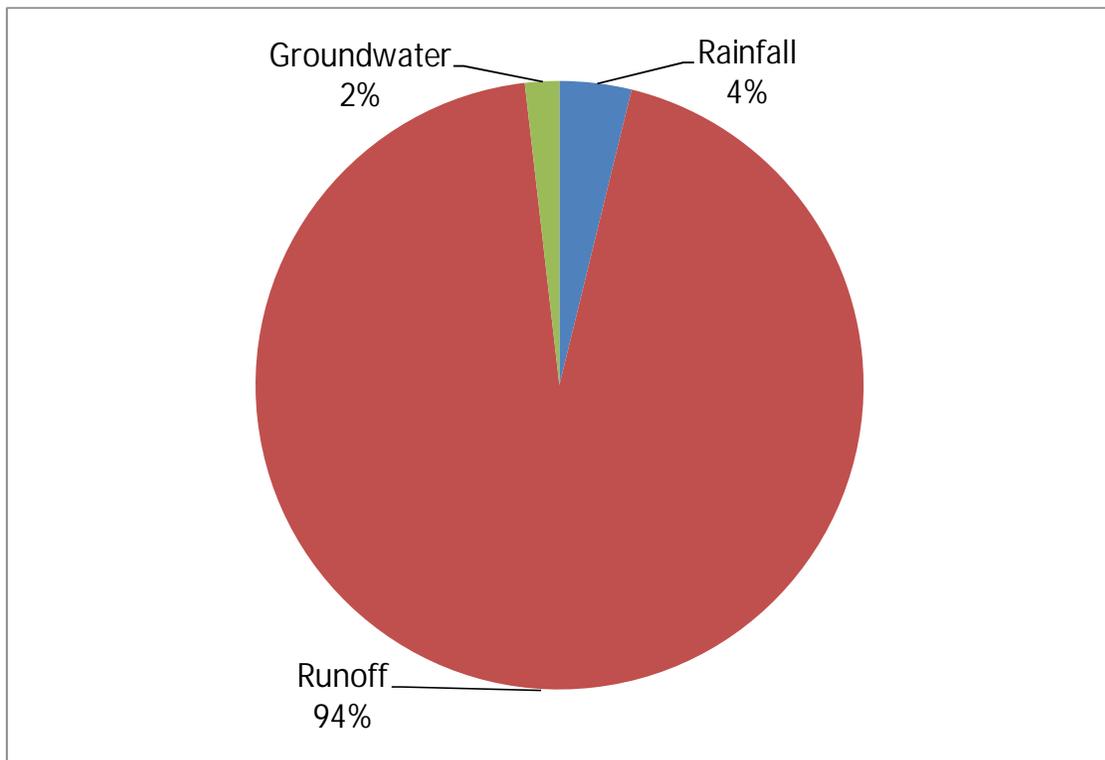
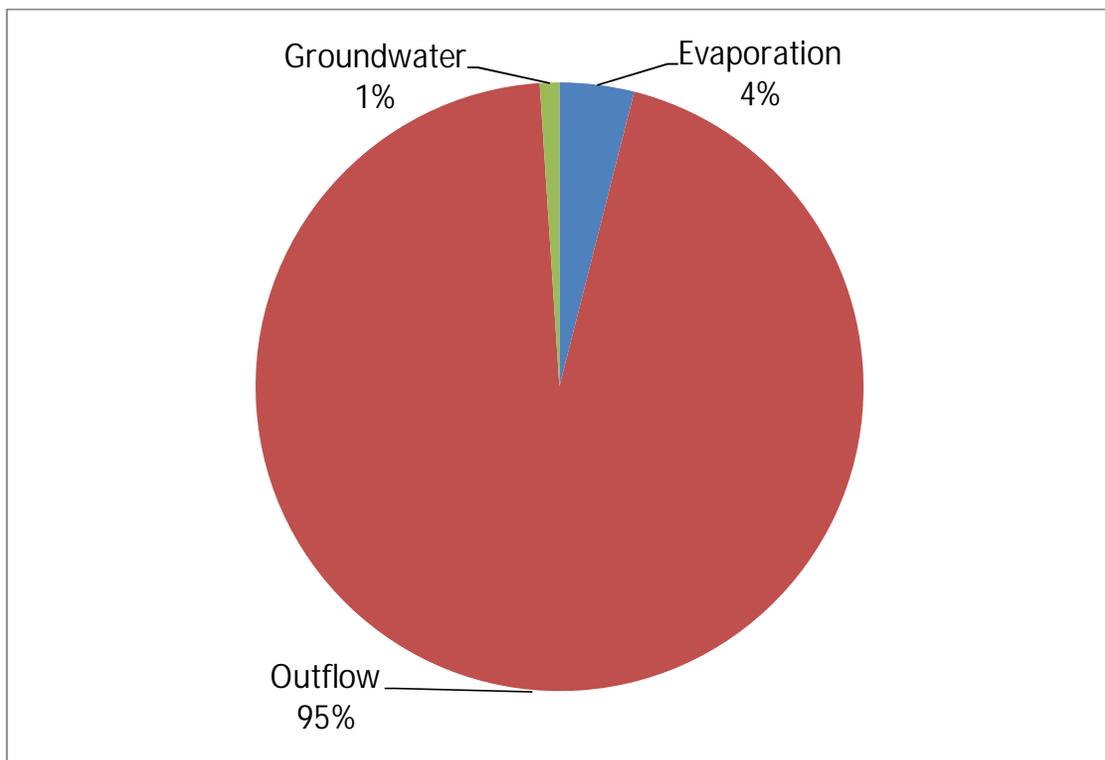
Inputs

Losses

Figure 3-10. Comparison of Hydrologic Inputs and Losses for the Elder Creek Pond from April 2009-March 2010.

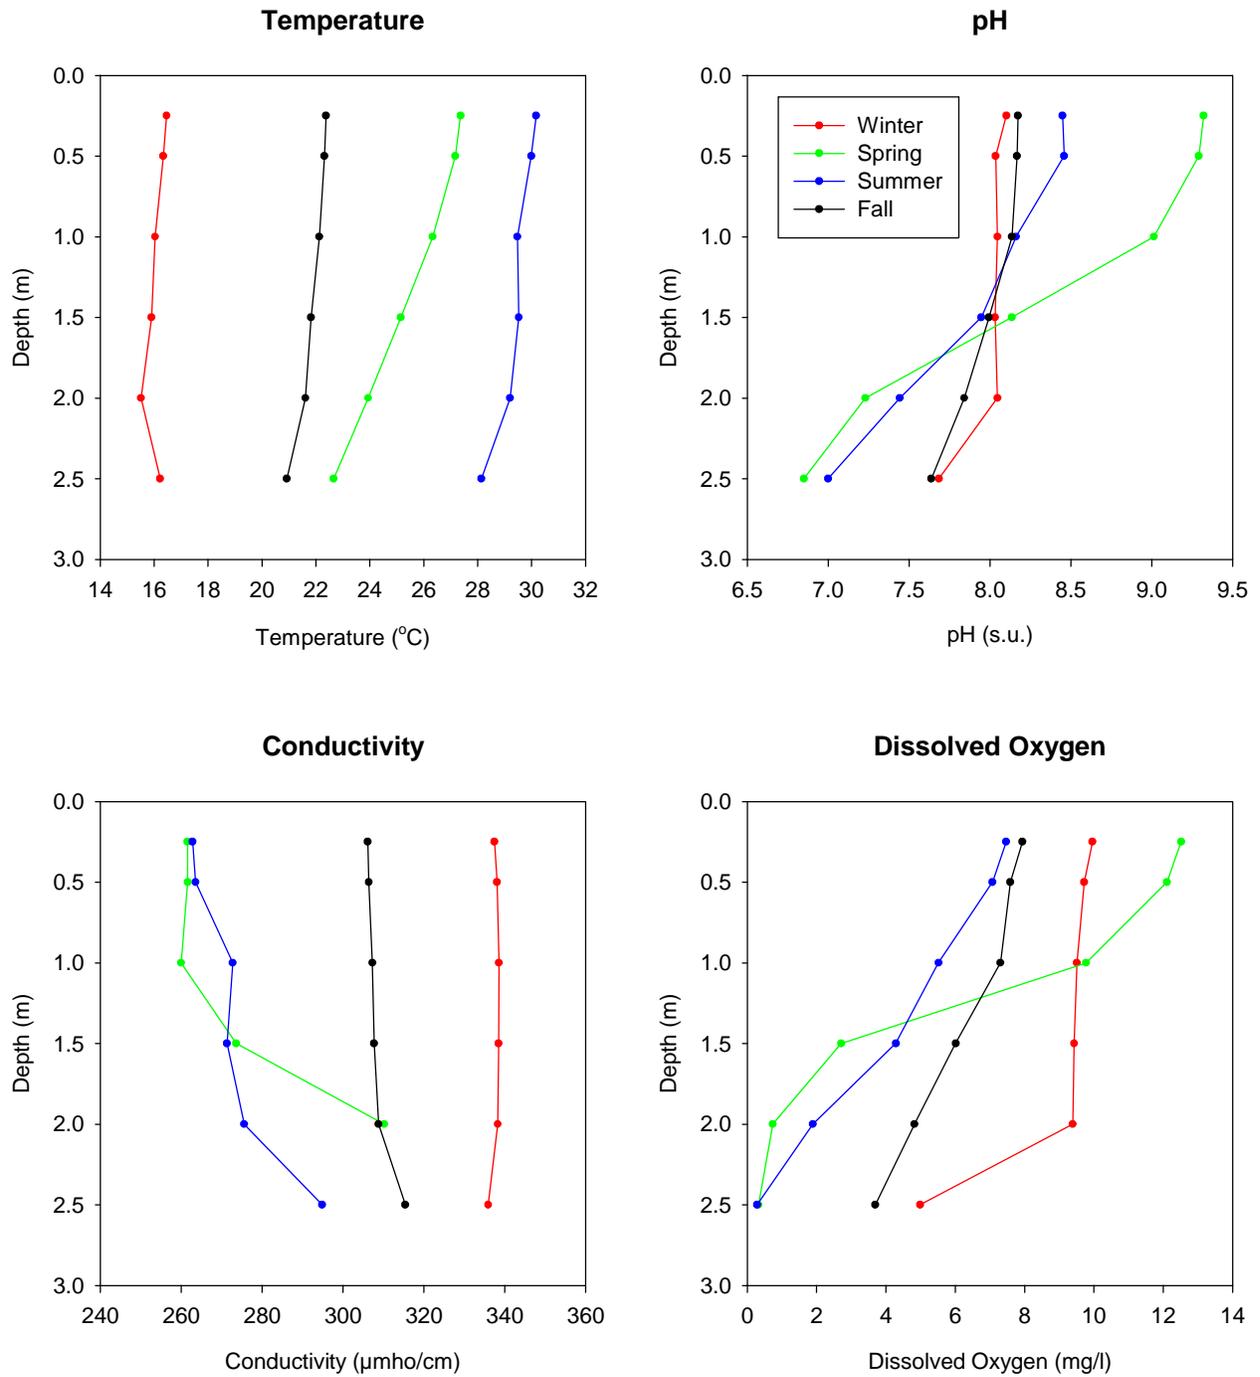
Figure 3-11. Compilation of Vertical Depth Profiles Collected in the Elder Creek Pond from April 1, 2009-March 31, 2010.

A graphical summary of vertical depth profiles collected in the Elder Creek pond from April 2009-March 2010 is given on Figure 3-11. The vertical profiles summarized in this figure reflect the average of profiles collected during winter, spring, summer, and fall conditions to illustrate seasonal changes in vertical water quality within the pond. For purposes of this analysis, winter is assumed to reflect the months of January-March, with spring reflecting the months of April-June, summer conditions reflected by July-September, and fall conditions reflected by October-December. Water depth within the pond ranged from approximately 2.5-3 m during the monitoring program.

In general, a slight decrease in temperature was observed with increasing water depth during a majority of the field monitoring events. The differences between top and bottom temperatures were most pronounced during spring conditions, although no evidence of thermal stratification was observed during any of the field monitoring events. Differences in temperature between top and bottom measurements ranged from approximately 1-2°C during winter, summer, and fall conditions. However, during spring conditions, the temperature difference between top and bottom measurements ranged from 3-4°C.

In general, a trend of decreasing pH with increasing water depth was observed during most of the monitoring events. Differences in pH between top and bottom measurements were relatively small during winter and fall conditions. This phenomenon, combined with the relatively isograde temperature profiles measured during these seasons, suggests that the pond exhibited well-mixed characteristics during winter and fall conditions. Differences in pH between top and bottom measurements were more pronounced during spring and summer conditions, with a pH range of approximately 6.7-9.4 during spring conditions and 7-8.2 during summer conditions.

Relative isograde conductivity measurements were observed within the Elder Creek during winter and fall conditions. A slight increase with increasing water depth was observed during both spring and summer conditions, although a decrease in conductivity was observed near the bottom sediments during the spring measurements. No evidence of significant internal release of ions is apparent in the measured conductivity values.

A general trend of decreasing dissolved oxygen concentrations with increasing water depth was observed during each of the seasonal conditions. The relative decrease in dissolved oxygen appears to be less during winter and fall conditions than during spring and summer conditions. Dissolved oxygen concentrations less than 2 mg/l were observed within the water column at water depths in excess of 2 m during spring and summer conditions. Aerobic conditions appear to exist throughout the water column of the pond during winter and fall conditions.

In general, the Elder Creek pond appears to be relatively well-mixed, particularly during winter and fall conditions, as evidenced by the relatively isograde conditions observed for temperature, pH, and conductivity during these periods. Dissolved oxygen levels within the pond appear to be adequate to support decomposition processes for biologically degradable materials and for support of aquatic wildlife. Areas of low dissolved oxygen were observed near the pond bottom during spring and summer conditions, although anoxic conditions appear to be limited to the bottom 0.5 m of the pond. No significant increases in specific conductivity were observed in lower layers of the pond, suggesting that internal recycling is not significant within the pond at this time.

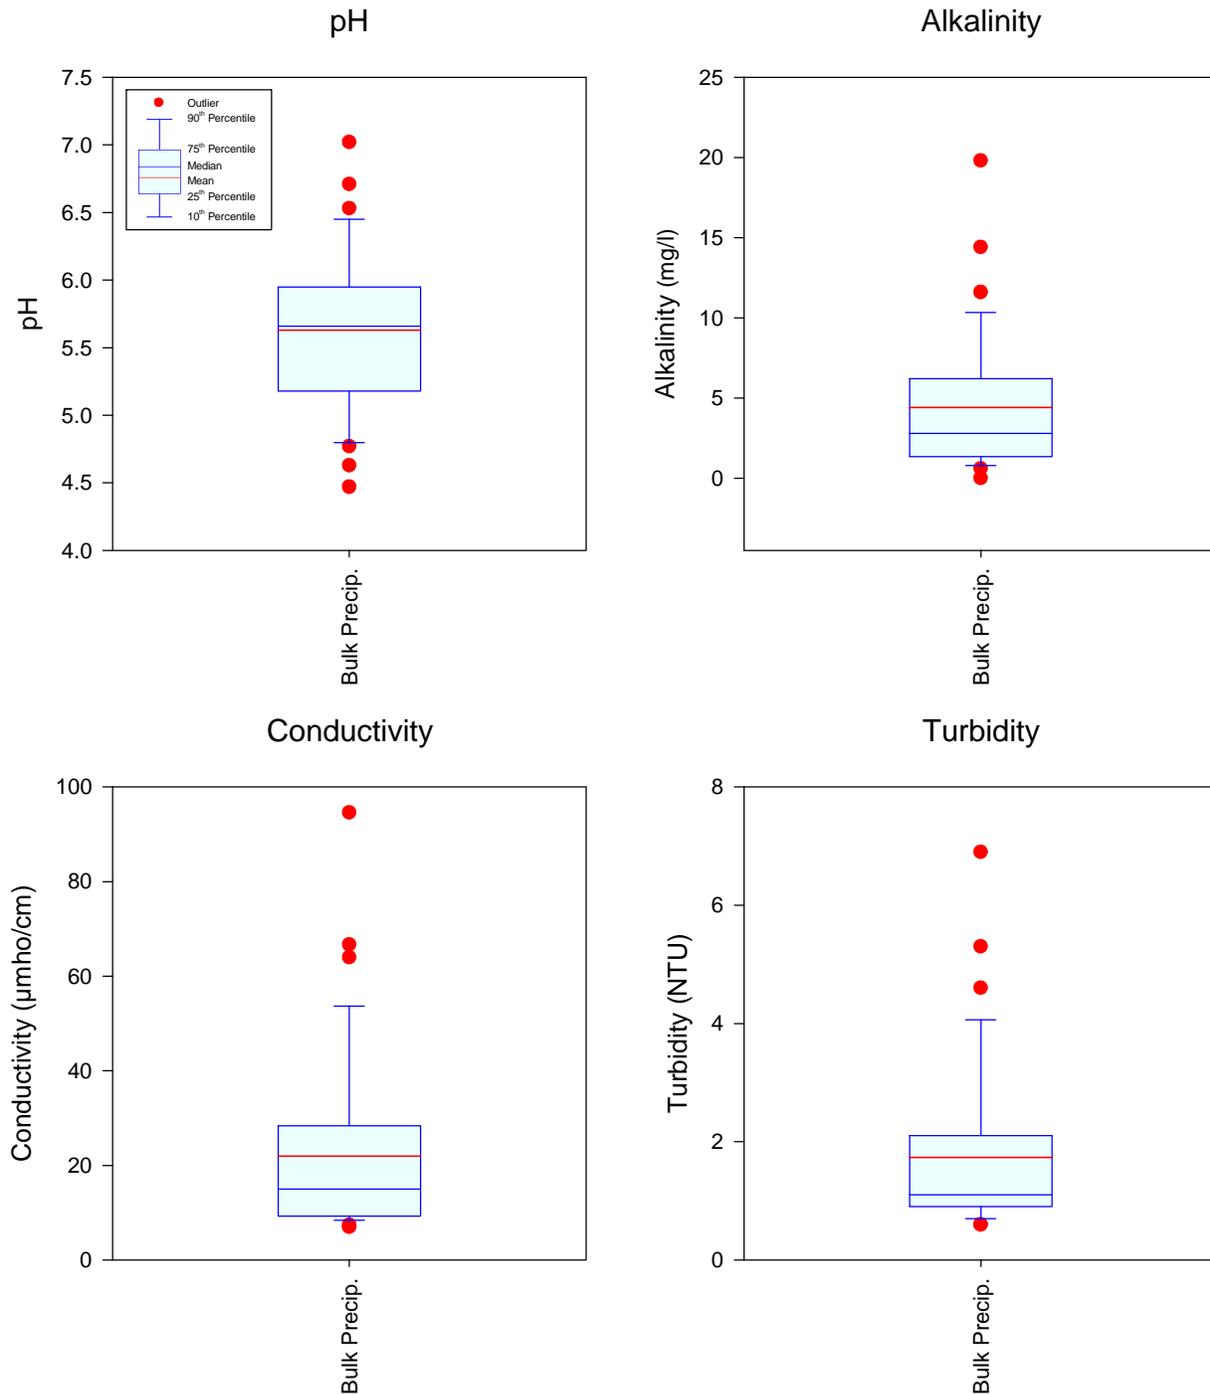
Figure 3-12. Statistical Comparison of General Parameters Measured in Bulk Precipitation at the Elder Creek Pond Site.

A statistical comparison of general parameters measured in bulk precipitation collected at the Elder Creek pond site is given on Figure 3-12. In general, bulk precipitation samples were characterized by a relatively high degree of variability for pH, alkalinity, and conductivity, with measured values for each of these parameters higher than concentrations commonly observed in bulk precipitation at other locations. In contrast, measured turbidity values in bulk precipitation were relatively low in value.

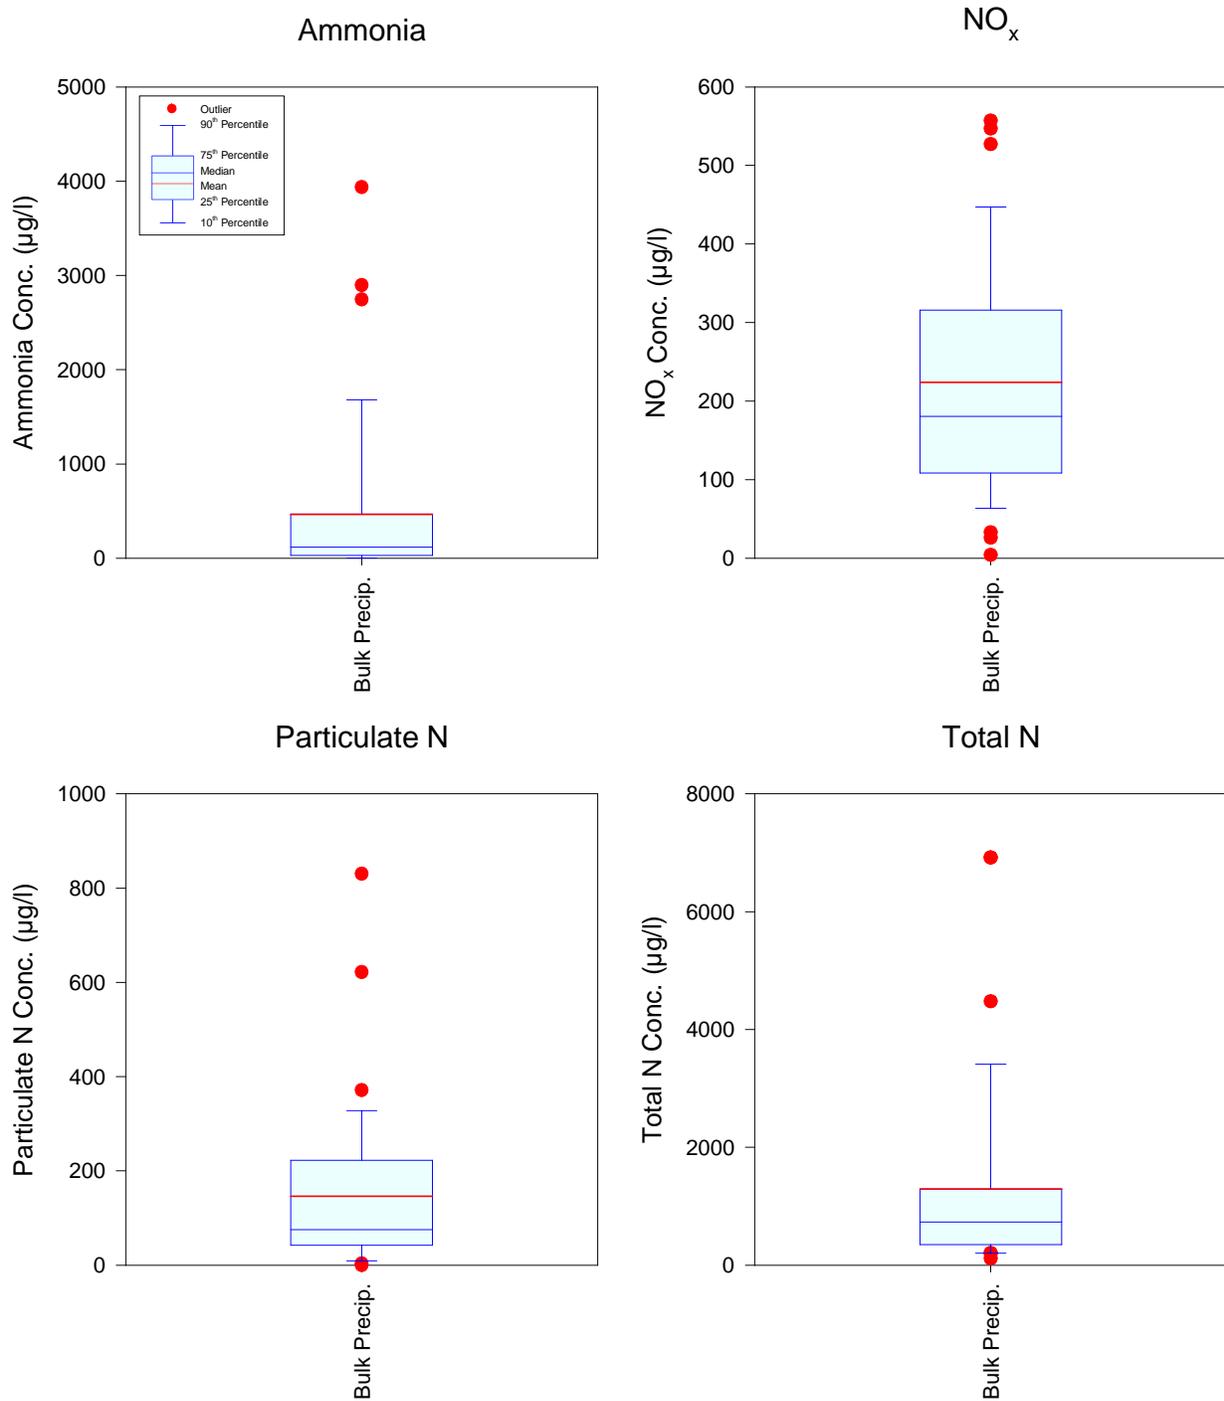
Figure 3-13. Statistical Comparison of Nitrogen Species Measured in Bulk Precipitation at the Elder Creek Pond Site.

A statistical comparison measured in bulk precipitation at the Elder Creek site is given on Figure 3-13. The majority of measured concentrations for ammonia, NO_x, particulate nitrogen, and total nitrogen fall within a relatively narrow range of values. However, substantially elevated values for these parameters were observed during 2-3 events measured at the site.

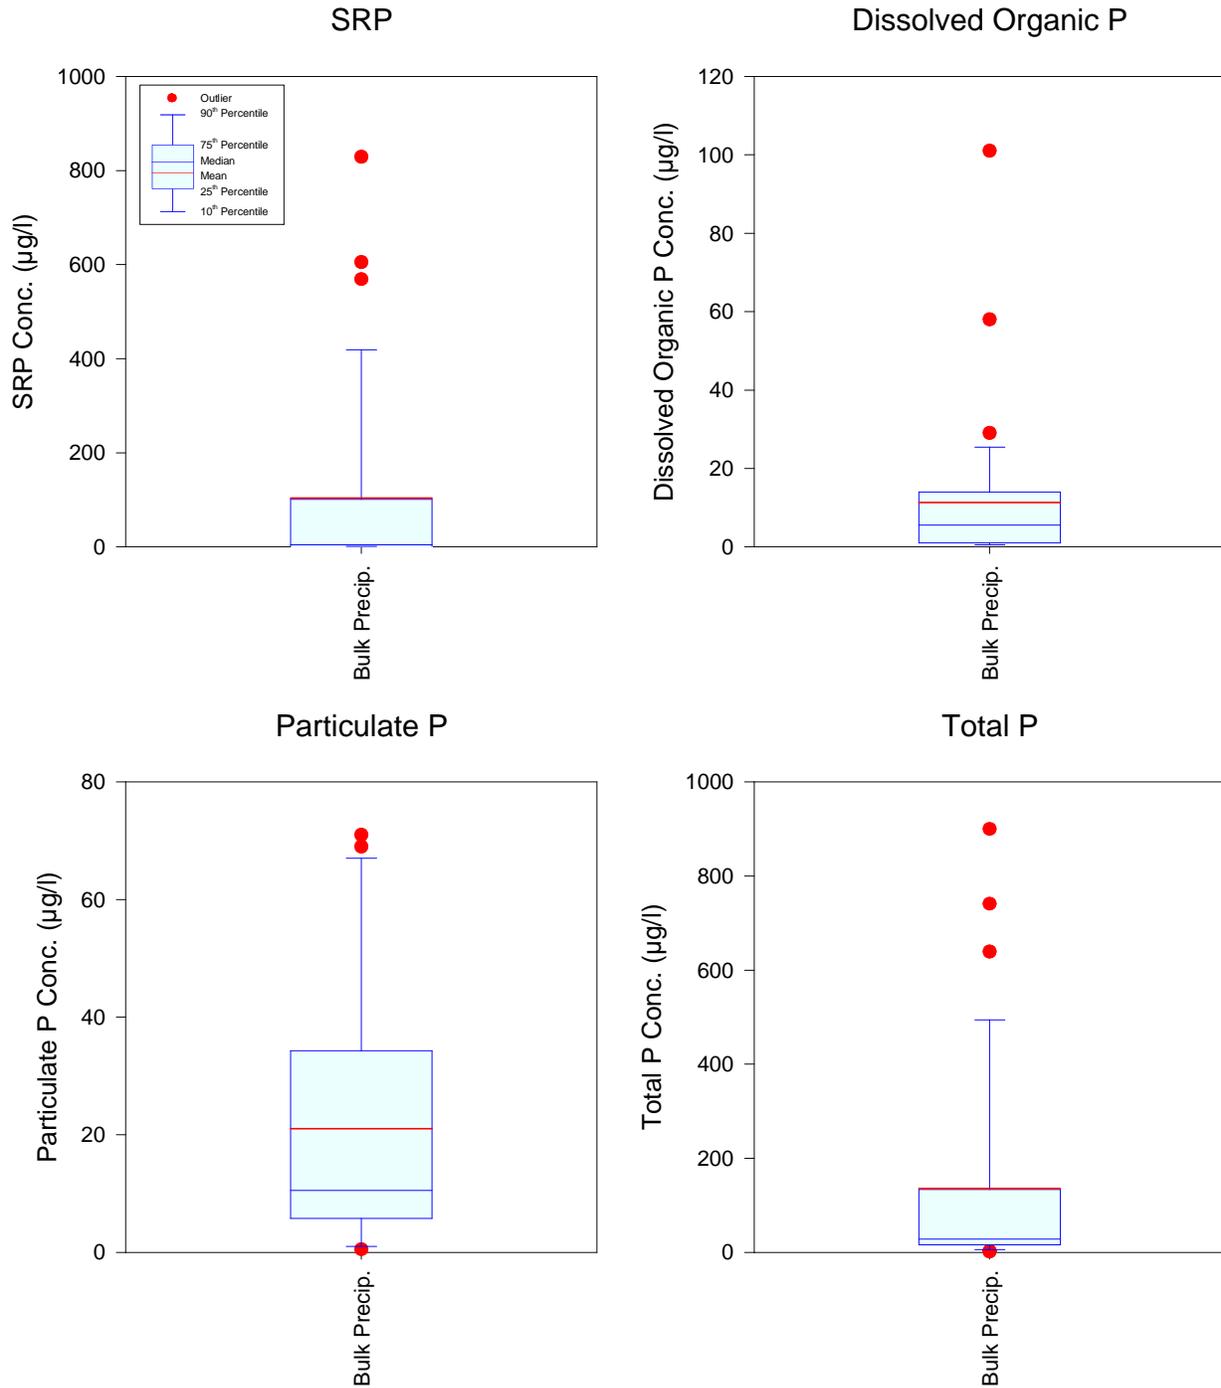
Figure 3-14. Statistical Comparison of Phosphorus Species Measured in Bulk Precipitation at the Elder Creek Pond Site.

A statistical comparison of phosphorus species measured in bulk precipitation at the Elder Creek site is given on Figure 3-14. In general, the majority of collected samples exhibited measured concentrations for SRP, dissolved organic phosphorus, particulate phosphorus, and total phosphorus which fell within a relatively narrow range and were relatively low in value. However, similar to the trend observed for nitrogen species, elevated levels of phosphorus species were also observed during 2-3 of the monitored bulk precipitation events.

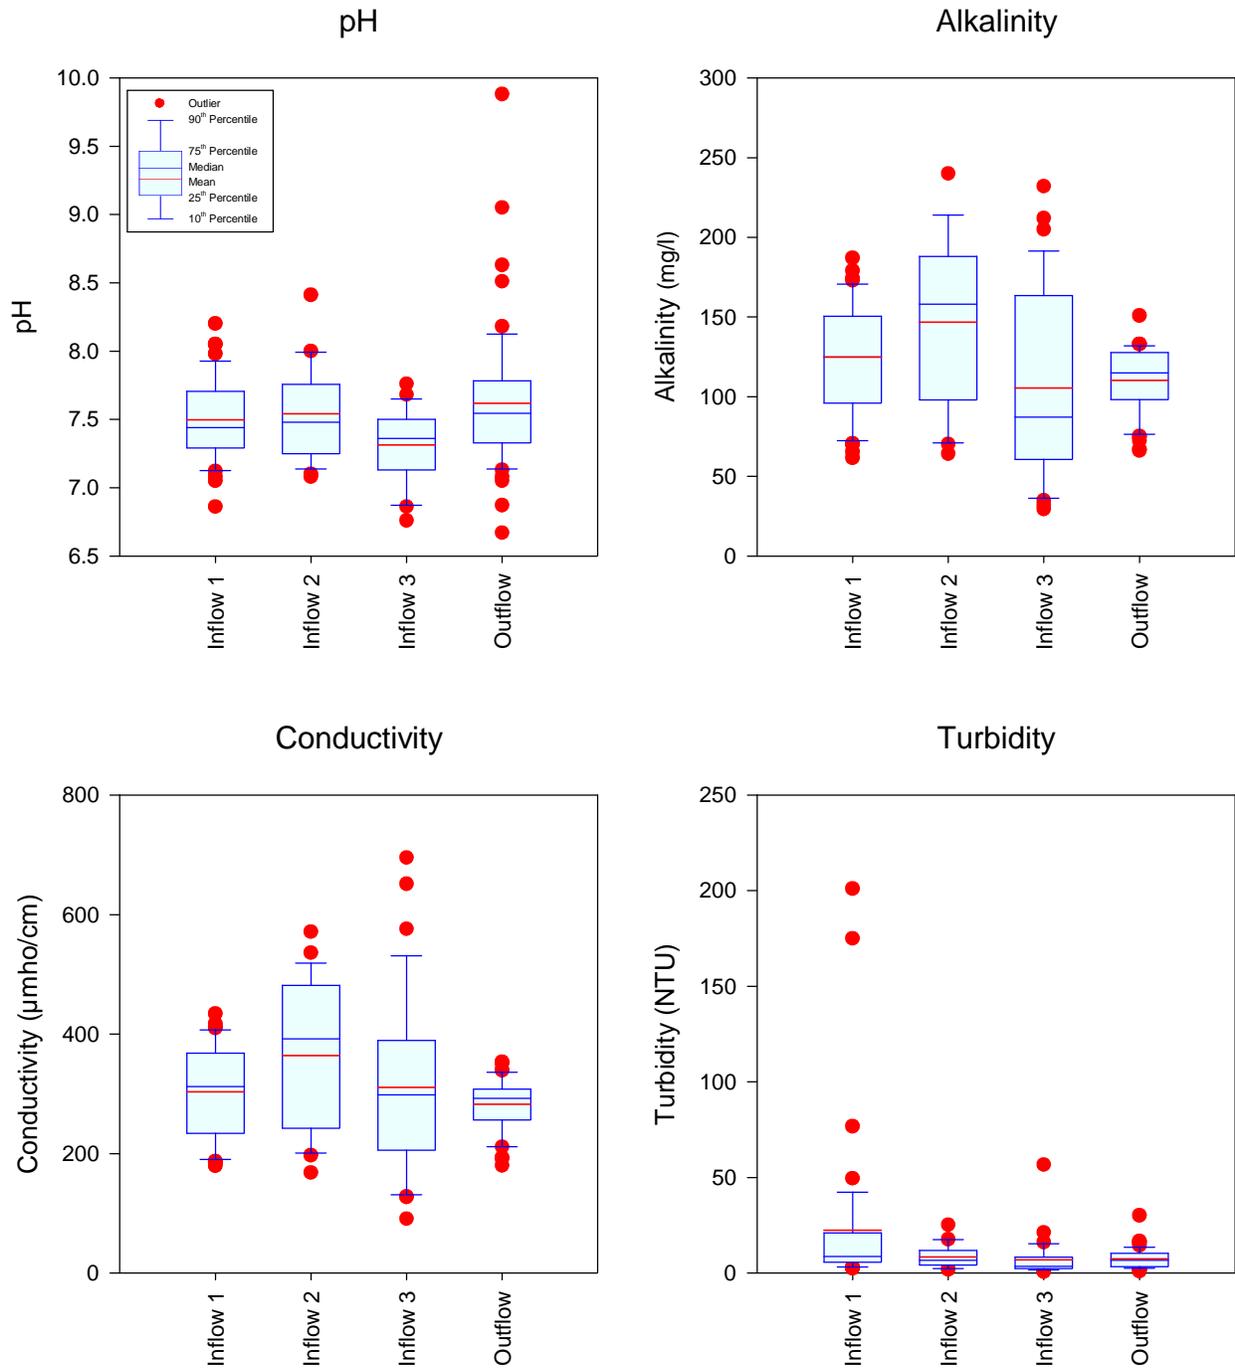
Figure 3-15. Statistical Comparison of General Parameters Measured in Pond Inflows and Outflows.

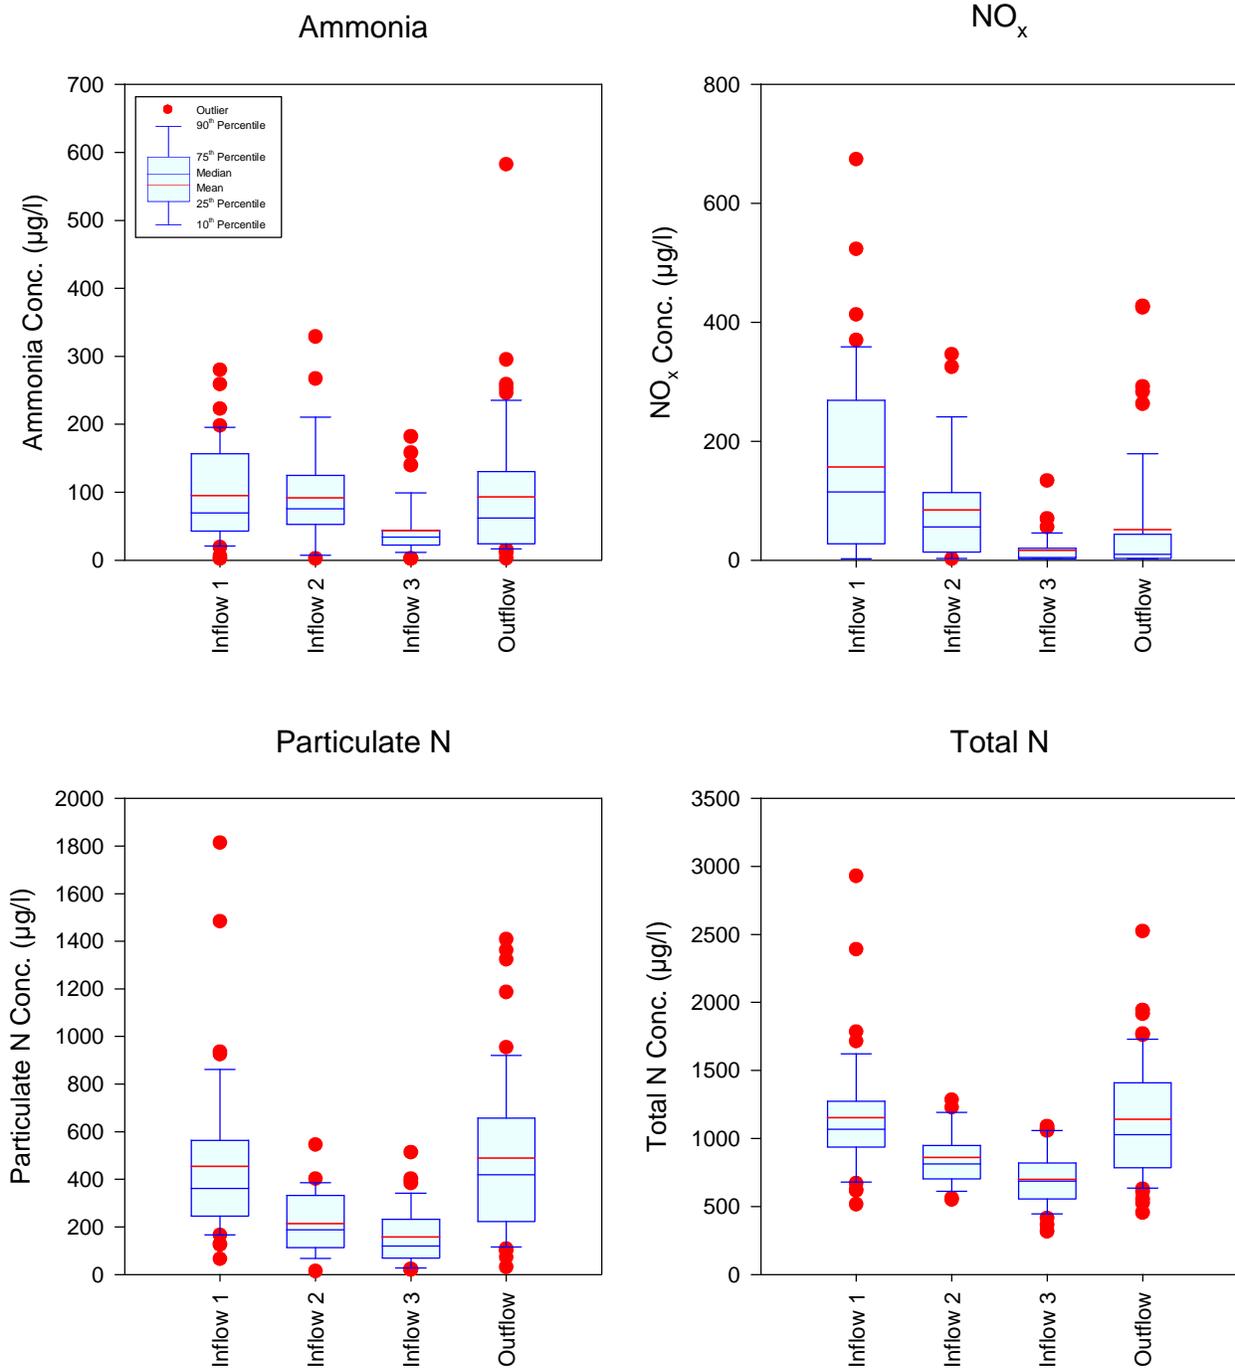
Figure 3-16. Statistical Comparison of Nitrogen Species Measured in Pond Inflows and Outflows.

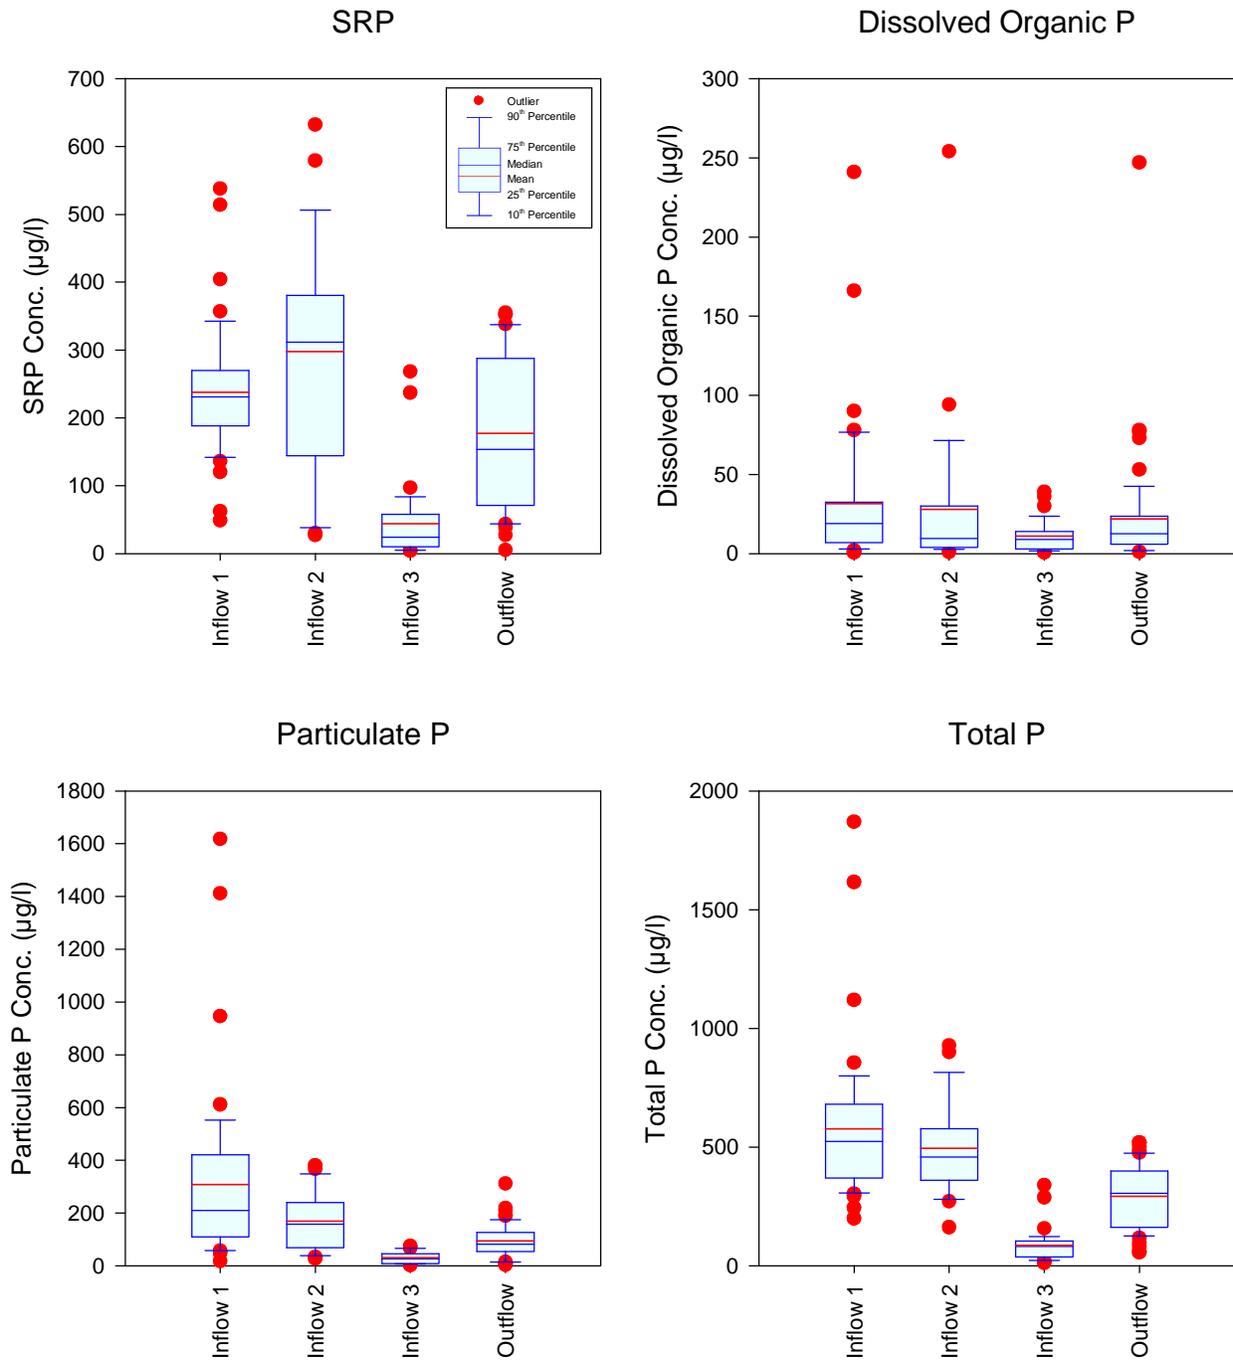
Figure 3-17. Statistical Comparison of Phosphorus Species Measured in Pond Inflows and Outflows.

A statistical comparison of phosphorus species measured in the tributary inflows and pond outflow samples is given on Figure 3-17. In general, measured concentrations of SRP, organic phosphorus, particulate phosphorus, and total phosphorus in the outfall appear to be lower in value than inflow concentrations measured at Sites 1 and 2, but higher in value than phosphorus concentrations measured at inflow Site 3. The variability in measured phosphorus concentrations appears to be lower at the outfall than observed at inflow Site 1 which represents the primary inflow into the pond.

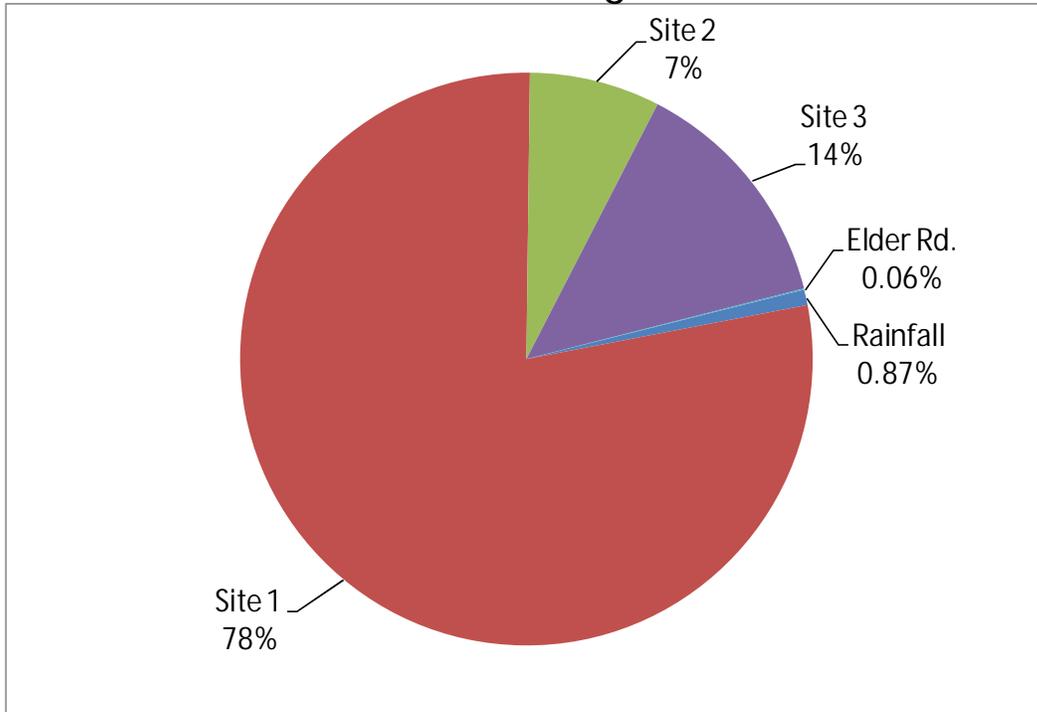
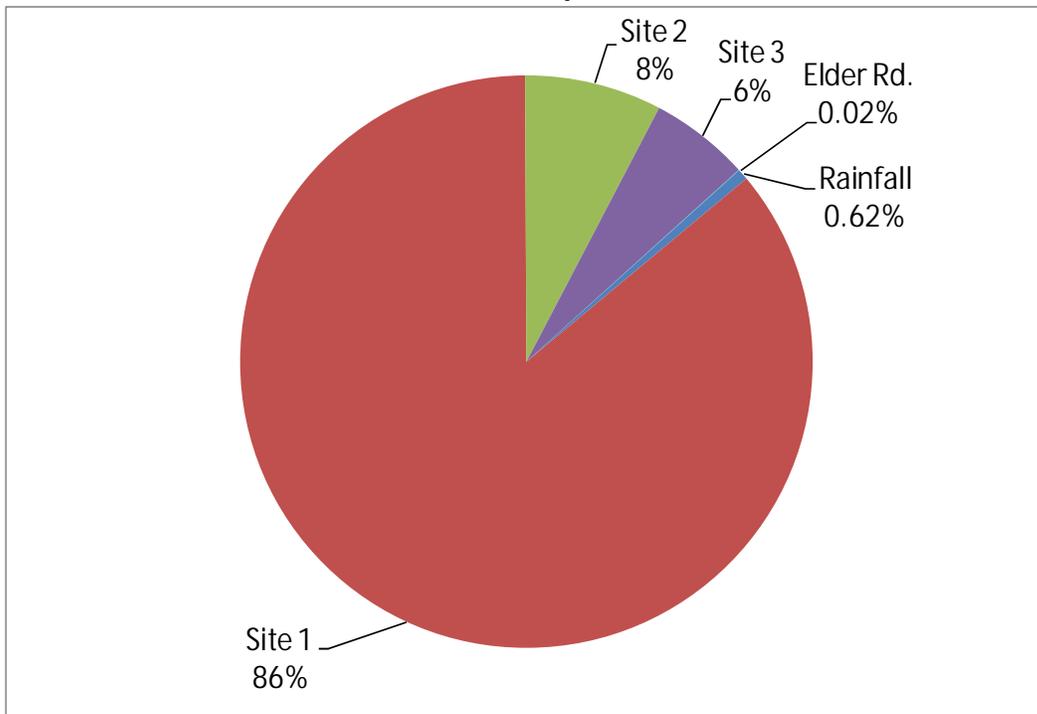
Total Nitrogen

Total Phosphorus

Figure 3-18. Comparison of Inputs of Total Nitrogen and Total Phosphorus to the Elder Creek Pond.

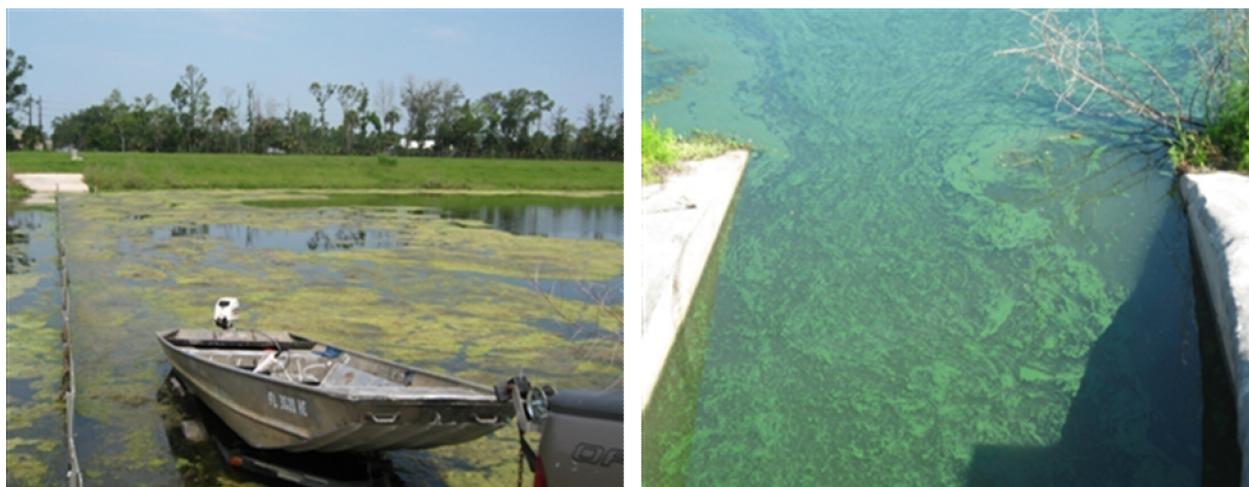
a. Floating filamentous algae

b. Blue-green algal bloom
