Elder Creek Stormwater Facility Performance Efficiency Evaluation

Final Report

September 2010

Seminole County, Florida

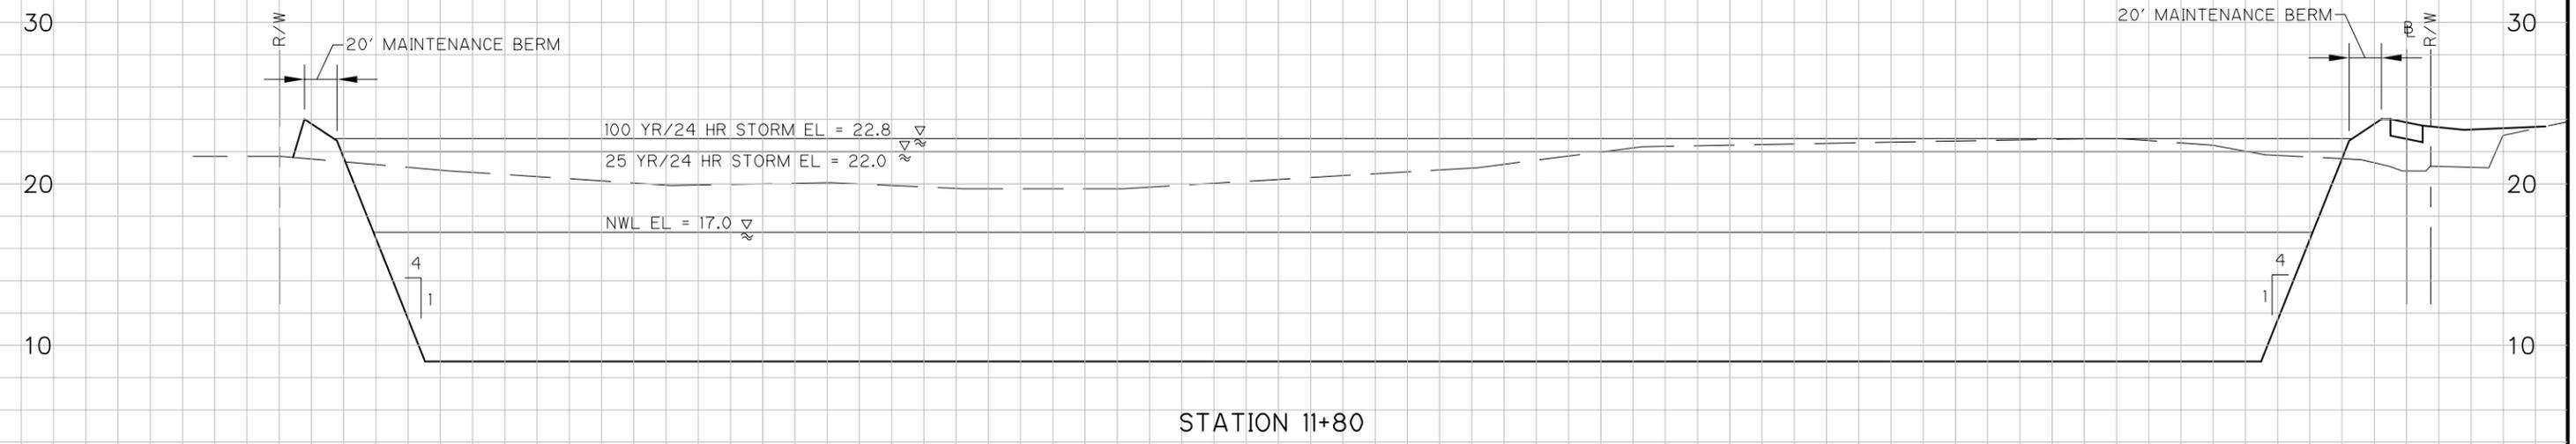
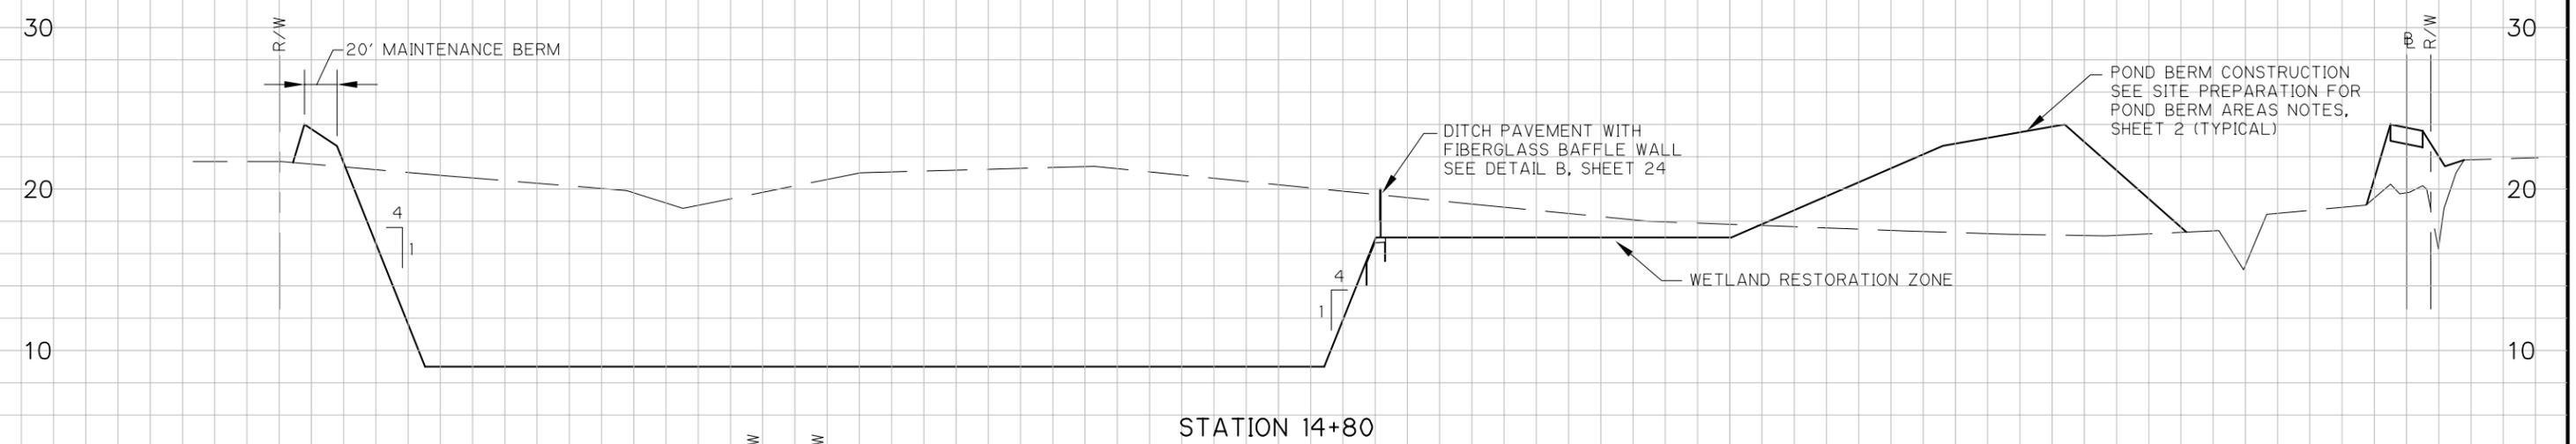
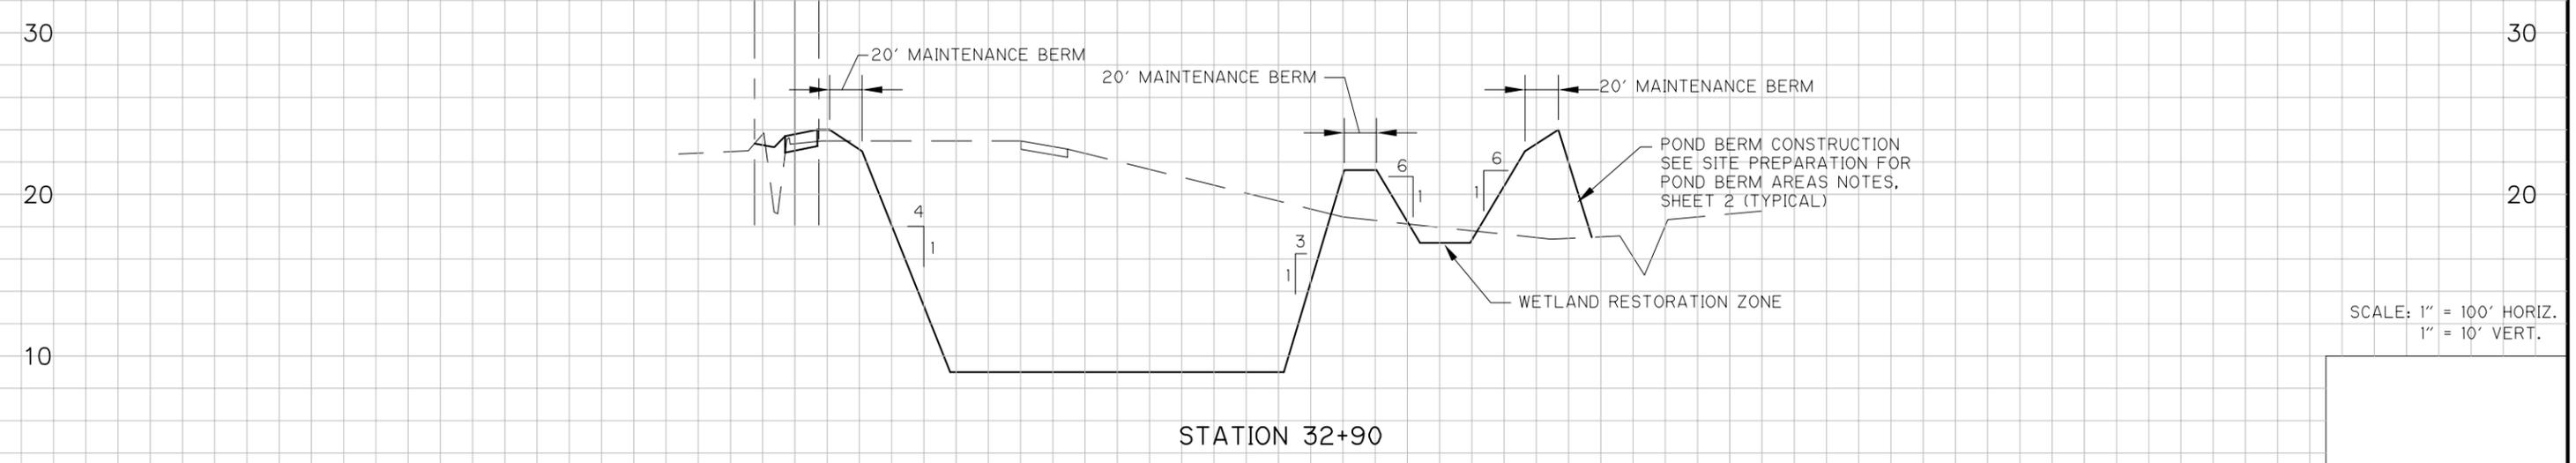
**POND
 PLAN**

SCALE: 1" = 100' HORIZ.
 1" = 10' VERT.

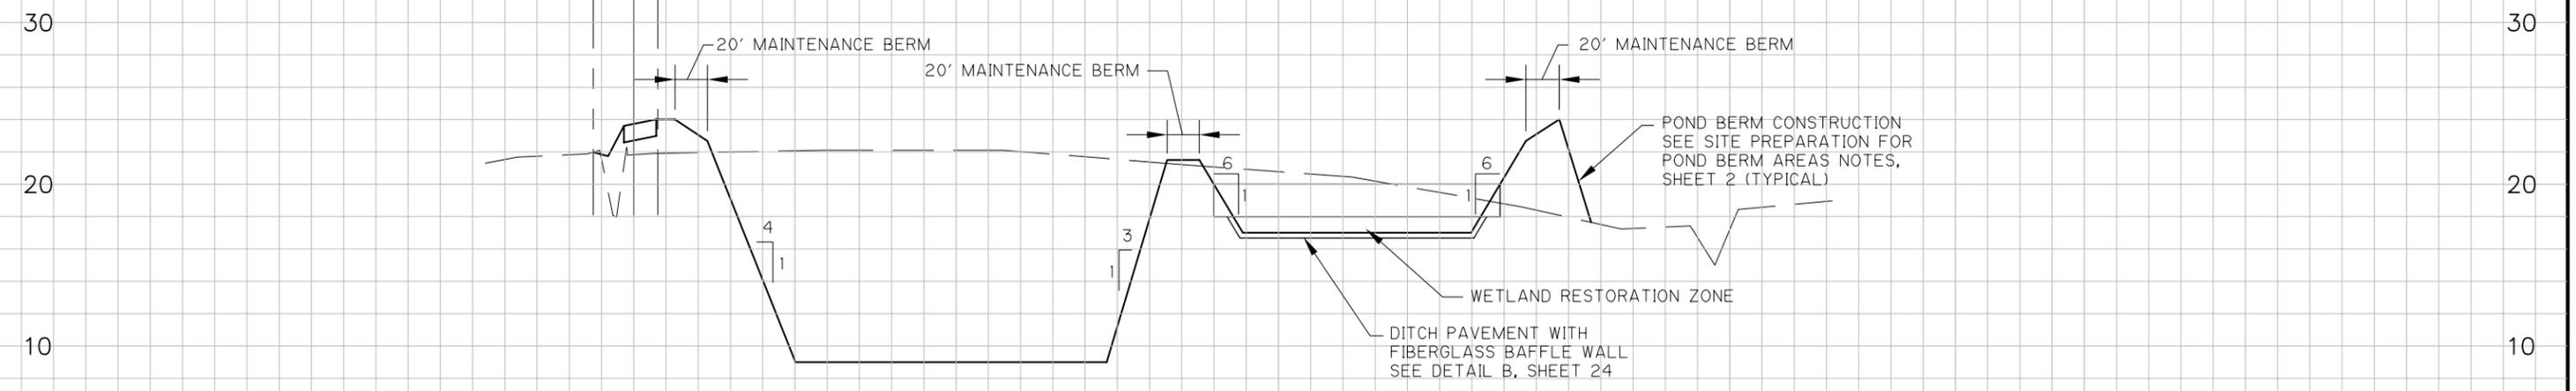
STATION 36+55

POND CROSS SECTIONS

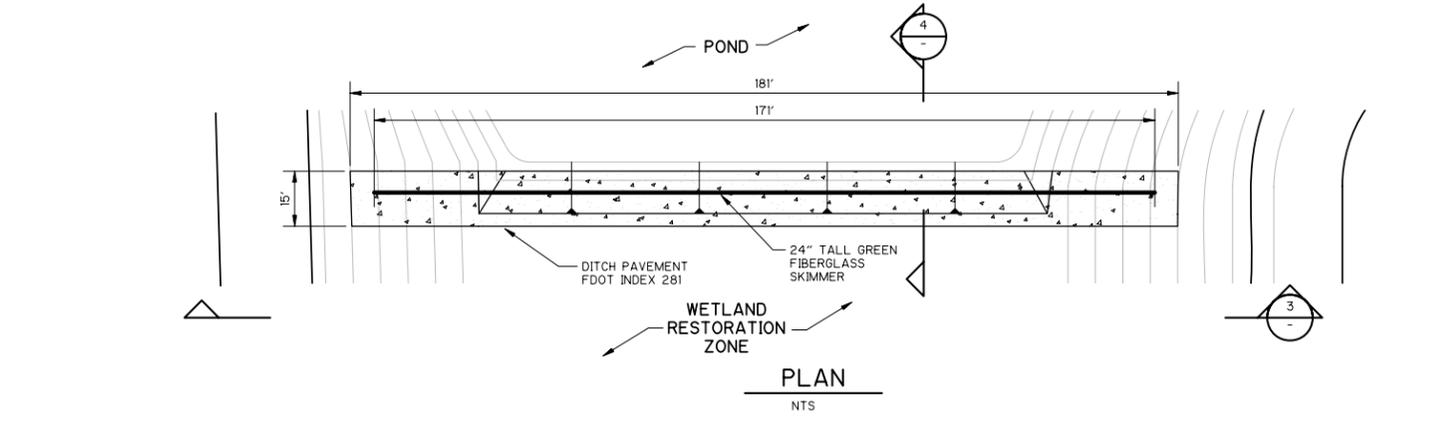
NOTE:
3/8" DIA STAINLESS STEEL STUD TYPE EXPANSION ANCHOR WITH NUT AND WASHER. EMBEDMENT DEPTH = 2 1/2". ANCHORS TO BE KWIK BOLT II BY HILTI CORPORATION, POWER-STUD BY POWERS FASTENING INC. OR TRUBOLT BY ITW RAMSET/RED HEAD OR EQUAL. ANCHORS TO BE INSTALLED ACCORDING TO THE MANUFACTURER'S RECOMMENDATIONS (12 REQUIRED PER SKIMMER SIDE).
