# Long Branch Creek Nutrient Source Evaluation and Assessment

*Final Report*

**Pinellas County, Florida**

**Environmental Research & Design, Inc.**

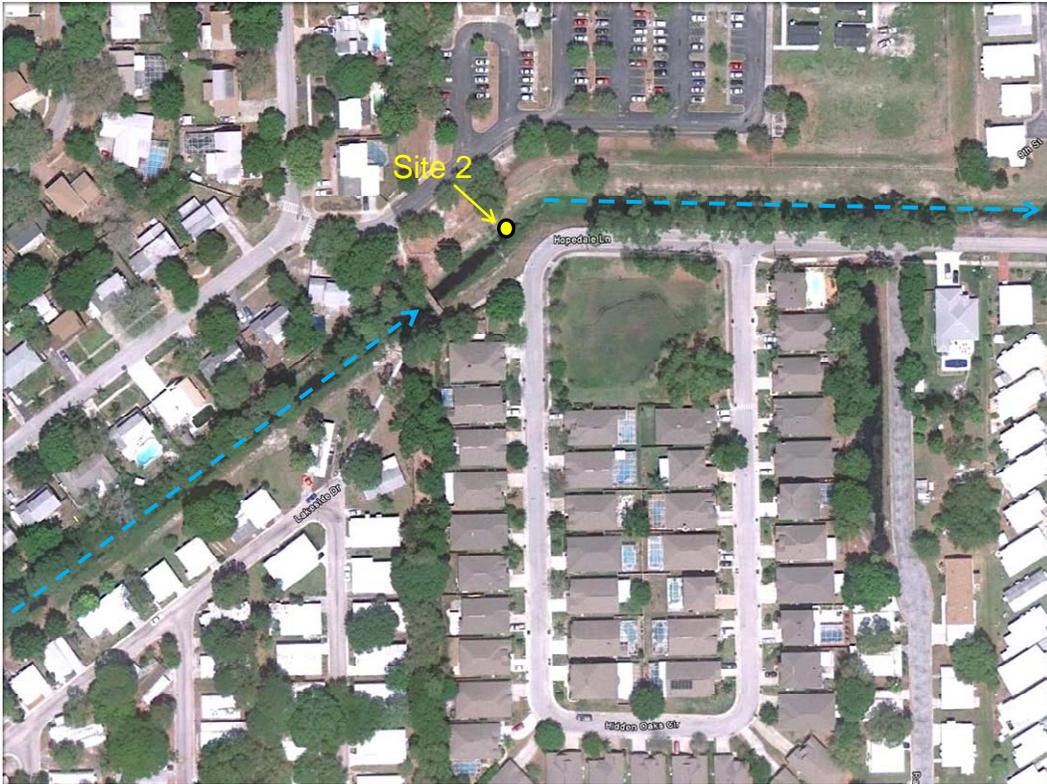
Figure 3-5. Detailed Location Map for Site 2.

A detailed location map for monitoring Site 2 is given on Figure 3-5. Monitoring Site 2 is also located in the southern headwaters segment downstream from monitoring Site 1. Photographs of monitoring Site 2 are given on Figure 3-6. The channel at this location consists of a moderately deep canal with steep side slopes and dense vegetation. Field monitoring at this site was conducted at a location with minimal aquatic vegetation to minimize interference with discharge measurements and field monitoring. Site 2 is intended to reflect any changes in water quality characteristics which occur between Belcher Road and Site 2.

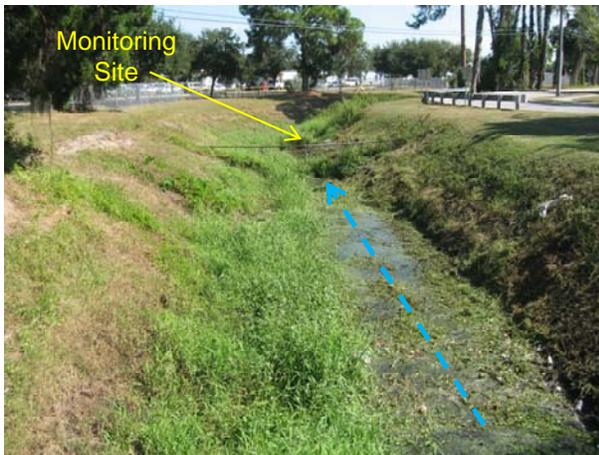
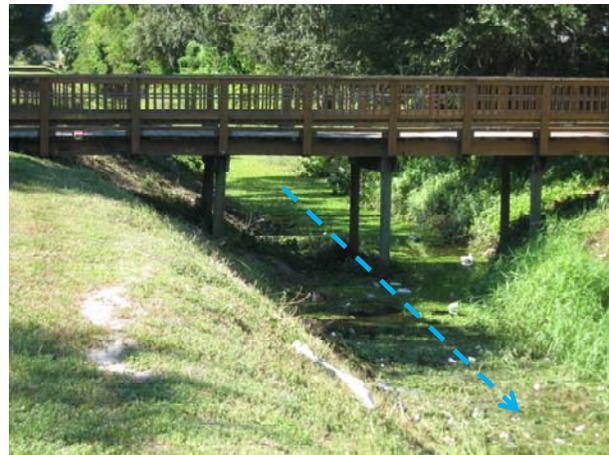
Figure 3-6. Photographs of Monitoring Site 2.

a. Channel downstream from foot bridge

b. Densely vegetated earthen channel

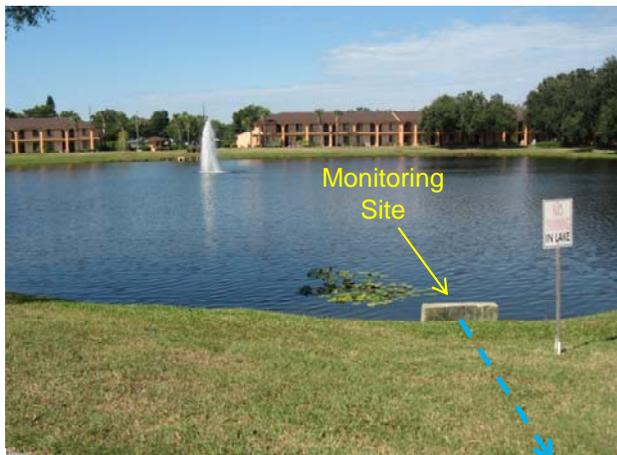
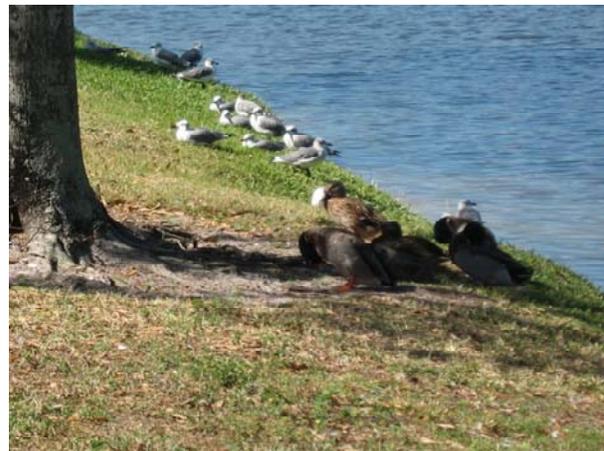
Figure 3-8. Photographs of Monitoring Site 3.

A detailed location map for Sites 3 and 4 is given on Figure 3-7. Each of these sites is located in the northern headwater segment to provide information on significant inputs to the northern headwaters. Site 3 reflects the discharge from Swan Lake which forms the headwaters of the northern channel segment. Photographs of Site 3 are given on Figure 3-8. Field monitoring at this site was conducted at the outfall structure for Swan Lake which forms the headwaters of the northern channel segment. The pond site was frequented by a wide variety of waterfowl which were present during each field monitoring event.

a. Monitoring site at lake outfall

b. Lake is home to many species of waterfowl

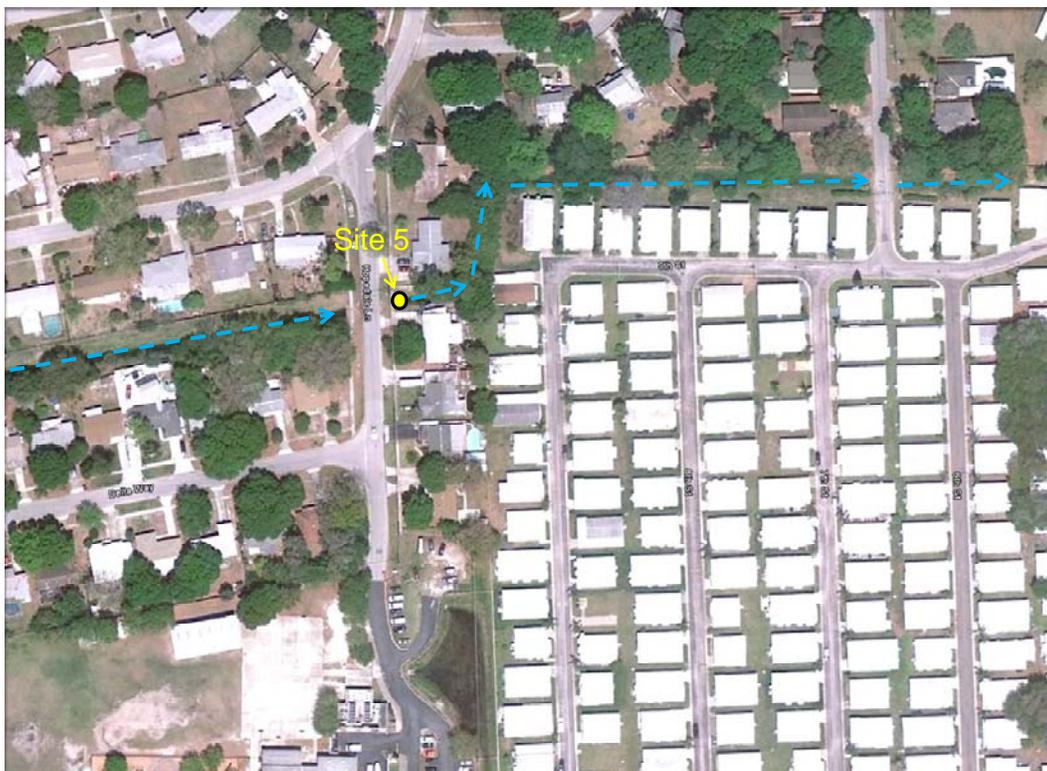
Figure 3-10. Detailed Location Map for Site 5.

A detailed location map for Site 5 is given on Figure 3-10. Site 5 is located in downstream portions of the northern channel, after inflows from Swan Lake, the tributary inflow reflected at Site 4, and inflow from a second lake located between Sites 4 and 5. Photographs of monitoring Site 5 are given on Figure 3-11. The monitoring site was located at the downstream side of the culvert crossing for Hopedale Lane. The channel at this location is relatively shallow and heavily choked with weeds, with generally a sluggish water movement.

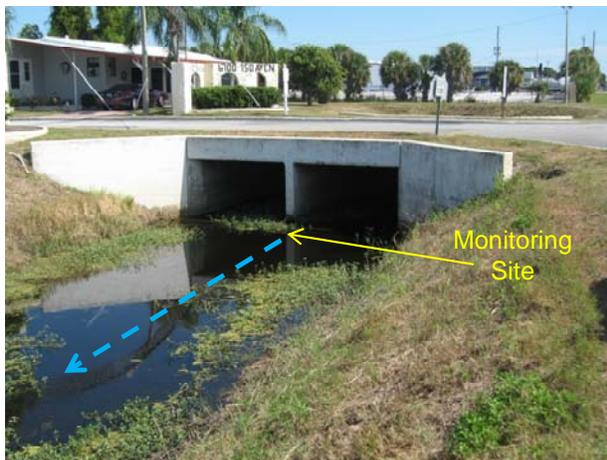
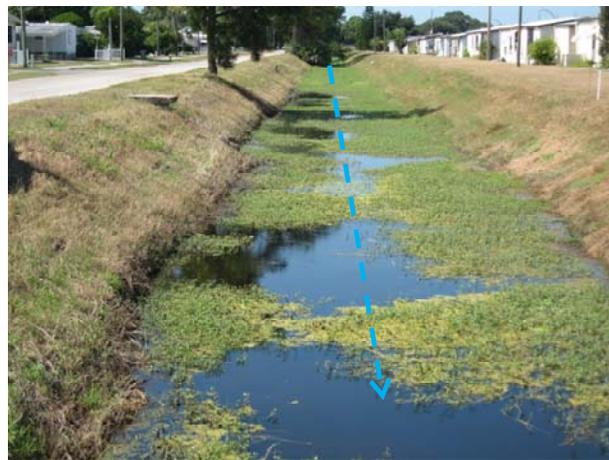
Figure 3-13. Photographs of Monitoring Site 6.

A detailed location map for Site 6 is given on Figure 3-12. Site 6 is located in the southern headwater segment, downstream from Site 2. Photographs of monitoring Site 6 are given on Figure 3-13. Site 6 is located on the downstream side of the double box culverts which transfer the southern channel beneath 3<sup>rd</sup> Street. The channel in this area is much wider and deeper than observed at the upstream monitoring sites. However, large portions of the channel are still choked with weeds and debris, similar to conditions observed in upstream areas.

a. Box culverts beneath 3<sup>rd</sup> Street

b. Wide channel choked with weeds and debris

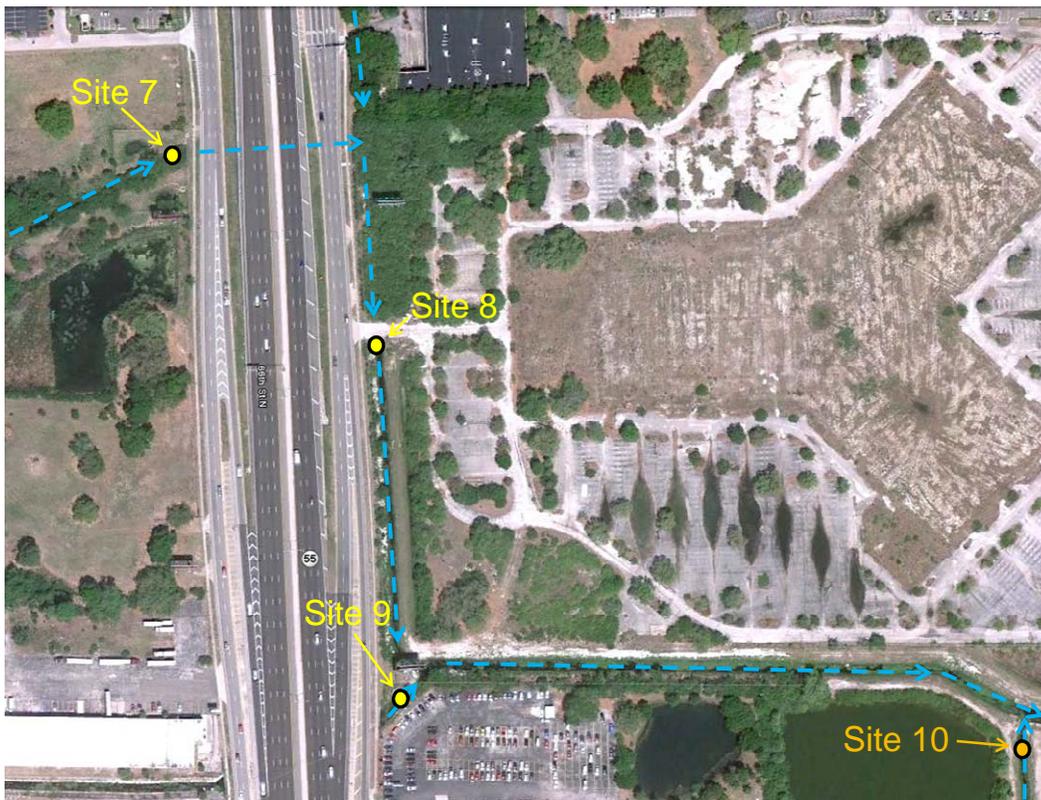
Figure 3-14. Detailed Location Map for Sites 7, 8, 9, and 10.

Detailed location maps for Sites 7, 8, 9, and 10 are given on Figure 3-14. Sites 7, 8, and 9 are designed to monitor water quality characteristics of the final discharges from the northern (Sites 7 and 8) and southern (Site 9) segments which form the headwaters of the main channel. Photographs of Site 7 are given on Figure 3-15. This site reflects the final discharge from the northern channel segment west of US 19. The channel in this area is relatively narrow and shallow, with a dense tree canopy. The monitoring site was located inside a fenced FDOT parcel immediately upstream of the point of conveyance into the box culvert which discharges the channel beneath US 19. A photograph of blue water conditions observed at Site 7 on October 19, 2010 is also given on Figure 3-15. Investigation by Pinellas County indicated that this color was due to illegal use of an aquatic dye in an upstream tributary.

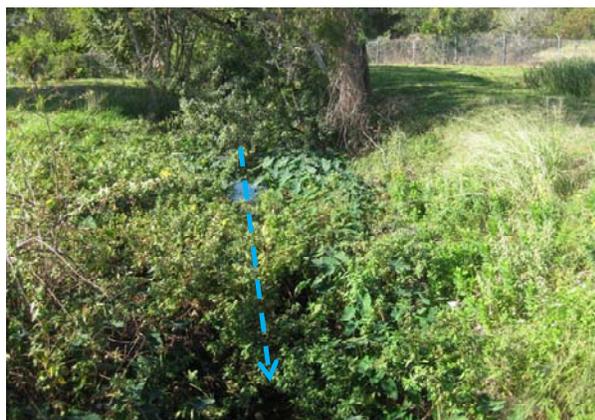
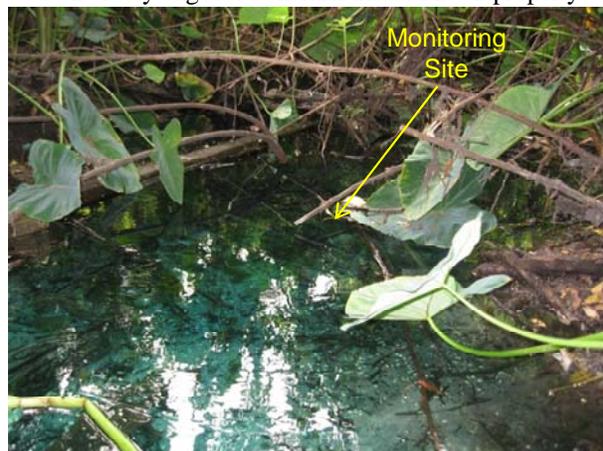
Figure 3-15.

a. Densely vegetated channel inside FDOT property

c. Blue water observed discharging through channel on 10/19/2010

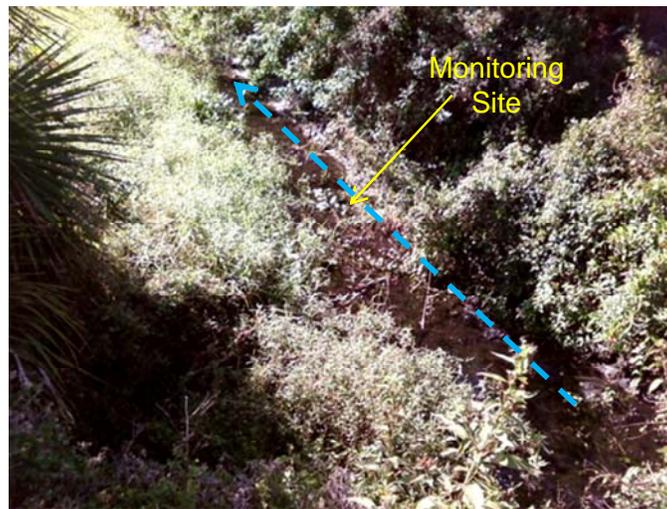
Figure 3-16. Photograph of Monitoring Site 8.

A photograph of monitoring Site 8 is given on Figure 3-16. This channel is located on the east side of US 19 and receives inflow from the northern headwaters segment west of US 19 along with a wetland depressional area located north of Site 8 which receives inflow from commercial areas adjacent to Roosevelt Blvd. The canal reflected by Site 8, which is the final monitoring site on the northern segment, discharges in a southerly direction and combines with the inflow from the southern headwaters segment at Site 9 to form the combined main channel. The channel at Site 8 is densely vegetated, with a narrow water width under most conditions.

a. Densely vegetated channel

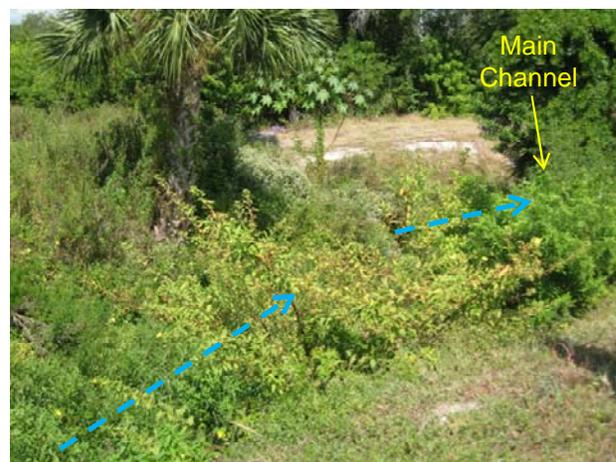
Figure 3-17. Photographs of Monitoring Site 9.

Photographs of monitoring Site 9 are given on Figure 3-17. Site 9 reflects the final discharge from the southern headwater channel into the main channel at the point of conveyance beneath US 19. The channel at this site is relatively wide and choked with dense emergent vegetation.

b. Inflow channel upstream from convergence with main channel

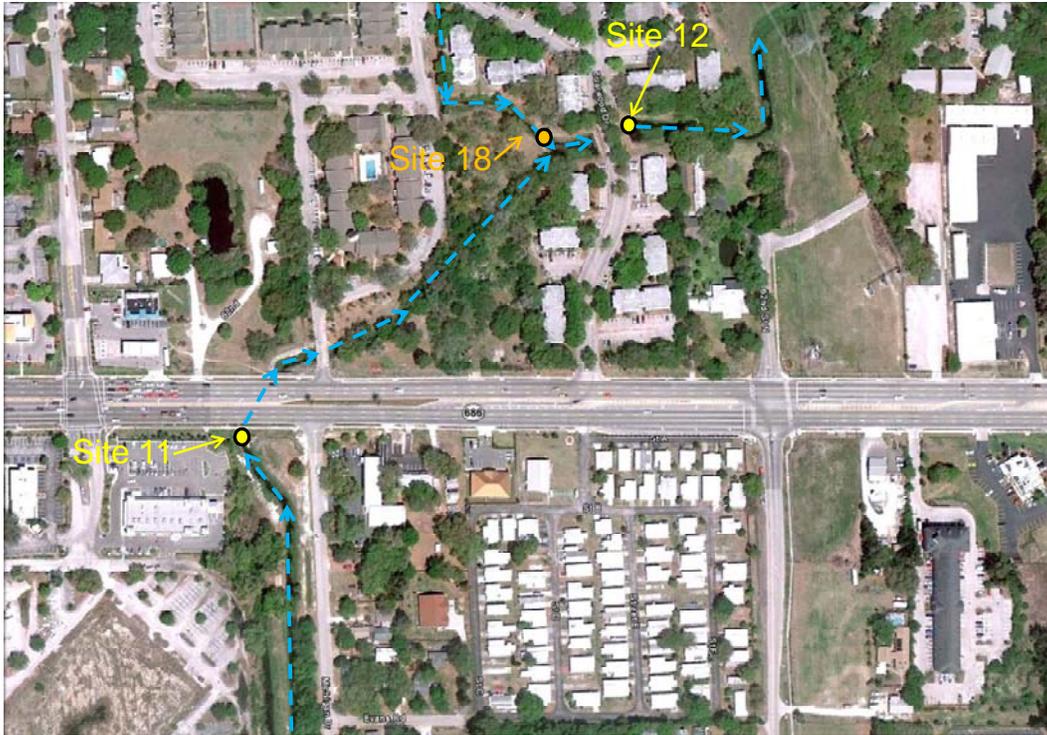
Figure 3-19. Detailed Location Map for Sites 11, 12, and 18.

Detailed location maps for Sites 11, 12, and 18 are given on Figure 3-19. Site 11 is located in the main channel on the south side of Roosevelt Blvd., with Site 12 located in the main channel on the north side of Roosevelt Blvd. Site 18 is located in a tributary inflow immediately upstream of Site 12. Photographs of monitoring Site 11 are given on Figure 3-20. This monitoring site is located upstream of the double box culvert which conveys the main channel beneath Roosevelt Blvd. The channel at this location is wide and shallow, with emergent vegetation along the sides of the channel. Also shown on Figure 3-20 is USGS gauging station 2307780, located just upstream from the field monitoring site.

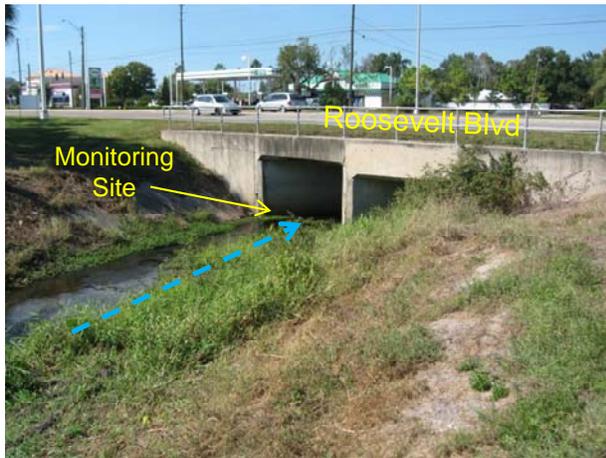
Figure 3-20. Photographs of Monitoring Site 11.

a. Box culverts beneath Roosevelt Blvd.

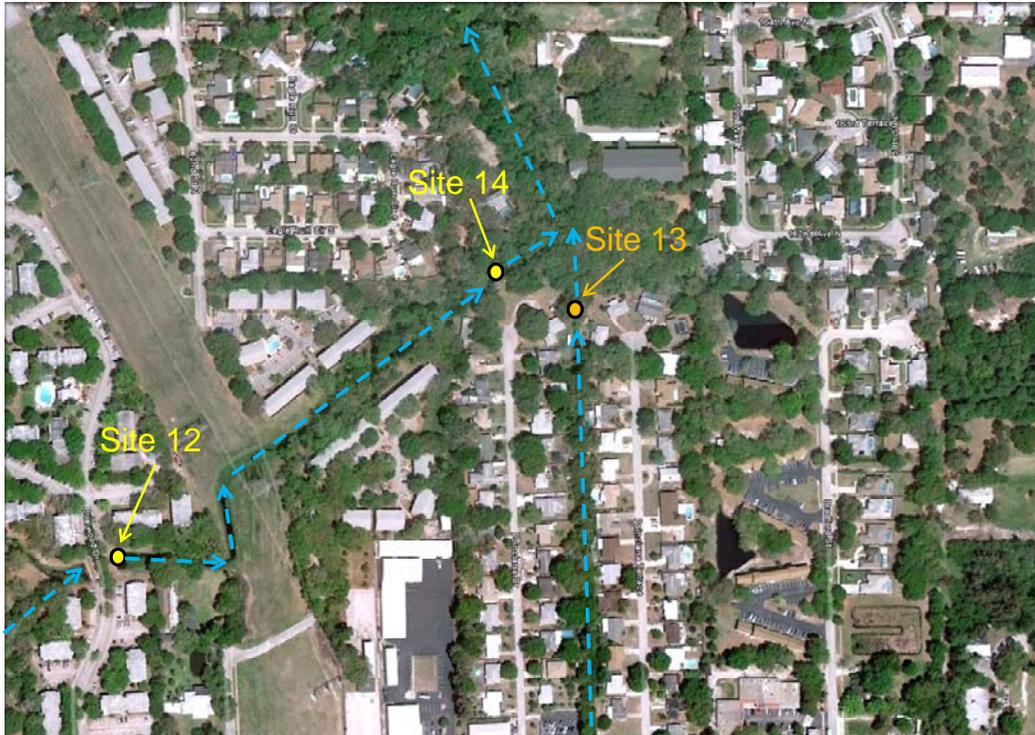
Figure 3-23. Detailed Location Map for Sites 13 and 14.

A detailed location map for Sites 13 and 14 is given on Figure 3-23. Site 14 is located within the main channel downstream from Site 12, while Site 13 reflects a tributary inflow which joins the main channel downstream from Site 14. Photographs of monitoring Site 13 are given on Figure 3-24. The tributary inflow is characterized by steep side slopes with a relatively narrow bottom width. The bottom of the channel is strewn with a variety of rocks and other debris. Water velocity in the tributary was generally relatively swift, although the water depth was typically less than 1 ft. A photograph of Site 14 is given on Figure 3-25. The main channel in this area becomes relatively narrow, with dense vegetation cover. This site is located adjacent to a facility which includes a number of horse stables.

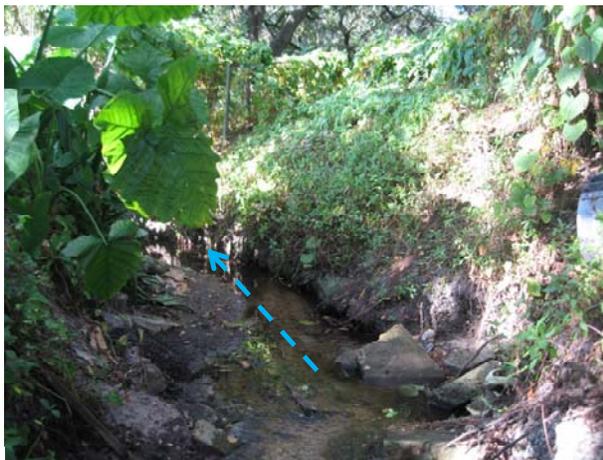
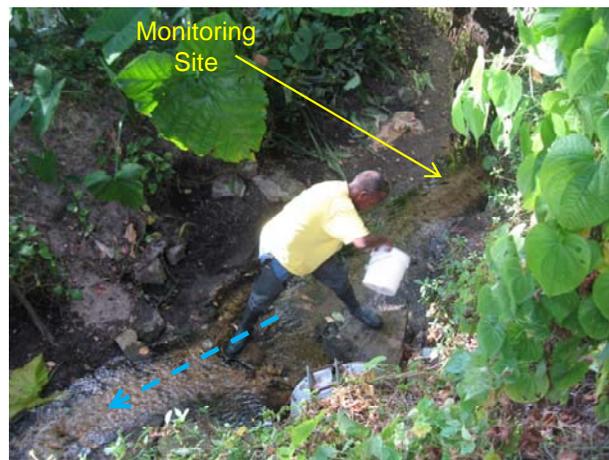
Figure 3-24. Photographs of Monitoring Site 13.

a. Tributary channel upstream from main channel

b. Sample collection in channel

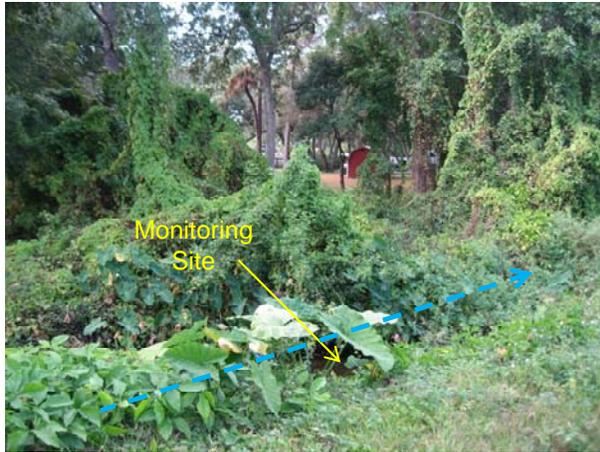
Figure 3-25.

a. Main channel adjacent to horse stables

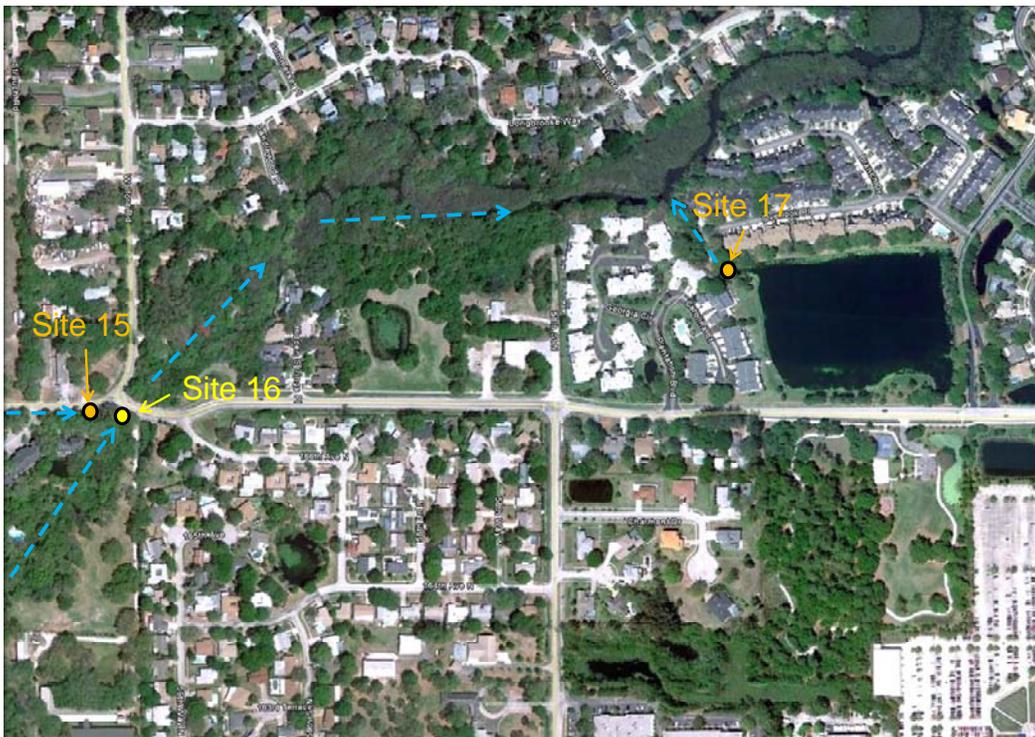
Figure 3-26. Detailed Location Map for Sites 15, 16, and 17.

Detailed location maps for Sites 15, 16, and 17 are given on Figure 3-26. Site 16 is located along the main channel and is the most downstream monitoring site included in this study. Sites 15 and 17 reflect inflows to the main channel. Photographs of monitoring Site 15 are given on Figure 3-27. This site receives inflow from a roadside ditch along Whitney Road which ultimately discharges into the main channel. The roadside channel is characterized by relatively steep sides with a narrow bottom width. Photographs of monitoring Site 16 are given on Figure 3-28. This monitoring site is located in the main channel at the box culvert crossing with Whitney Road. Monitoring was conducted on the upstream side of the box culvert. The inflow from the Whitney Road ditch is also visible on Figure 3-28b.

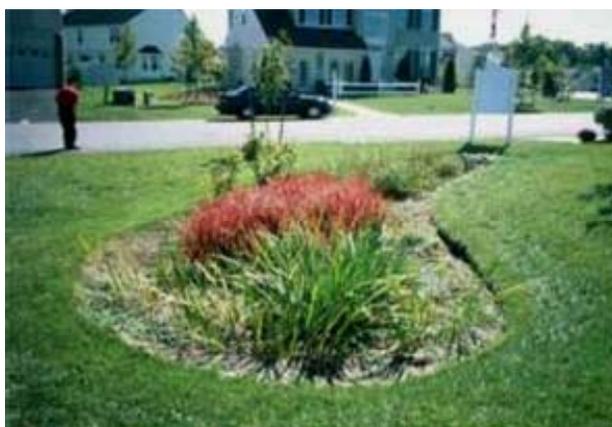
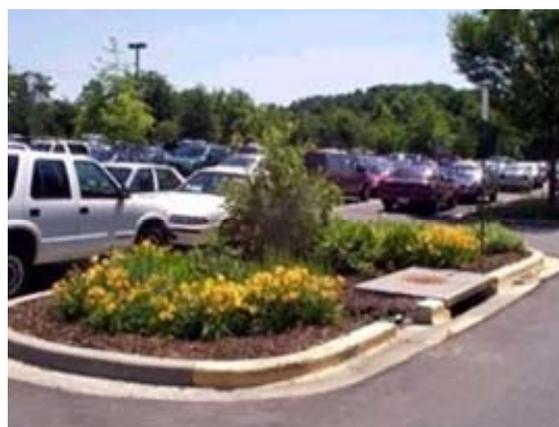
Figure 5-2. Photographs of Bio-retention Systems.

Typical photographs of bio-retention systems used in a residential and commercial setting are given on Figure 5-2. These systems are used to collect and store runoff from a relatively small area and infiltrate the runoff into the groundwater between storm events. The planted vegetation aids in uptake and adsorption of nutrients during migration through the upper layers of the soil. Since bio-retention systems are simply dry retention ponds with planted vegetation, the removal efficiency of a bio-retention pond is a direct function of the percentage of the annual runoff volume which is infiltrated into the ground.

a. Bio-retention on a residential setting

b. Bio-retention on a commercial setting

Bio-retention areas, also referred to as rain gardens, are landscaped depressional areas used to store and infiltrate runoff into groundwater. Although the term “bio-retention” is relatively new in the stormwater BMP field, this process is simply a smaller version of the standard dry retention design used in Florida for several decades with the exception that the grass used to line the bottom of the pond is replaced with more decorative vegetation. Bio-retention systems are more suited to small drainage basins rather than the larger drainage basin areas which commonly discharge to a standard dry retention pond.

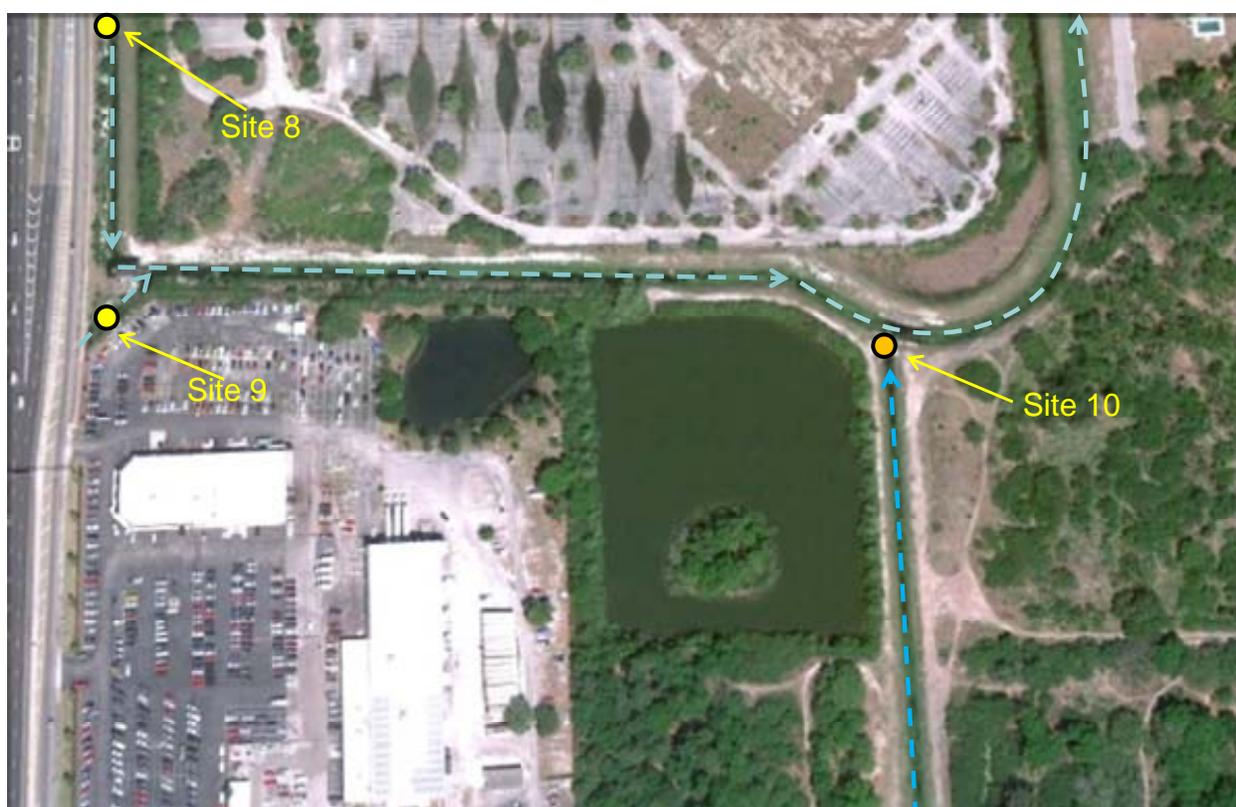
Figure 5-5. Overview of Drainage Patterns in the Vicinity of Monitoring Sites 8, 9, and 10.

An overview of drainage patterns in the vicinity of the main channel east of US 19 is given on Figure 5-5. Inflows from the northern headwater segment (monitored at Site 8) combine with inflows from the southern headwater segment (monitored at Site 9) to form the main channel. An additional tributary inflow to the main channel occurs from Site 10, as indicated on Figure 5-5. As discussed in Section 4.3.2.1, inflow into the main channel from Site 8 was found to have elevated concentrations of total nitrogen, total phosphorus, and fecal coliform bacteria, while inflows from Site 9 were characterized by moderately elevated levels of total nitrogen, total phosphorus, and fecal coliform bacteria. Since these two inflows form the headwaters of the main channel, reductions in nutrient and fecal coliform concentrations at these sites would likely carry downstream and improve water quality characteristics throughout the main channel.

A large borrow pit pond currently exists south of the main channel and west of tributary inflow monitoring Site 10. The depth of this pond is not known at this time, but it appears that the pond could perform a function as a regional wet detention pond. Construction activities are currently ongoing in the parcel located immediately south of the pond, and it is likely that the constructed development will utilize the borrow pit pond as a stormwater management facility. However, the size of the pond appears to be substantially larger than would be required to provide treatment for a development in the southern portions of the parcel.

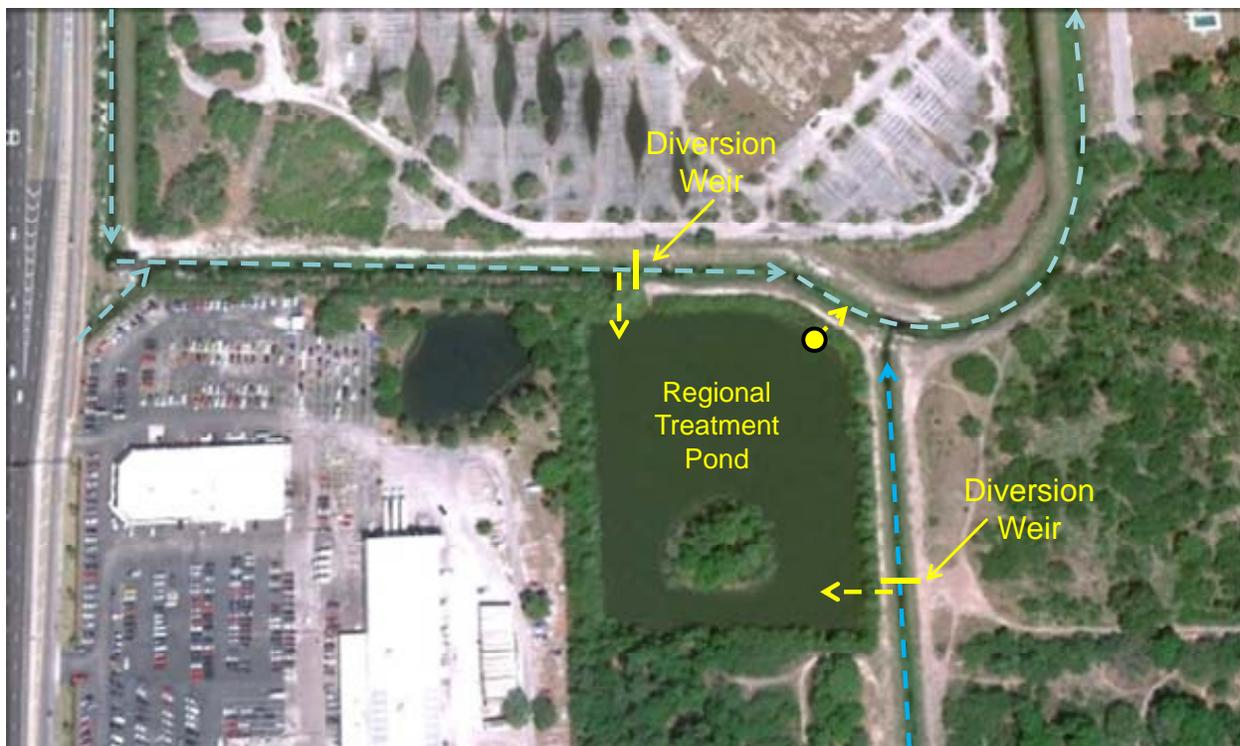
Figure 5-6. Conceptual Schematic for Regional Treatment Pond for Upstream Portions of Long Branch Creek.

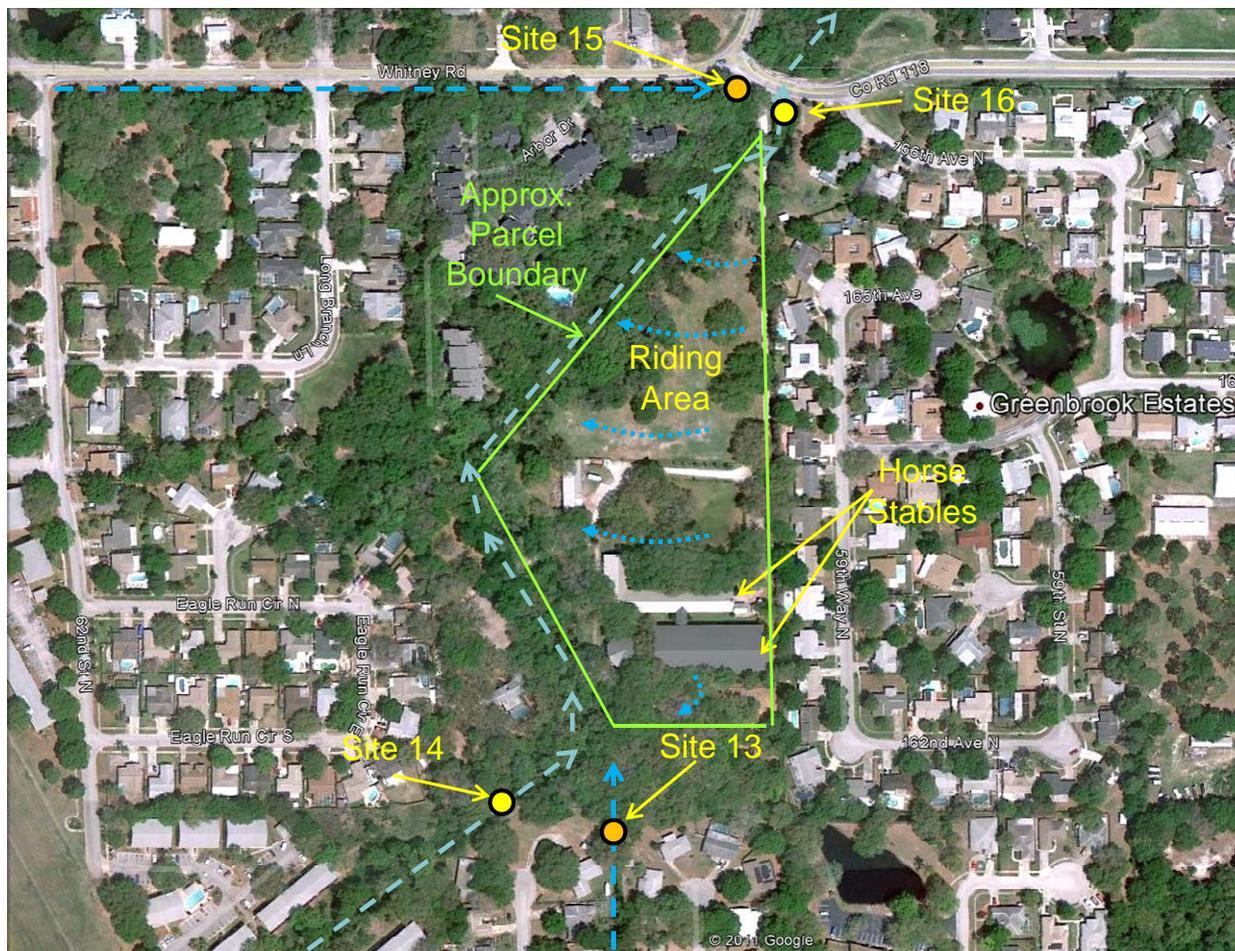
Figure 5-7. Overview of Drainage Patterns in the Vicinity of Main Channel Sites 14 and 16.

An overview of drainage patterns in the vicinity of main channel Sites 14 and 16 is given on Figure 5-7. The only significant inflows into Long Branch Creek between Sites 14 and 16 is the tributary inflow at Site 13. However, based upon the field monitoring conducted by ERD, mass loadings of nitrogen and phosphorus introduced into the main channel from this tributary inflow are minimal in comparison with the overall mass loadings. Inflows into the main channel from this site were characterized by substantially elevated concentrations of both total phosphorus and fecal coliform bacteria, but the overall mass loadings of these parameters were relatively low. However, additional monitoring or research is recommended to identify the sources of the elevated phosphorus and fecal coliform counts observed in this tributary.

One of the most significant features along Long Branch Creek between Sites 14 and 16 is the horse stables and riding area which are located along virtually the entire eastern portion of the creek between the two monitoring sites. Existing drainage patterns in the area result in surface runoff discharging from east to west and ultimately entering the main channel from this parcel. Runoff from residential areas also enters the main channel from areas west of the channel, although there is nothing about the physical characteristics of this neighborhood which would suggest elevated loadings of either total phosphorus or fecal coliform bacteria. All homes within the parcel are currently serviced by a central sanitary sewer system, and discharges of fecal coliform bacteria from this area do not appear likely. Therefore, the horse stables and riding area appear to be the most logical source of the elevated nutrients and fecal coliform bacteria observed between monitoring Sites 14 and 16.

Assuming that the horse farm parcel is the source of the elevated nutrients and fecal coliform bacteria entering Long Branch Creek, then the observed loadings can be reduced either by enhanced on-site management practices or constructing a treatment system to either treat or prevent runoff from the property from entering Long Branch Creek. Improvements in management activities are always desirable, and should be a first step in evaluating and reducing on-site loadings. However, BMP management practices for equestrian activities are not foolproof and do not always prevent introduction of contaminants through on-site runoff. Therefore, in addition to enhanced management practices, a berm and swale system is proposed to retain on-site runoff within the horse farm parcel.

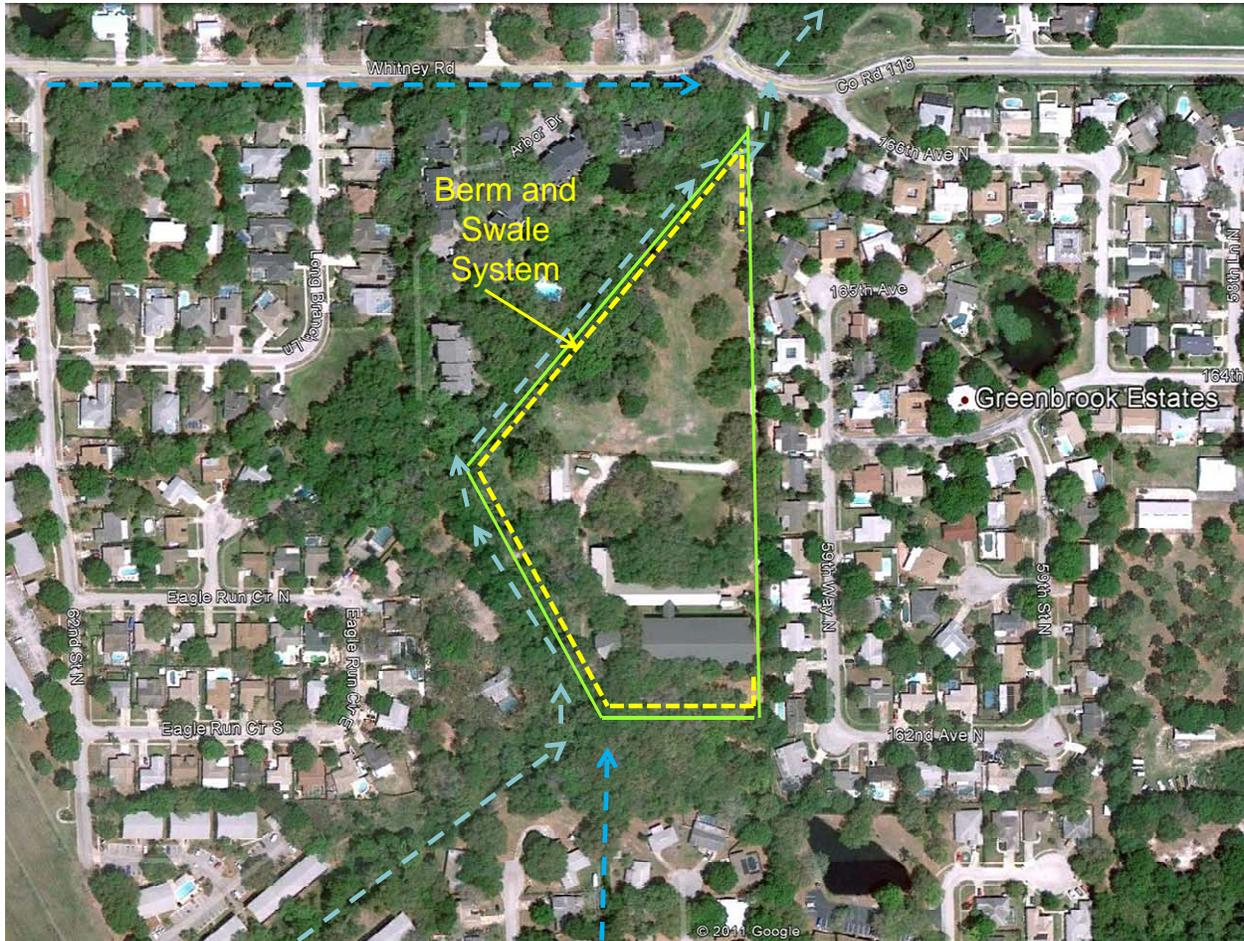
Figure 5-8. Proposed Berm and Swale System for Horse Stable Parcel.

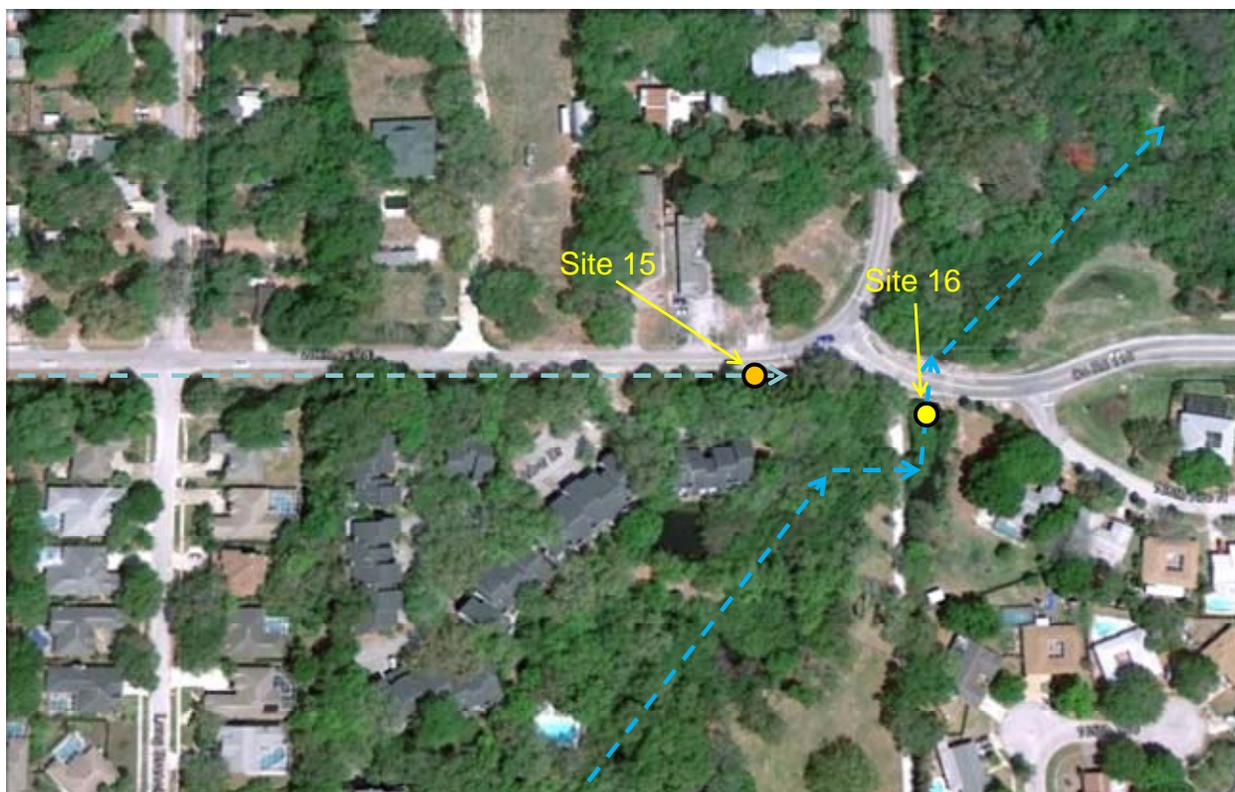
Figure 5-9. Overview of Drainage Patterns in the Vicinity of Monitoring Sites 15 and 16.

As discussed in Section 4, substantially elevated levels of fecal coliform bacteria were observed in discharges from tributary inflow Site 15. Measured concentrations of nitrogen and phosphorus discharging from this tributary were moderate in value, with the main water quality problem appearing to be elevated fecal coliform bacteria. An overview of drainage patterns in the vicinity of monitoring Sites 15 and 16 is given on Figure 5-9. As indicated on Figure 3-27b, the inflow from the Whitney Road ditch enters the box culvert which passes Long Branch Creek beneath Whitney Road. The ditch alongside Whitney Road consists of a relatively deep earthen channel which runs the entire length of Whitney Road and directs roadway runoff, along with adjacent watershed runoff, to the point of inflow into the main channel. Evidence of fecal coliform bacteria was observed at this site even under low flow conditions, suggesting a non-runoff related inflow of bacteria into the drainage system.

As discussed previously, the most appropriate method of reducing fecal coliform bacteria at this site would be to evaluate and identify the sources of the fecal coliform bacteria within the watershed. If the specific sources cannot be identified, it may be appropriate to construct a treatment system to attenuate some of the fecal coliform bacteria prior to entering Long Branch Creek.

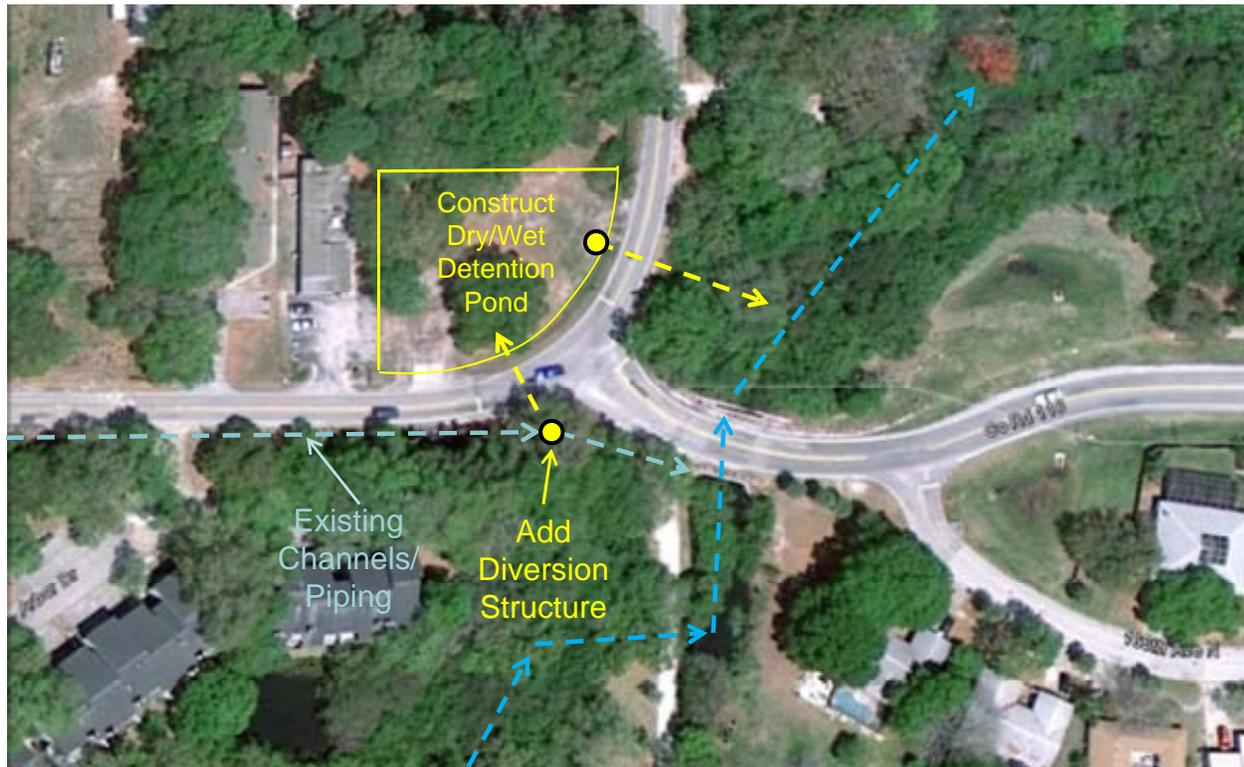
Figure 5-12. Alternative Conceptual Treatment System for the Whitney Road Drainage Swale.

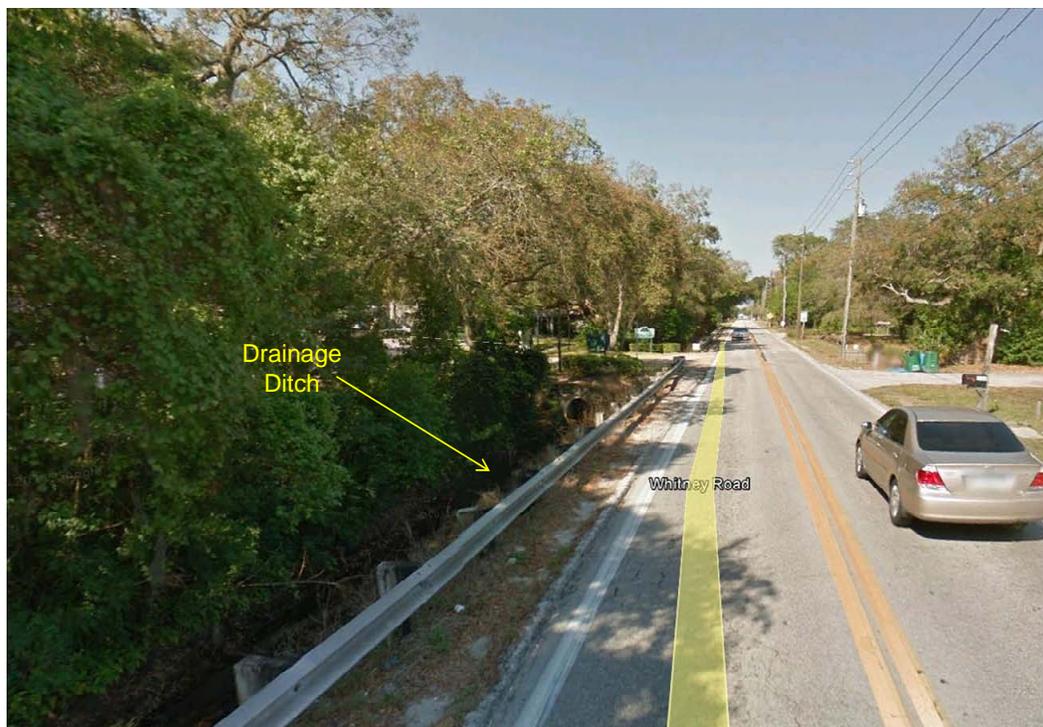
Figure 5-13. Roadside Drainage System Along Whitney Road.

A less expensive and potentially more effective BMP option for the Whitney Road drainage system would be to construct a series of berms or check-dams in the existing roadside drainage system along Whitney Road. A photograph of the drainage system is given on Figure 5-13. Under current conditions, stormwater runoff is collected and conveyed through a deep open channel located on the south side of Whitney Road. This channel extends for much of the length of Whitney Road which discharges into Long Branch Creek. The drainage system is both wide and deep, particularly in downstream portions of the channel. These areas seem like excellent opportunities for construction of check-dams or berms to retain portions of the stormwater volume within the channel, as well as increase residence time for the drainage which will allow settling of particulate matter and die-off and predation of the microbiological contaminants. If adequate right-of-way is available, the channel could be easily expanded in some areas to provide a larger area and volume of stored water. Any proposed modifications to the drainage system would need to be evaluated using hydrologic modeling to ensure that flooding conditions would not be produced. However, if this option is feasible, it would be a relatively inexpensive and effective method of treating stormwater runoff along Whitney Road prior to discharge into Long Branch Creek.

Based upon the field monitoring conducted by ERD, a constant baseflow was present within the channel during much of the field monitoring program. This baseflow exhibited elevated levels of nutrients and fecal coliform bacteria which would also receive treatment with the proposed drainage system modifications. If adequate storage can be provided, and if the proposed water storage areas do not negatively impact the hydraulics of the system, this option would likely be more effective than the proposed pond treatment systems discussed previously.
