# Klosterman Bayou and Joe's Creek Nutrient Source Evaluation

*Final Report*

*February 2010*

**Pinellas County, Florida**

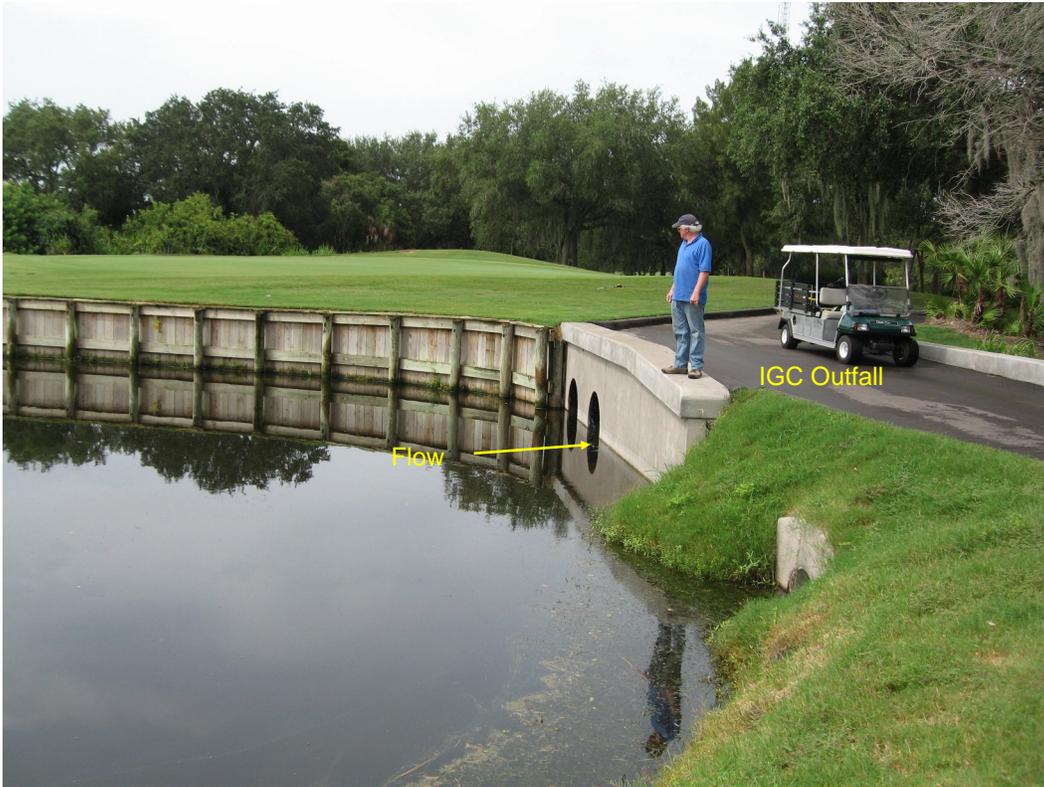
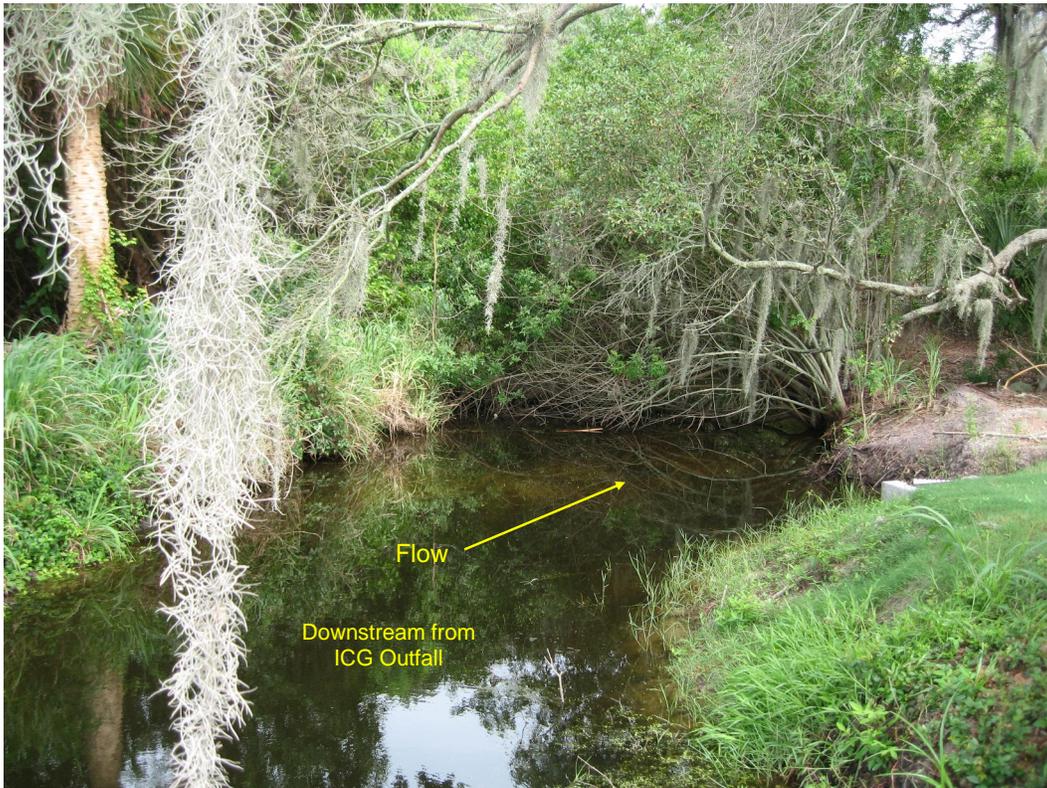
Figure 2-7. Outfall Structures for the Freshwater Segment of the Klosterman Bayou Watershed.

a. IGC Outfall Structure

b. Channel Downstream from IGC Outfall

All surface water runoff generated in northern portions of the freshwater segment of the Klosterman Bayou watershed ultimately enters the series of interconnected lakes located in the western-central portion of the basin area. Discharges from these lakes occur through a series of flapper valves, which prevent backflow of brackish water into the lake system. A photograph of the discharge structure from the IGC is given on Figure 2-7. The flapper valves are located inside the two culverts which discharge from the final pond system into the marine portion of the watershed. An additional reuse pump station is also located adjacent to the interconnected lakes.

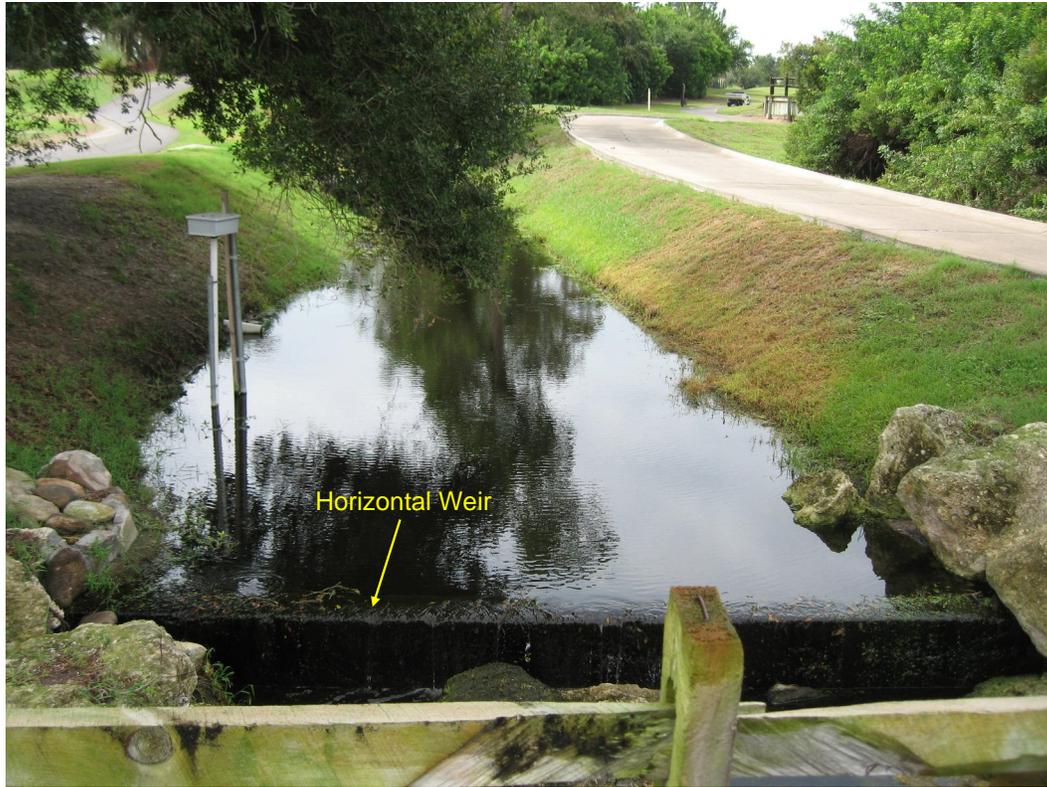
b. Horizontal Weir Structure

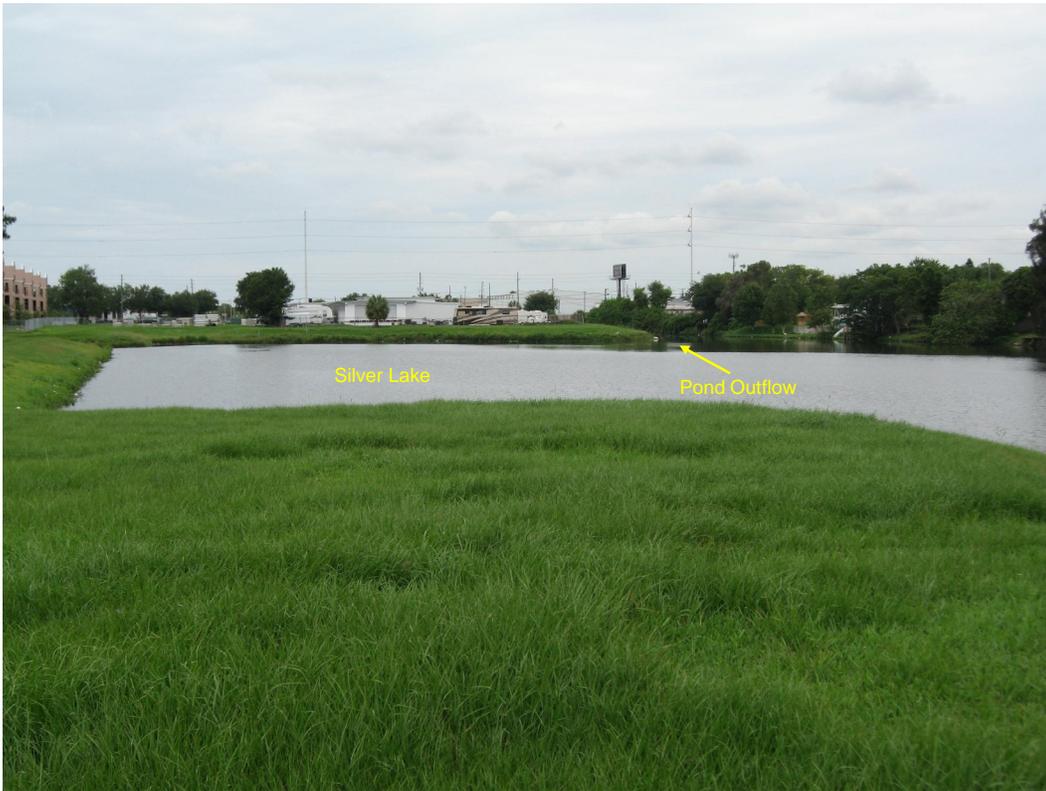
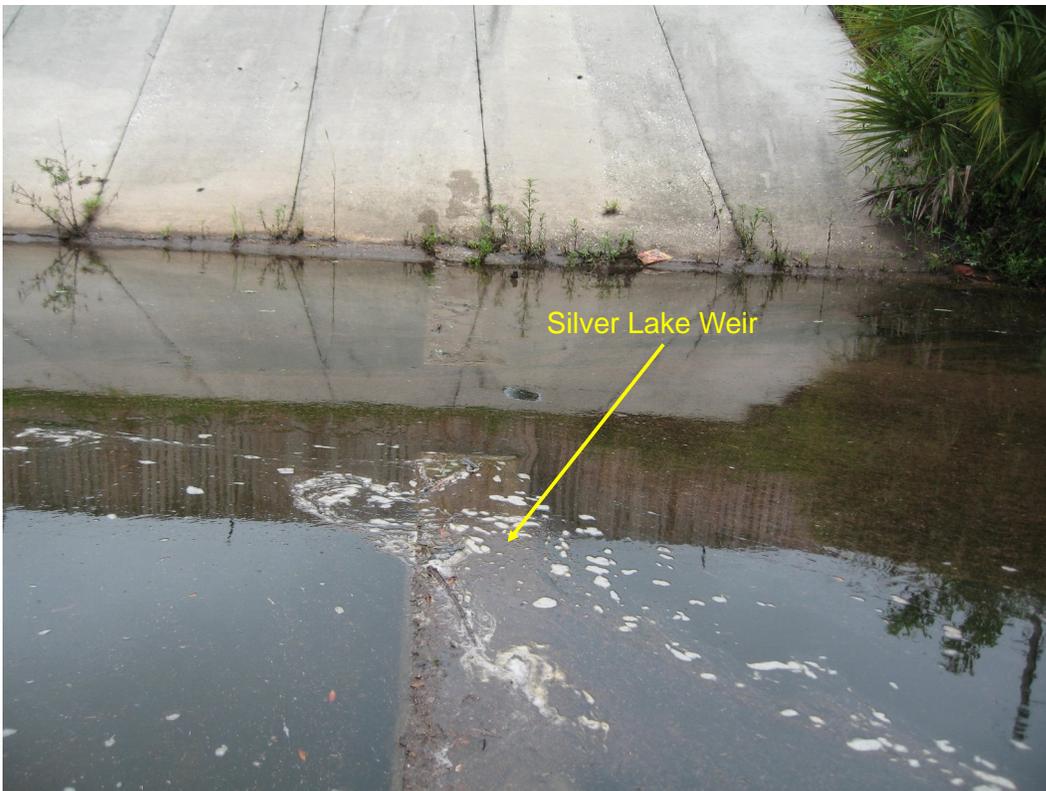
Figure 2-20. Photographs of Silver Lake.

a. Silver Lake

b. Silver Lake Weir

Photographs of upstream portions of Joe's Creek are given on Figure 2-19. Joe's Creek originates as the discharge from the box culvert structure indicated on Figure 2-19. Discharges from the culvert enter a man-made waterbody referred to as Silver Lake which provides detention for inflows prior to discharging downstream. Photographs of Silver Lake are given on Figure 2-20. Water level in Silver Lake is regulated by a compound weir structure, consisting of a rectangular concrete weir with a 4-ft wide x 1 ft deep trapezoidal weir in the center of the rectangular weir. The photograph indicated on Figure 2-20b shows a rare submerged condition for the Silver Lake weir. During the majority of monitoring events conducted by ERD, water levels in Silver Lake were lower than the weir crest elevation, with a minimal flow discharging through the trapezoidal portion of the weir.

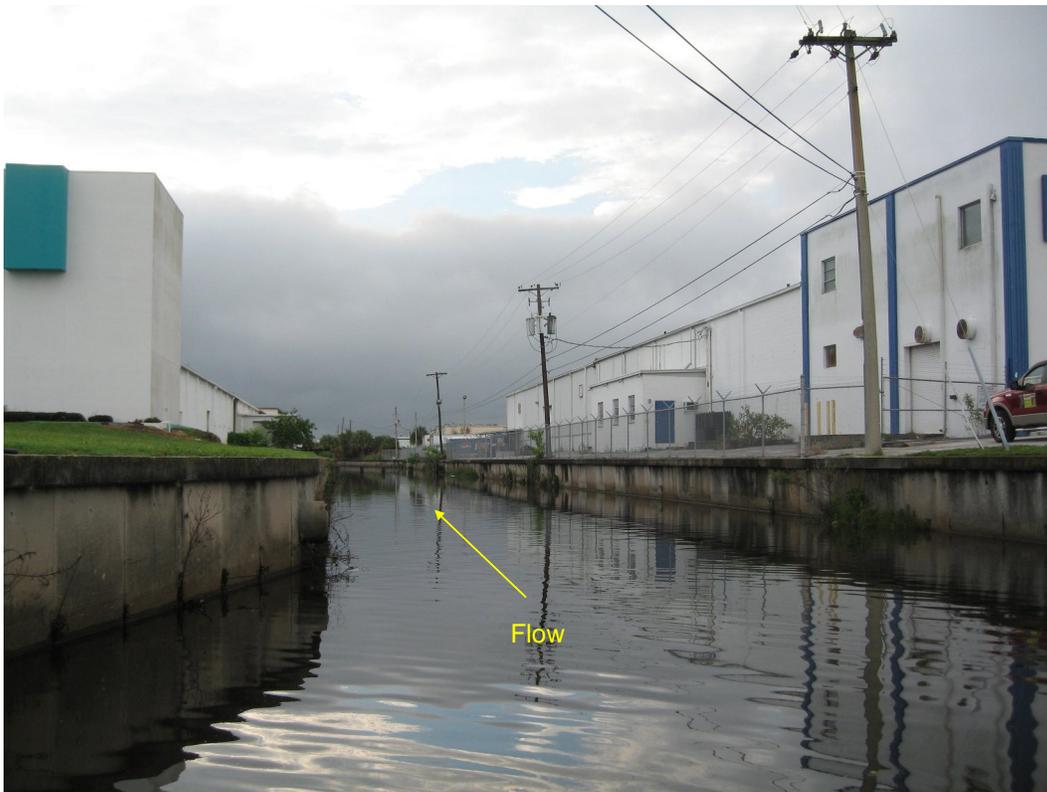
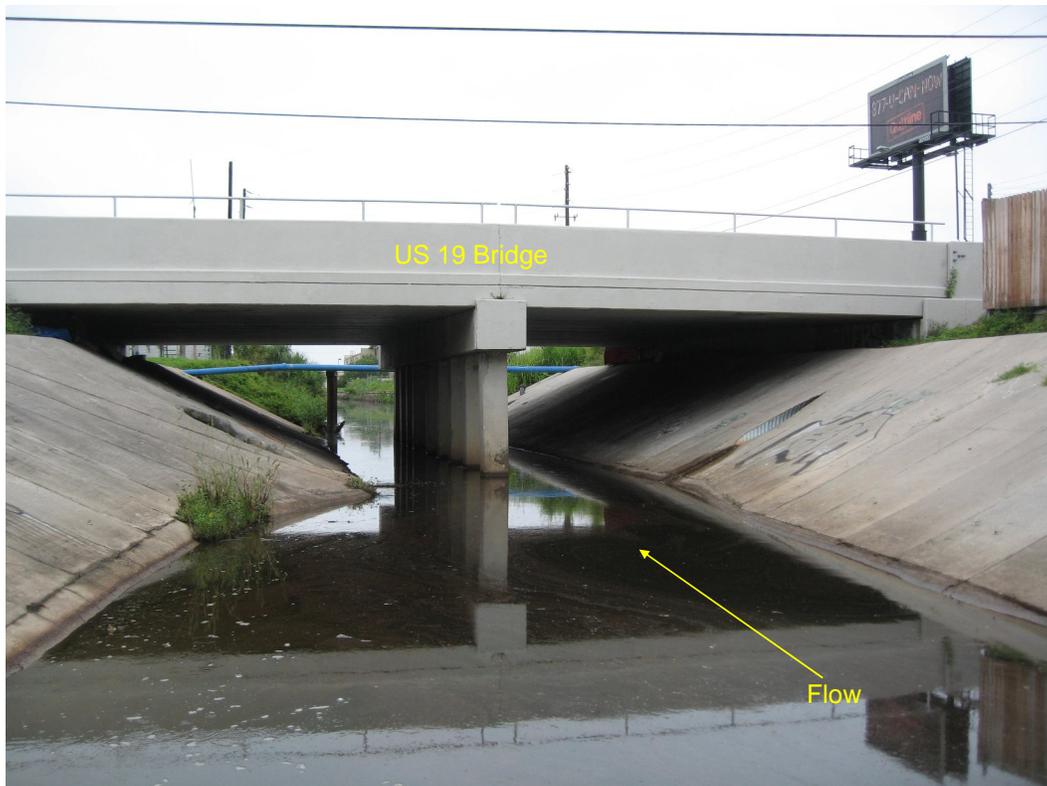
Figure 2-21. Channelized Portions of Joe's Creek.

a. Joe's Creek Downstream from Silver Lake Weir

b. Joe's Creek at U.S. 19 Bridge Crossing

After leaving Silver Lake, discharges through Joe's Creek enter a channelized portion of the creek characterized by vertical sea walls and concrete-lined channels. These channelized areas extend approximately from the Silver Lake weir to the U.S. 19 bridge. Photographs of the channelized portions of Joe's Creek are given on Figure 2-21. A number of miscellaneous inflows discharge to Joe's Creek through this area which introduce additional volumetric and pollutant loadings to the creek. Photographs of miscellaneous inflows are given on Figure 2-22.

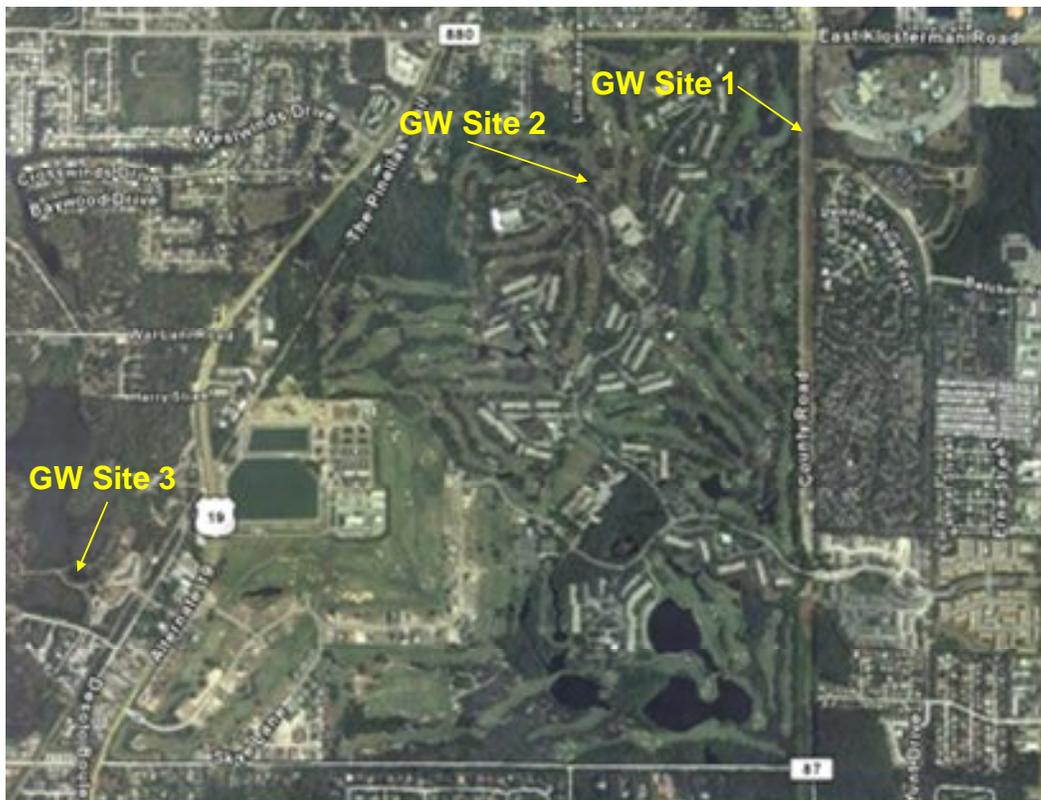
Figure 3-7. Overview of Groundwater Monitoring Sites in the Klosterman Bayou Watershed.

An overview of the groundwater monitoring sites for the Klosterman Bayou watershed area is given on Figure 3-7. Groundwater monitoring sites were selected to provide information on groundwater quality upstream of the project site, within the project site, and downstream from the project site.

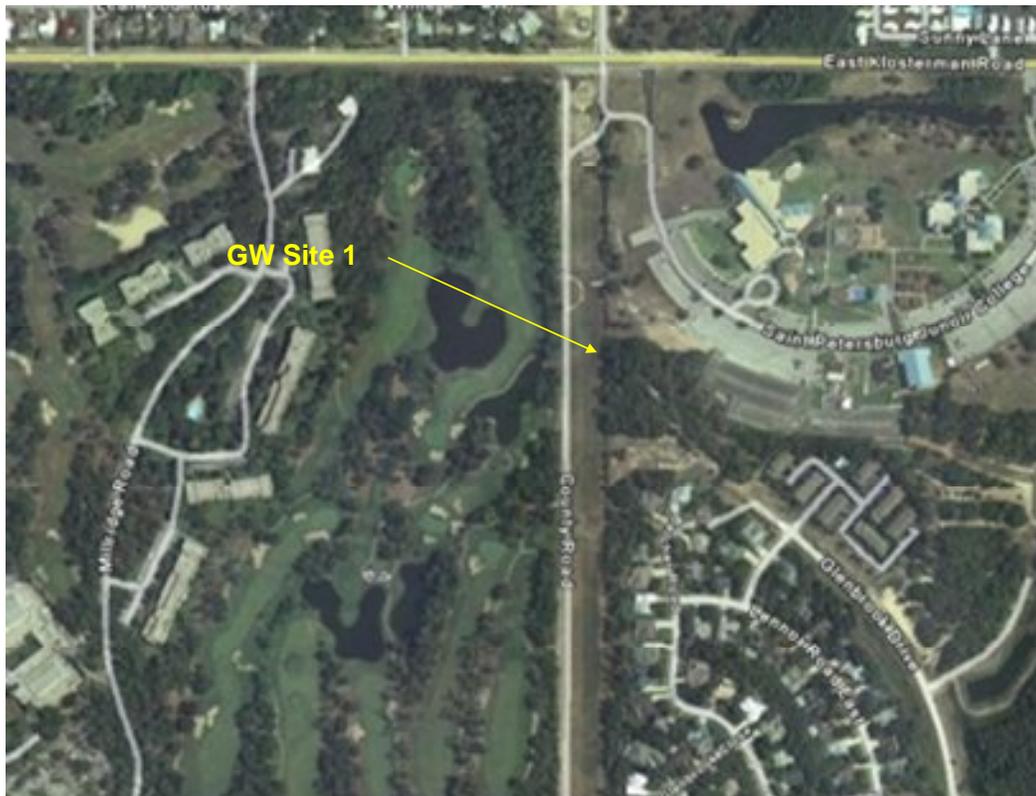
Figure 3-8. Location of Groundwater Monitoring Site 1 in the Klosterman Bayou Watershed.

The upgradient groundwater monitoring site for the Klosterman Bayou watershed area (Site 1) was located in the area northeast of the golf course site, as indicated on Figure 3-8. This groundwater monitoring site was located in the undeveloped utility corridor east of the golf course complex. The specific location for this site was selected in the field to avoid impacts from adjacent surface flows and provides characterization of shallow groundwater prior to entering the IGC site.

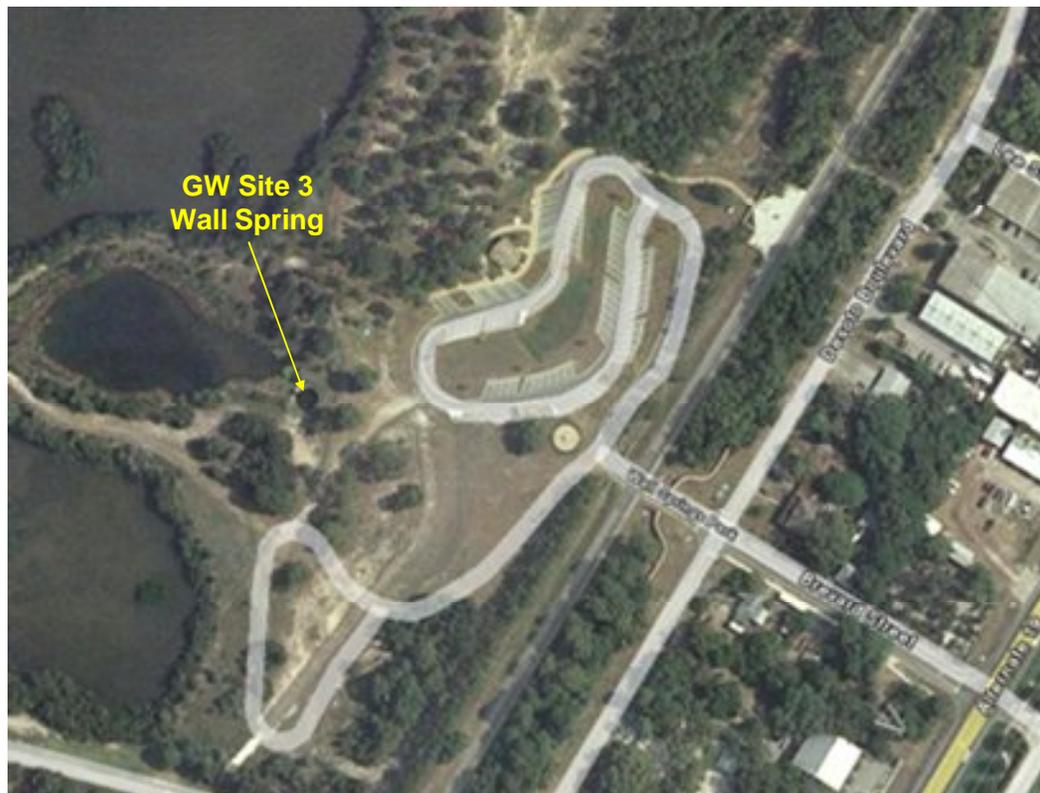
Figure 3-10. Location of Groundwater Monitoring Site 3 in the Klosterman Bayou Watershed.

The selected location for groundwater monitoring Site 3 in the Klosterman Bayou project area is illustrated on Figure 3-10. This site is located hydrologically downstream from the golf course complex and is intended to evaluate impacts on groundwater from the golf course operations. After reviewing potential monitoring sites, it was decided that discharges from Wall Spring be used to represent groundwater discharges downstream from the golf course complex. This spring is hydrologically connected to the shallow aquifer system underlying the Klosterman Bayou watershed.

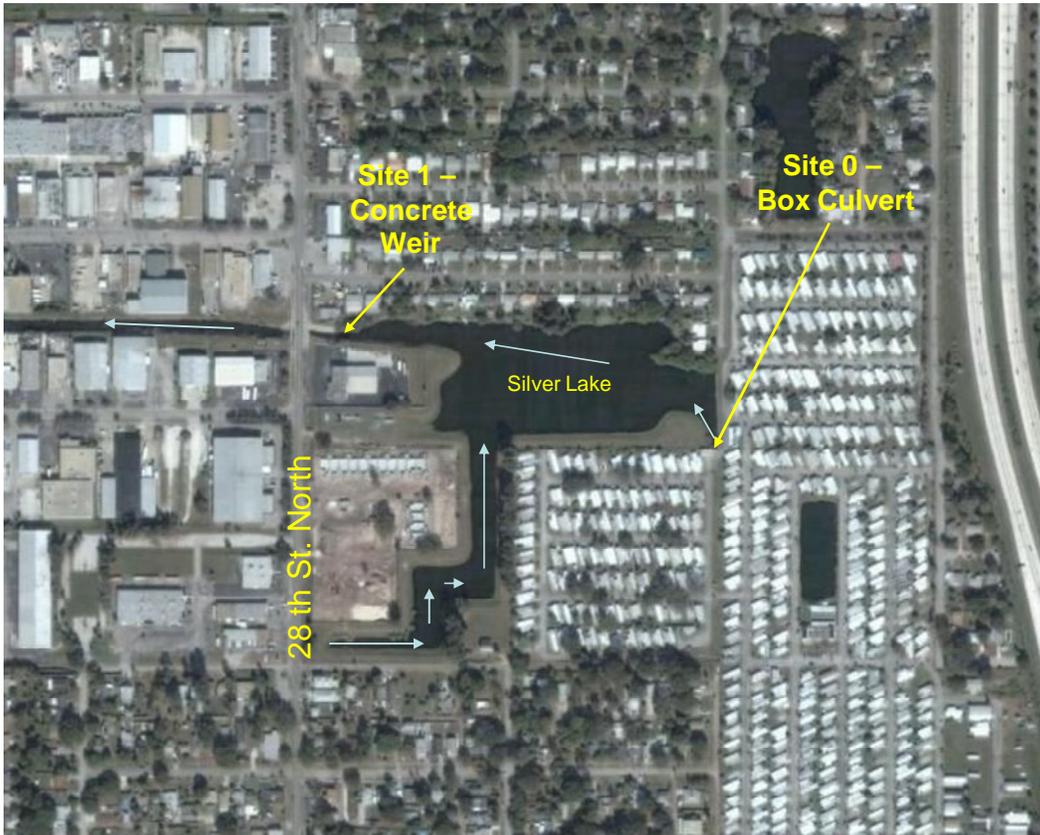
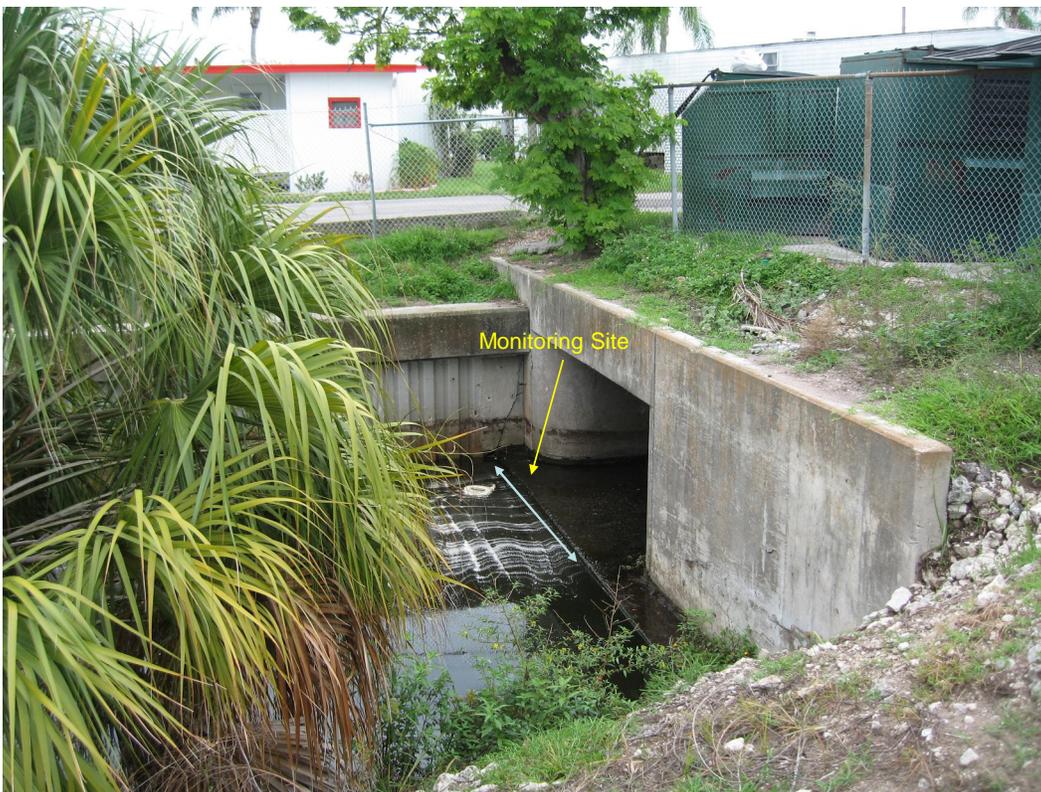
Figure 3-12. Locations of Surface Water Monitoring Sites 0 & 1 in the Joe's Creek Watershed.

a. Site Locations

b. Box Culvert Discharge Monitoring Site

The monitoring site designated as Site “0”, indicated on Figure 3-11, was added after the initial five monitoring sites had been selected and approved by Pinellas County and the District. This site represents inflow at the headwaters of Joe's Creek and allows an evaluation of changes in water quality characteristics during migration through Silver Lake. The location for Site 0 is indicated on Figure 3-12. This site is located at the discharge for the box culvert illustrated on Figure 2-19.

The selected location for surface water monitoring Site 1 is also shown on Figure 3-12a. This site is located on the downstream side of the weir structure at the discharge from Silver Lake into the headwaters of Joe's Creek. This monitoring site represents water quality in the upstream portions of Joe's Creek.

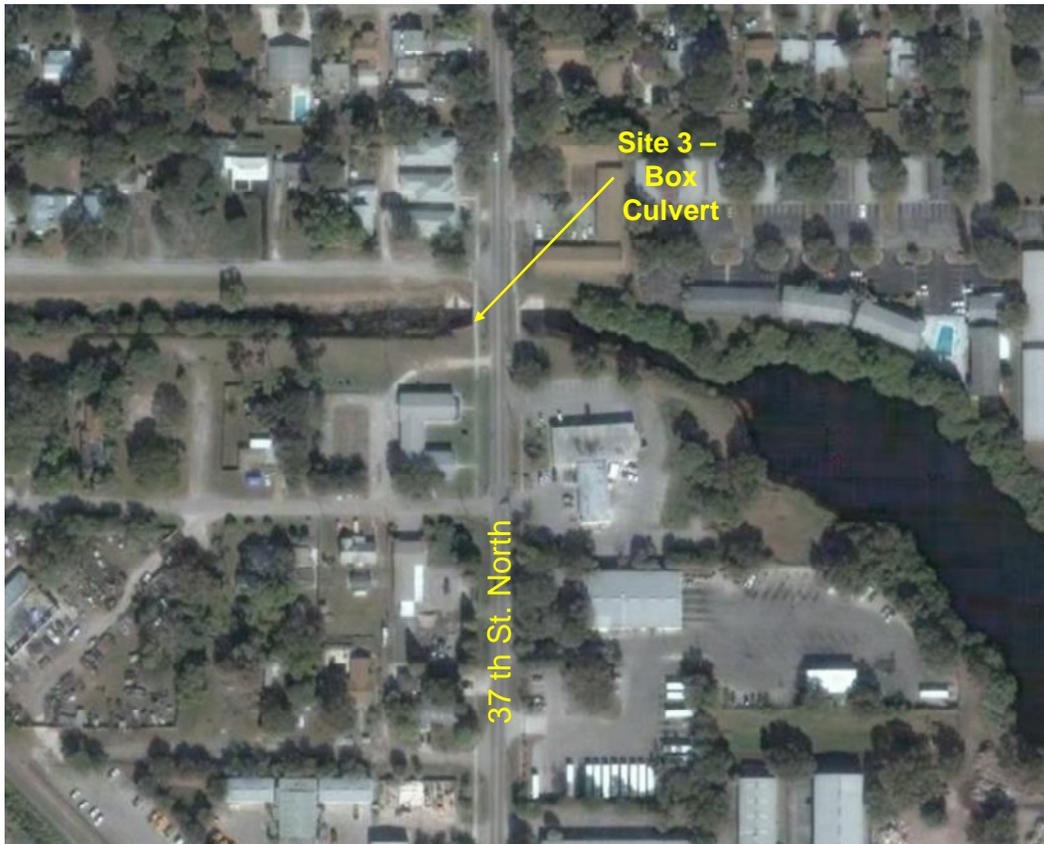
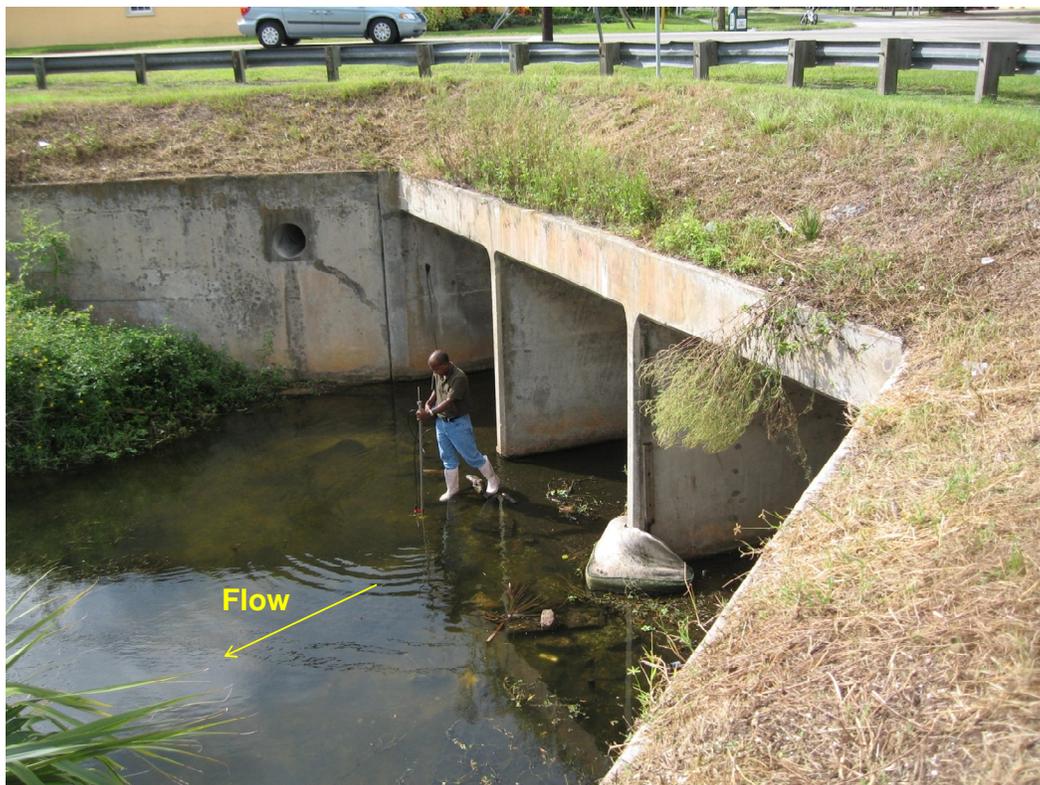
Figure 3-14. Location of Surface Water Monitoring Site 3 in the Joe's Creek Watershed.

a. Site Location

b. Monitoring Site

The location of surface water monitoring Site 3 is indicated on Figure 3-14. This monitoring site is located on the downstream side of the box culvert which conveys Joe's Creek beneath 37<sup>th</sup> Street North. This site is also used to represent inflow characteristics into the wetland and pond improvement project.

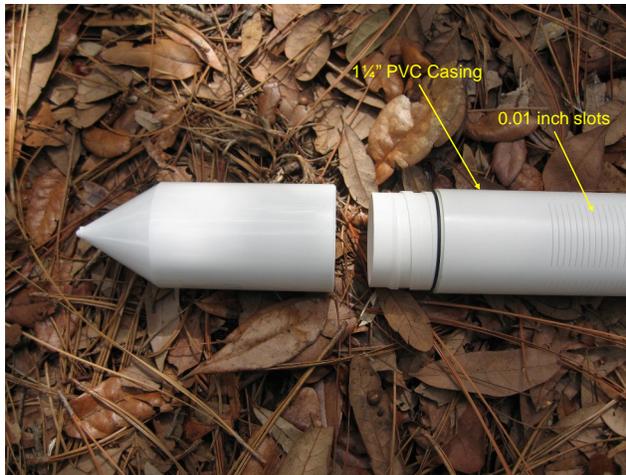
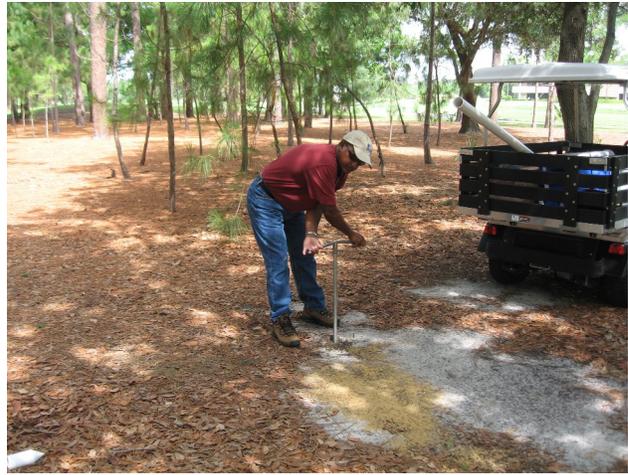
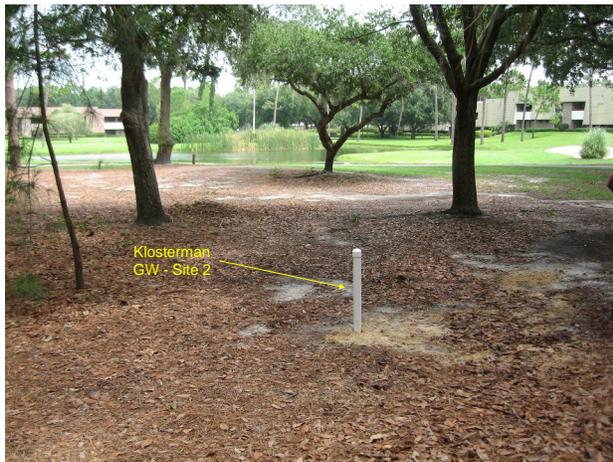
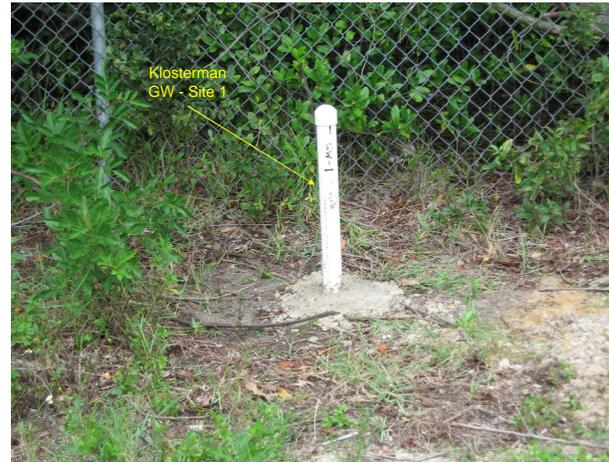
Figure 3-21. Monitoring Well Construction Details.

a. Slotted Groundwater Well

b. Well Installation

c. Klosterman Groundwater Monitoring Site 2

d. Klosterman Groundwater Monitoring Site 1

Each of the groundwater monitoring wells consisted of a 1.25-inch slotted casing which was hand-augered to a depth of approximately 3-4 ft below the surficial groundwater table at the time of installation. A diagram of monitoring well installation details is given in Figure 3-19. Construction logs for the monitoring wells are given on Figure 3-20. Each of the wells contained a bottom slotted PVC screen, approximately 4 ft in length, with slot widths of 0.01 inches. The void space around the well was filled with 20-30 silica sand to a level above the slotted PVC screen. Soil backfill from the excavated hole was then placed around the well to a level approximately 6 inches below the ground surface. A 6-inch thick bentonite pellet seal was then added to prevent short-circuiting of water through the well bore hole. The 1.25-inch PVC riser extended 24 inches above the ground, with a vented PVC cap placed on the top to prevent contamination of the well between monitoring events. Photographs of typical monitoring well construction are given on Figure 3-21.
